## Souza II: Restoration Opportunities on a Tributary to Brushy Creek

A project of the East Contra Costa County Habitat Conservancy

**PRELIMINARY FINDINGS:  
HISTORICAL ECOLOGY OF SOUZA II PROPERTY**

**A Technical Memorandum to Contra Costa County**

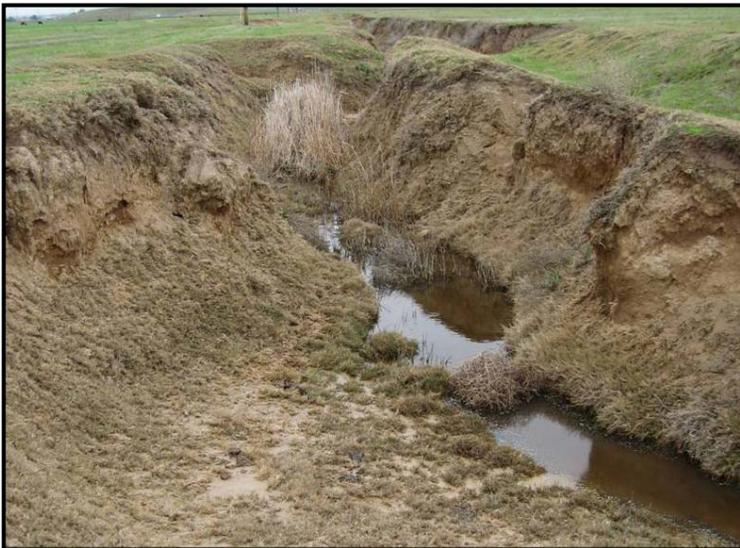
*In channel wetland vegetation*

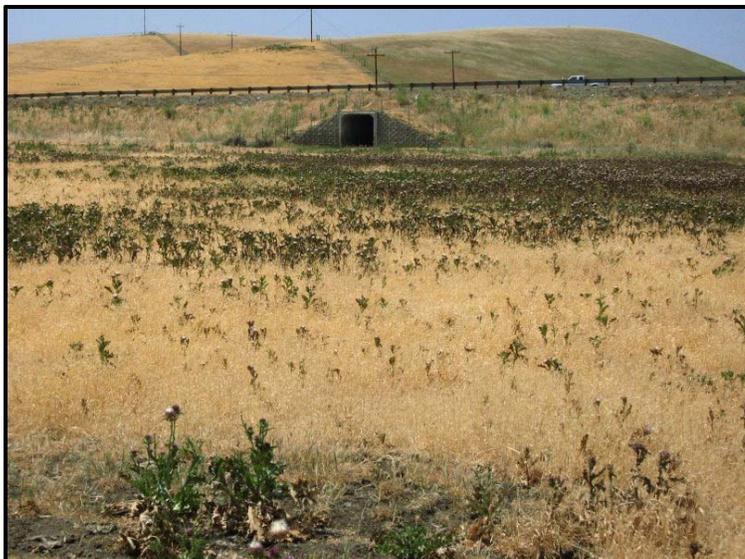
*Thistle infestation on northwest portion of parcel*

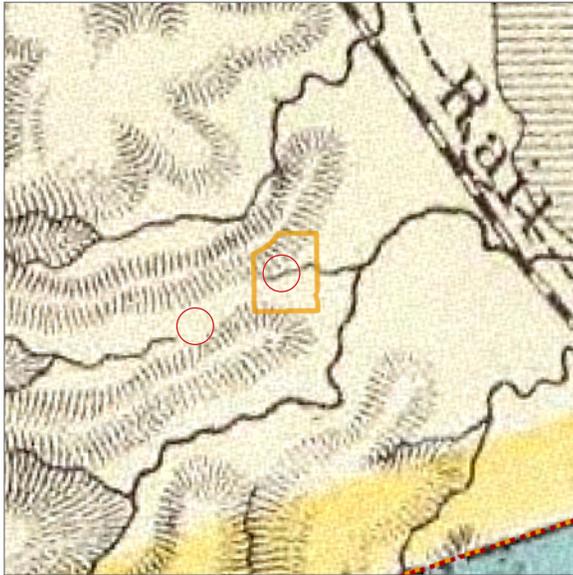
DETAIL OF BRUSHY CREEK AREA FROM CALIFORNIA GEOLOGICAL SURVEY  
"TOPOGRAPHICAL MAP OF CENTRAL CALIFORNIA", WHITNEY AND HOFFMAN, 1873

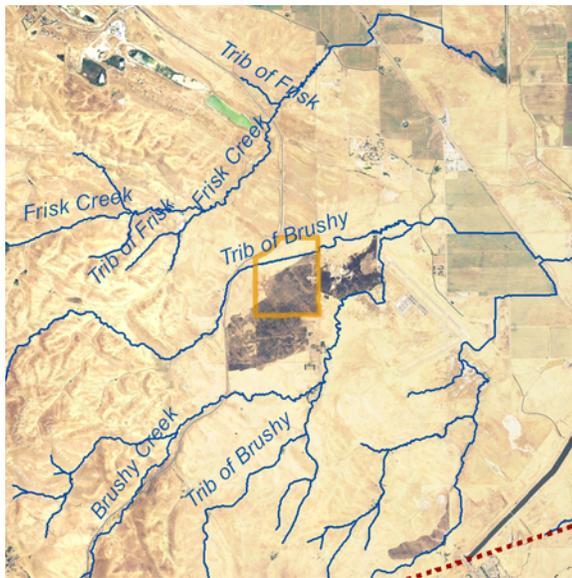
scale: 1:96,000

Figure 1. Souza II property (center of map, outlined in orange) with contemporary stream network depicted on 2005 imagery.

The Souza II property is approximately 190 acres recently purchased for restoration purposes by Contra Costa County. Currently a tributary of Brushy Creek runs from west to east across the property in a deeply incised and straight channel. The tributary connects with Brushy Creek about a mile beyond the east edge of the Souza II property (see Fig. 1).

The tributary to Brushy Creek on the Souza II property is currently a deeply incised and relatively straight channel, connecting to the main of Brushy Creek (see Fig 1). Several of the earliest historical maps show the tributary as discontinuous, with the defined channel ending approximately 1/2 mile to the southwest of the property and reappearing

The sources presented here suggest that the Brushy Creek tributary had a distinctly different channel/wetland morphology than the current straight and deeply incised connection across the Souza II property (see Fig. 1).

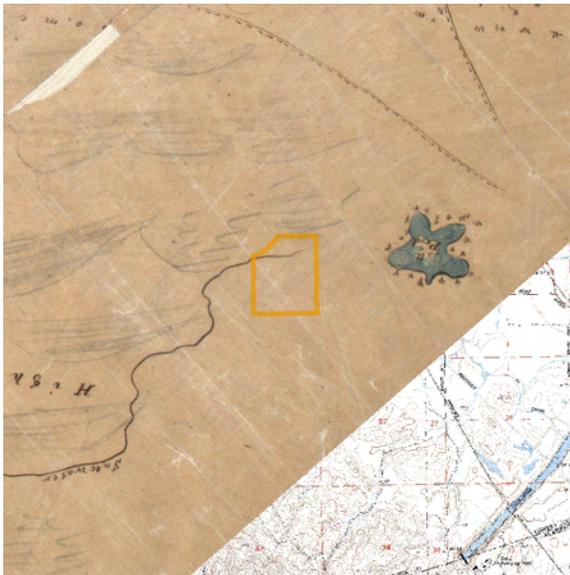
scale: 1:96,000

Figure 2. This detail from an 1853 map of Los Meganos appears to be a copy made by the U.S. Surveyor General's Office of the 1853 original *diseño* (land grant map), probably for the confirmation hearings for the land grant. The map depicts a channel and pond on the east side of the grant. The channel, marked "Salt water", ends about one-half a mile above a body of water, marked "Pond" on this map. The same feature is marked "Salt Pond" on the original map. Once georeferenced, this channel falls in the same location as the tributary to Brushy Creek; however further investigation is required to confirm the location.

The newly established township and range lines are depicted on each map, and were used to help align the map during georeferencing in the GIS. Measurement between persistent features in the georeferenced *diseño* and the contemporary landscape varies, but overall was remarkably good for such an early map. For example, Briones, Deer, and Horse valleys correspond to the location of the same valleys on a contemporary map, and the lower portion of Marsh Creek agrees in general trend and direction. However, without further investigation, it is difficult to say with certainty the channel portrayed on the land grant map is the tributary to Brushy Creek.

Fig. 2: Los Meganos confirmation survey, U.S. Surveyor's Office, 1853

The tributary of Brushy Creek currently crosses the property on the area of historical Solano silty clay and an alkali affected area. This could indicate the presence of an alkali meadow/wetland. The land grant map from 1853 confirms a channel with “salt water” as well as a salty pond in the area.

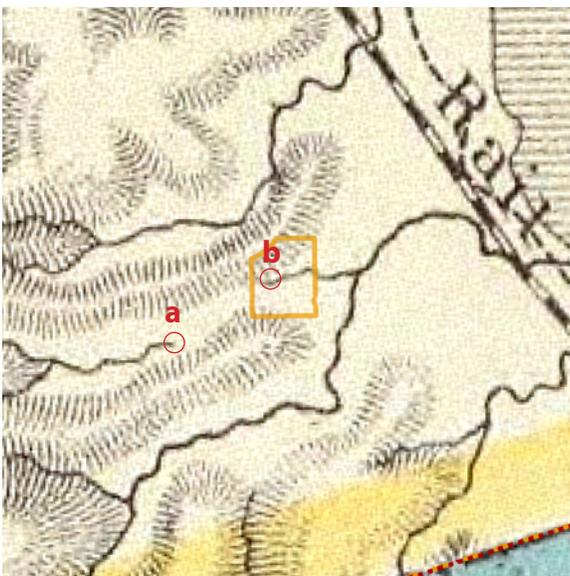
scale: 1:96,000

Figure 3. However, this 1873 map by Hoffmann and Whitney of the California Geological Survey shows the tributary to Brushy Creek quite clearly, and depicts the channel as stopping west of the Souza II boundary (a) and reappearing to the east (b).

This small scale (1:380,000) yet detailed map, entitled "Topographical Map of Central California Together With a Part of Nevada" was part of a statewide surveying and mapping effort by the California Geological Survey.

Fig. 3: Topographical Map of Central California (California Geological Survey), Whitney and Hoffman, 1873

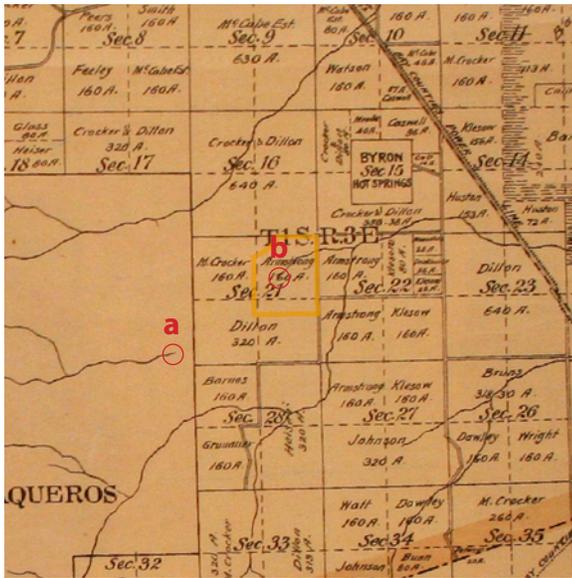
scale: 1:96,000

Figure 4. The "Official Map of Contra Costa County California" from 1908 was "compiled from private surveys and official records" by surveyor T.A. McMahon. The portion shown to the left indicates the tributary of Brushy Creek is discontinuous for 1500 meters, ending close to the eastern edge of the Los Vaqueros land grant (a), and reappearing again in the NE of section 21, on the Souza II property (b).

Fig. 4: Official Map of Contra Costa County, McMahon, 1908

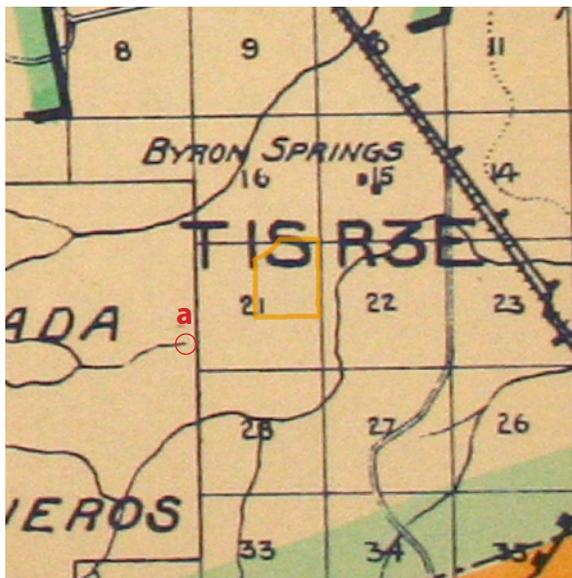
scale: 1:96,000

Figure 5. In a privately published map of Contra Costa and Alameda counties by C.F. Weber and Co. in 1913, the tributary of Brushy Creek also ends close to the eastern edge of the Los Vaqueros land grant boundary (a). On this particular map, the channel does not reappear before the Brushy Creek mainstem (though it's unclear if that was omitted due to the large township and range numbers).

Fig. 5: Map of Contra Costa and Alameda Counties, Weber 1913

The General Land Office survey notes indicate there was a natural creek channel on the east side of the property in 1862. This is consistent with the evidence found on the historical maps described above, as each map source (except for Fig. 5) shows the channel in evidence on the east side of the Souza II property. This also appears to be evident in the historical and contemporary aerial photographs.

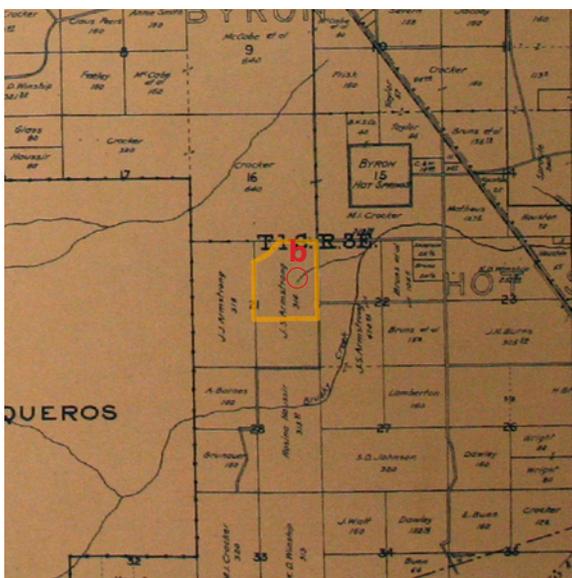
scale: 1:96,000

Figure 6. In 1914, a new edition of the "Official Map of Contra Costa County California" was published. In this version by Arnold and Glass, the tributary to Brushy Creek is only shown as a channel starting within the Souza II property (b), and not on the eastern side of Los Vaqueros land grant.

Fig. 6: Official Map of Contra Costa County, Arnold & Glass, 1914

Maps prior to 1916 show the channel as discontinuous. It is possible these sources are not independent, but rather are compiled and therefore may repeat information rather than be independent confirmation. For example, the second “official” map of the county (Arnold and Glass, 1914; see Fig. 6) likely built on the first (McMahon, 1908; see Fig. 4), so the gap in the creek’s channel indicated on both maps is not necessarily evidence of the creek being surveyed on two separate occasions. The privately published map in 1913 may have been compiled from the published McMahon county map as well. However, the 1873 California Geological Survey clearly depicts the creek as being discontinuous (Whitney and Hoffman, 1873; see Fig. 3). Additionally, if this depiction of the tributary to Brushy Creek as discontinuous was incorrect, it is likely it would have been corrected on the second map of the county in 1914.

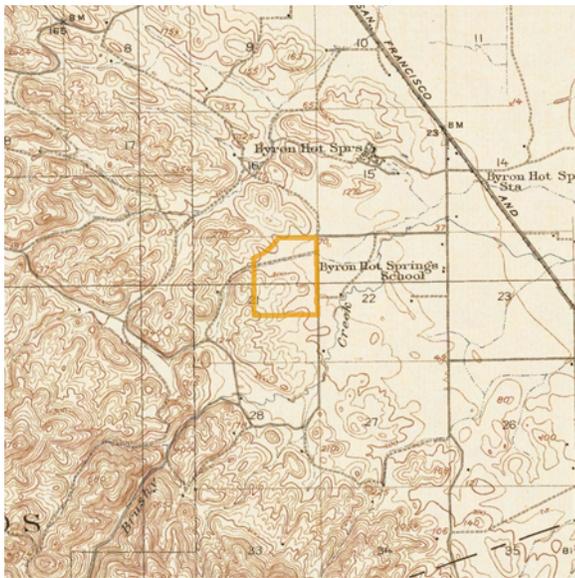
scale: 1:96,000

Figure 7. The 1916 USGS quadrangle of Byron (15 minute, 1:63500 scale) shows the tributary continuous across the Souza II property. The quadrangle indicates the channel now runs closely parallel to a dirt road through the Souza II property in a straight line.

By 1916, the U.S. Geological Survey map shows the tributary connecting across the Souza II property (Fig. 7).

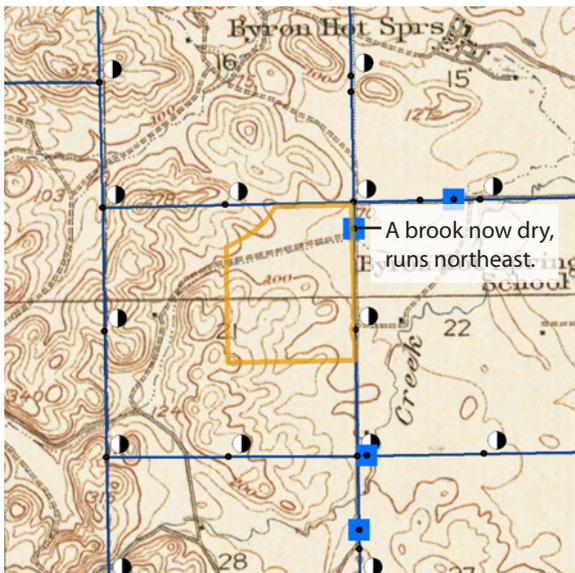
scale: 1:48,000

Figure 8. Dyer noted in the 1863 GLO survey as he crossed the tributary to Brushy Creek that “a brook now dry, runs northeast”. The survey notes also indicate that there were no trees in the vicinity (indicated here by black and white circles).

E.H. Dyer surveyed the eastern boundary of Township 1S, Range 3E, Section 21 (the eastern edge of the Souza II boundary) for the General Land Office Survey (GLO) in June 1862. In his survey notes, he records “A brook now dry, runs northeast” as he crosses the tributary at the section line, indicating the bed of the creek appeared to have carried water at some point. The western edge of Section 21 was only surveyed to establish the eastern boundary of Los Vaqueros land grant, and does not contain notes about any fluvial features.

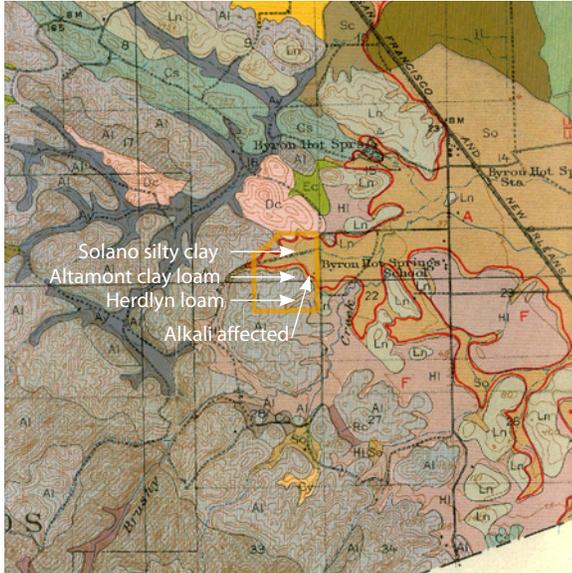
scale: 1:96,000

Figure 9: The 1933/39 USDA soil map shows three soil types on the property:

- So: Solano silty clay, coinciding with area of “alkali affected” in red (“hummocky microrelief”; poor drainage; alkaline, especially subsoil; high salt content)
- Al: Altamont clay loam (easily cultivated, retentive of moisture)
- Hi: Herdlyn loam (poor in organic material; hard and baked when dry)

The historical USDA soil survey is consistent with the modern survey, showing alkali soils with low permeability. The straight and incised tributary to Brushy Creek on the Souza II property is on poorly drained Solano silty clay, in an alkali affected area. Solano silty clay is described as having a “hummocky microrelief”, suggesting vernal pool conditions.

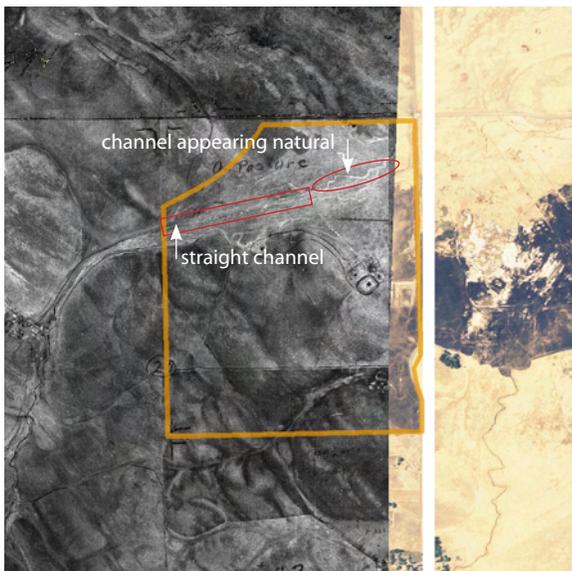
scale: 1:24,000

Figure 10: A mosaic of 1939 aerial photographs, shown against contemporary imagery.

The historical aerial photographs show a straight channel through most of the property, but also shows multiple shallow channels, possibly indicating seasonally wet swales or sloughs. Note area of natural appearing channel on east edge of property (Fig. 10).

The 1939 aerial photographs show multiple shallow channels as well as a straight ditch through the project area. Remnants of at least one of these shallow channels are still visible.
