**THE LOMA PRIETA
(SANTA CRUZ MOUNTAINS)
CALIFORNIA,
EARTHQUAKE OF 17 OCTOBER 1989**

Division of Mines and Geology

**THE LOMA PRIETA
(SANTA CRUZ MOUNTAINS), CALIFORNIA,
EARTHQUAKE
OF
17 OCTOBER 1989**

Special Publication 104

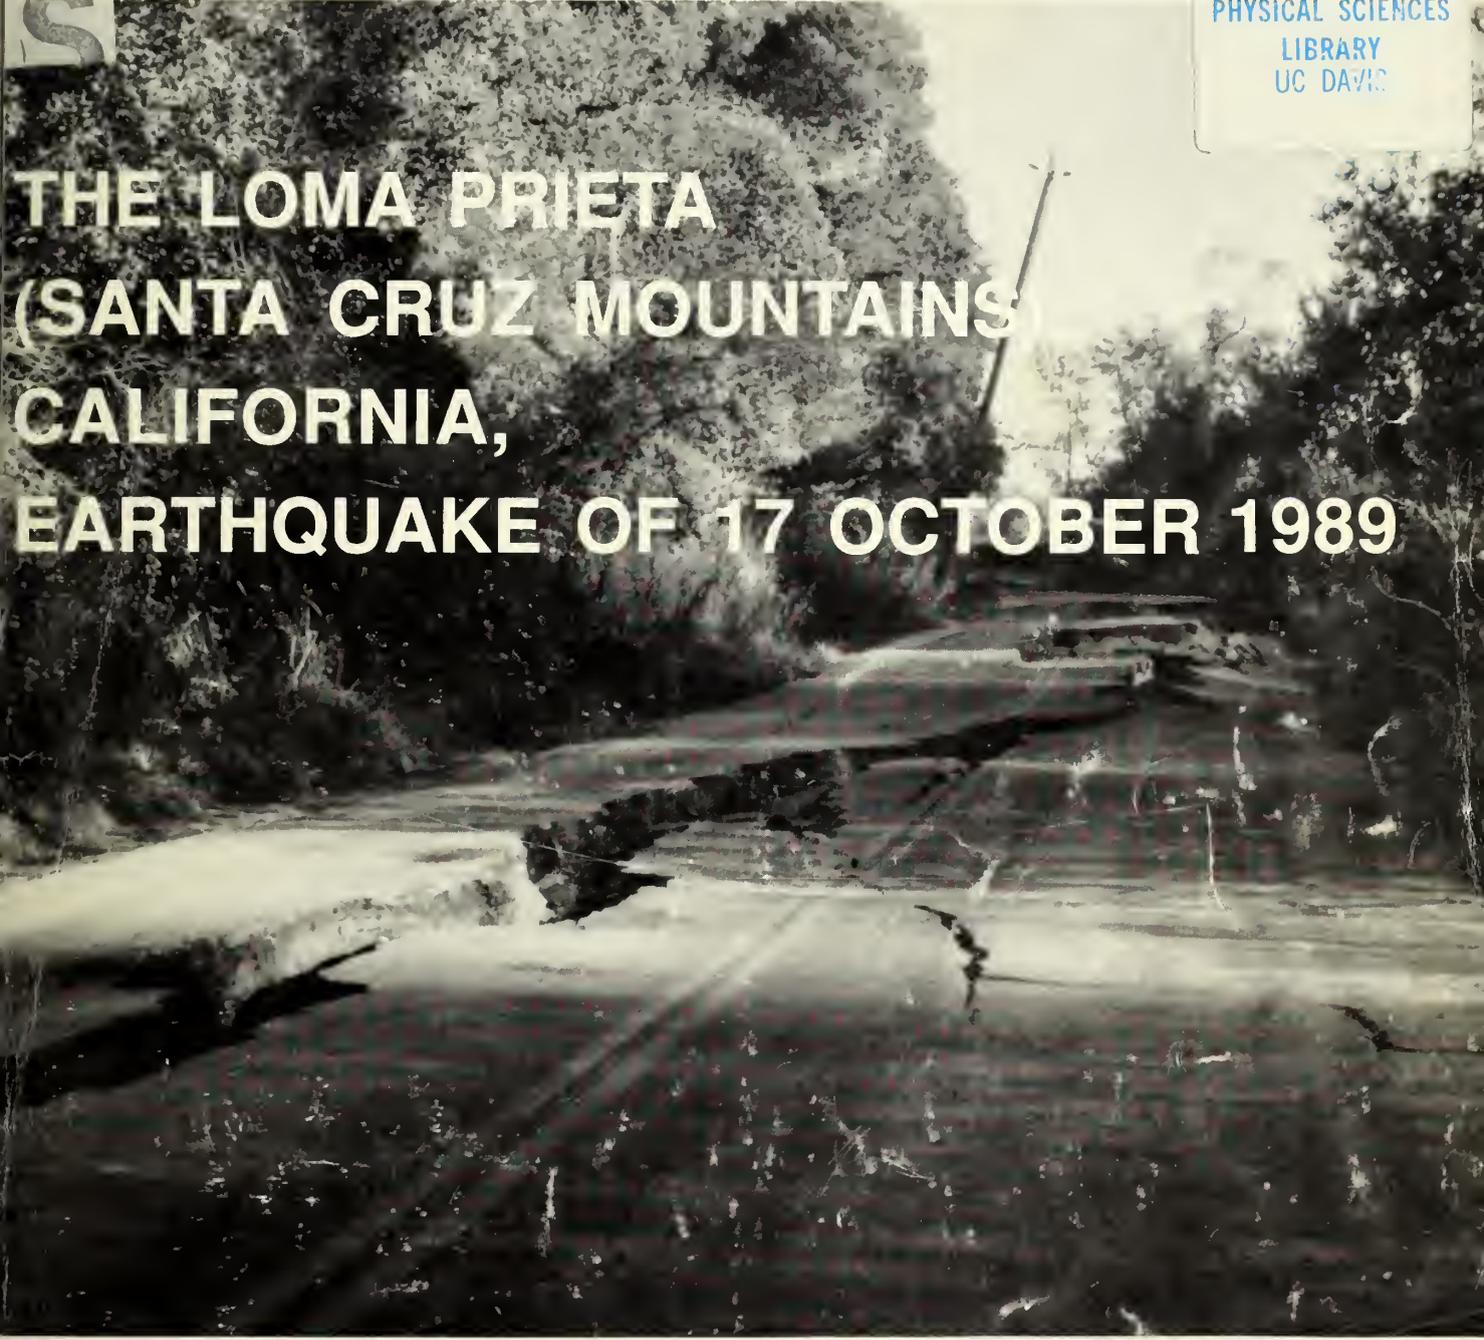
Cover Photo:

View to the south of Hazel Dell Road, located in the Santa Cruz Mountains about 8.5 kilometers north of Watsonville. The large fissures in the road were caused by lateral spreading due to liquefaction of saturated sediments in Simas Lake and intense shaking associated with the M_s 7.1 Loma Prieta earthquake (note leaning telephone pole). Simas Lake, located just west of Hazel Dell Road, is a closed depression formed by recurring surface fault rupture along the San Andreas fault. *Photo by W. A. Bryant, 10/18/89.*

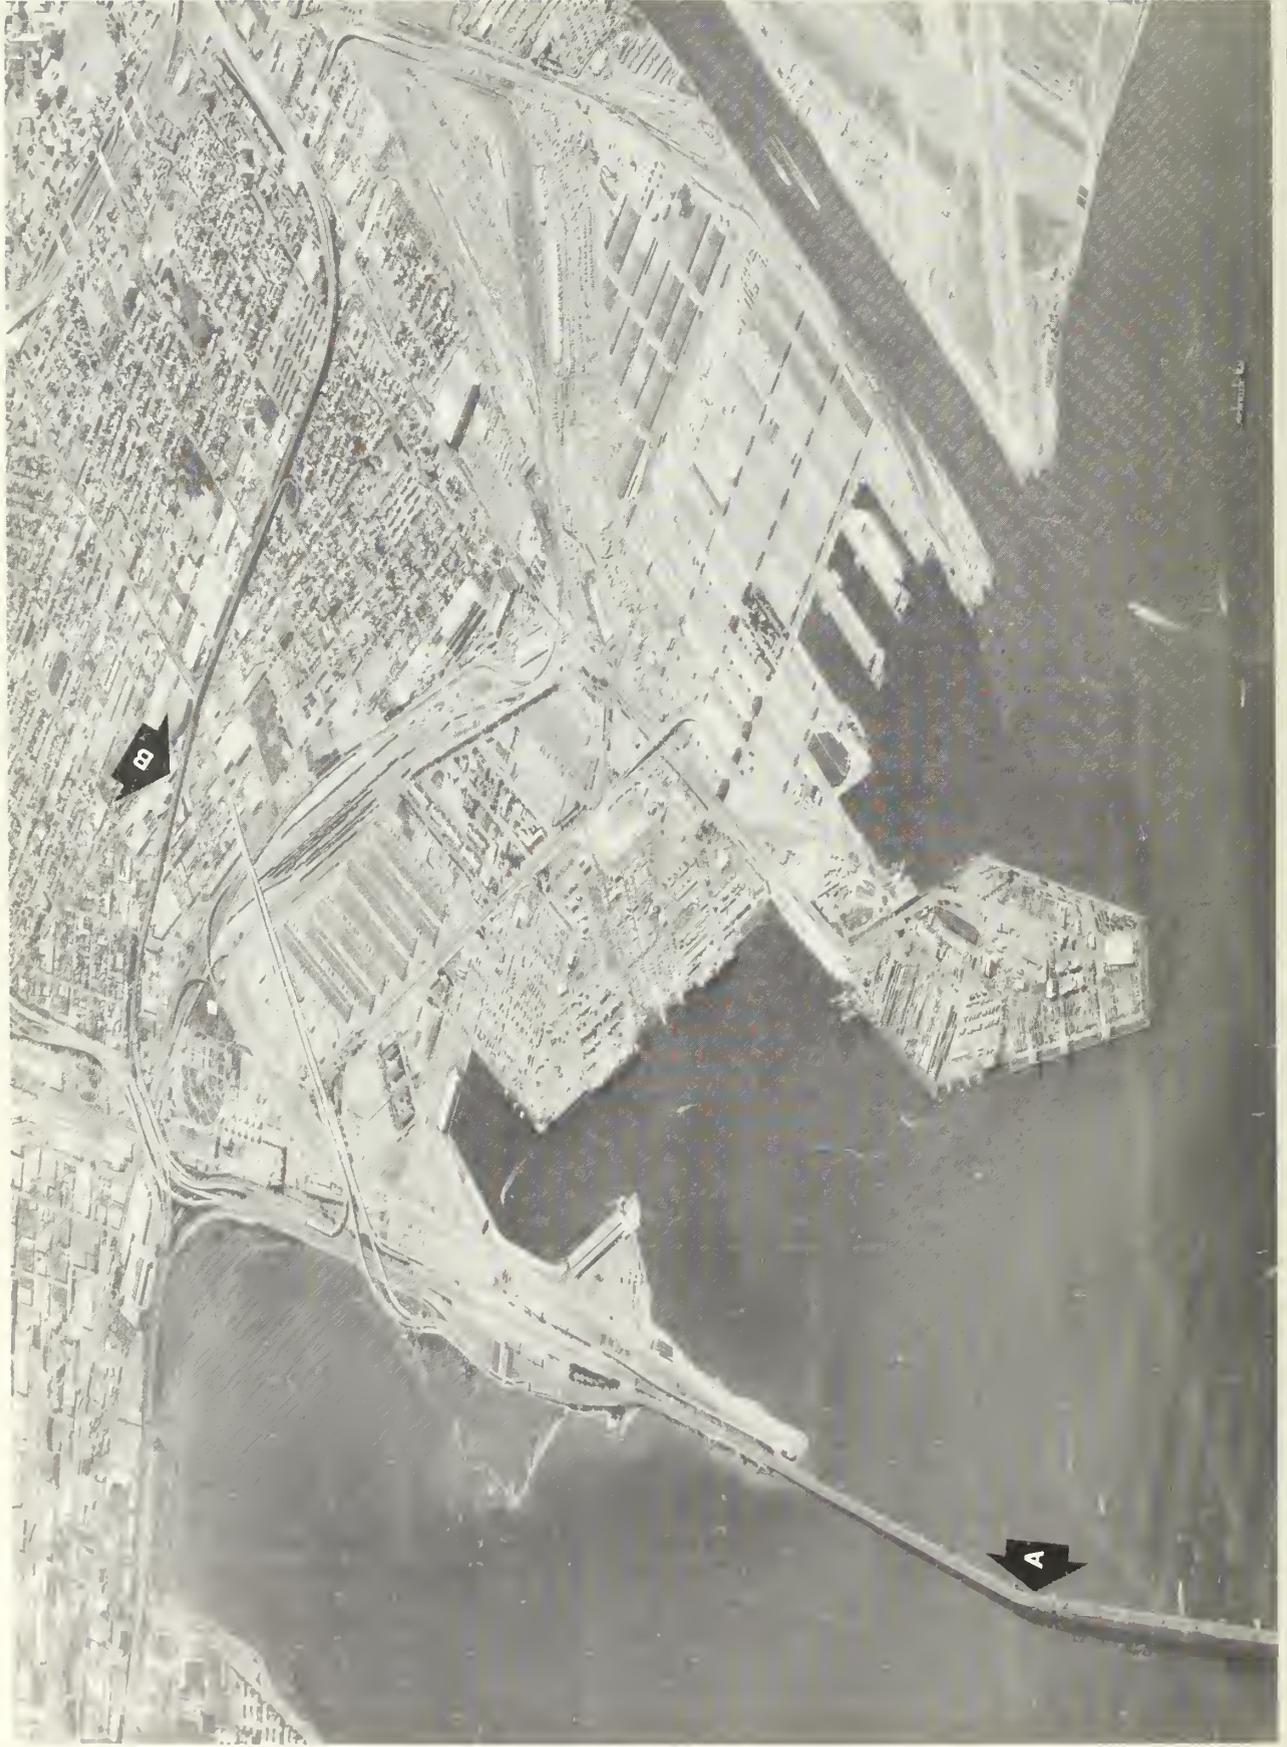
Oblique high-altitude U-2 photograph of the damaged San Francisco-Oakland Bay Bridge (A) and collapsed Cypress Freeway (B) taken on October 18, 1989, the morning after the earthquake (courtesy of USAF). The image was captured by an IRIS-II panoramic aerial camera looking northeast from an altitude of about 65,000 feet (see article by Real and others, this volume).

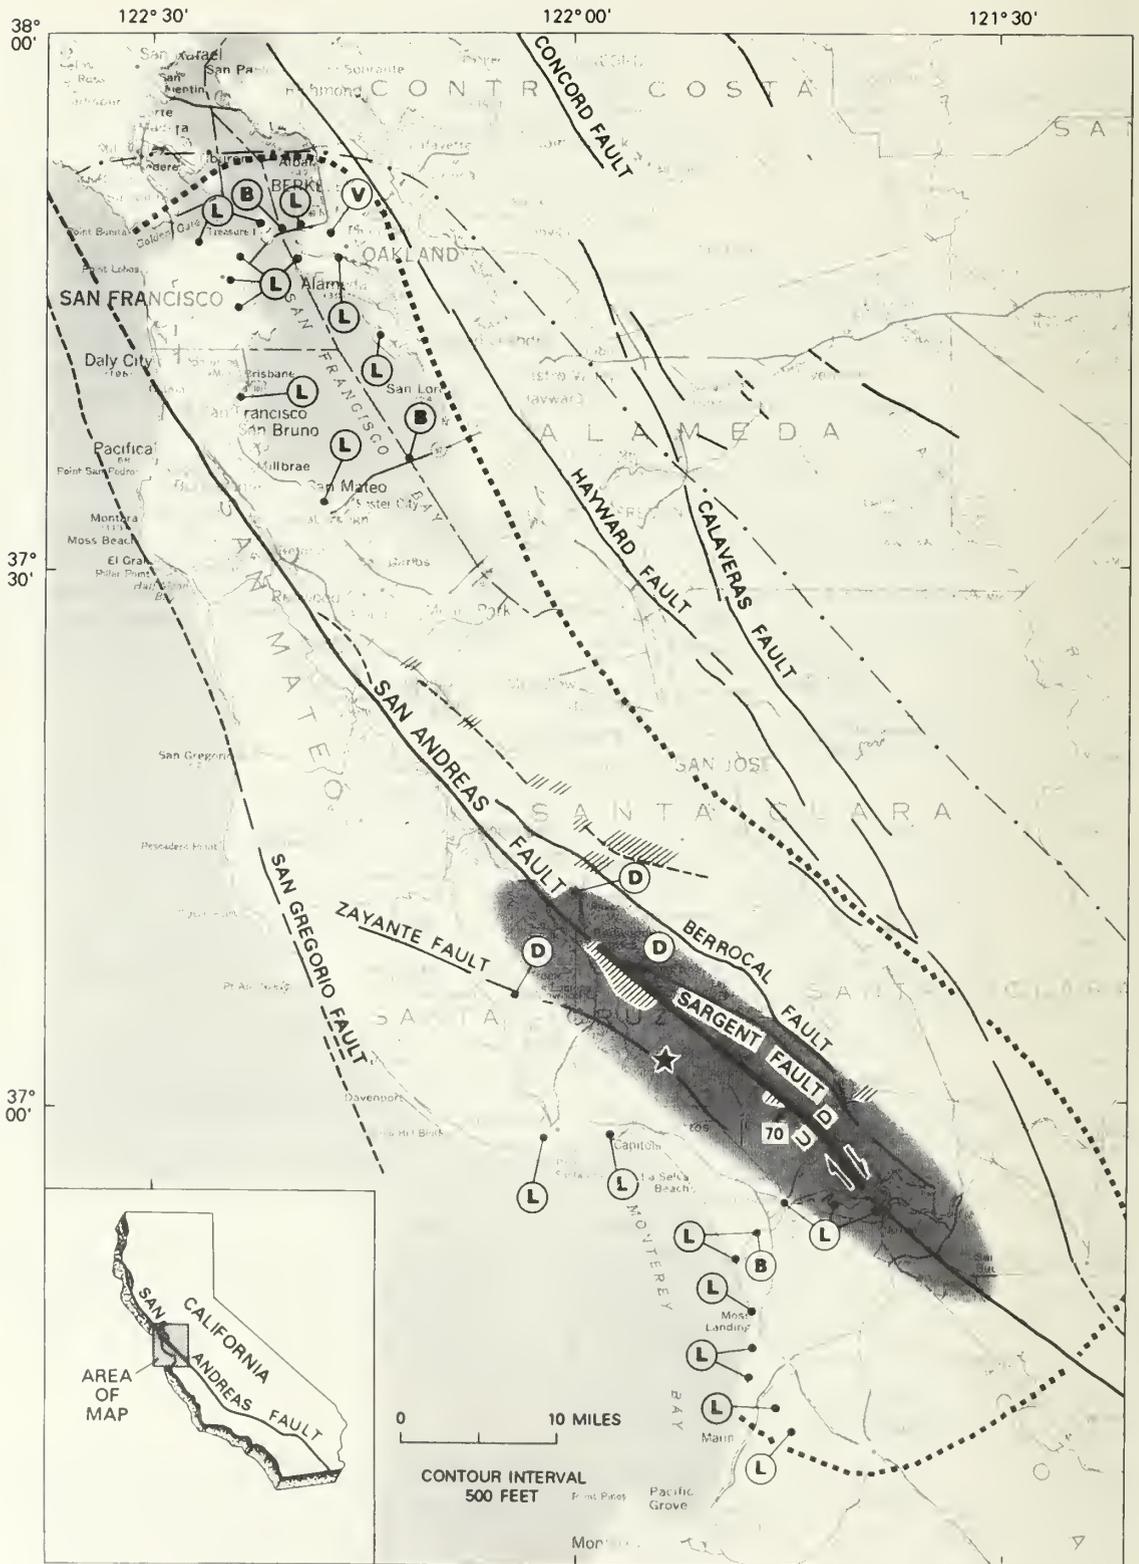
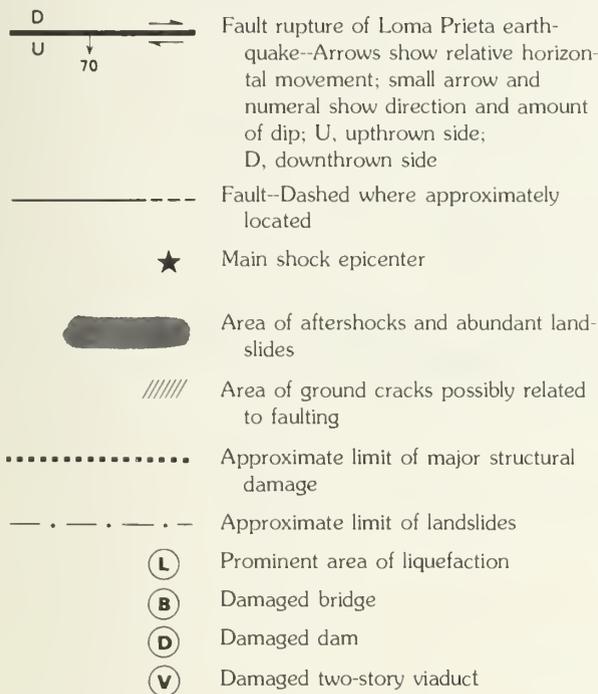
Figure 1. Mainshock epicenter of Loma Prieta earthquake and inferred fault rupture relative to areas of larger aftershocks, abundant ground cracks, and landslides and to limits of structural damage. Also shown are locations of major damaged structures and principal areas of ground cracks and liquefaction (source: Plafker and Galloway, 1989).

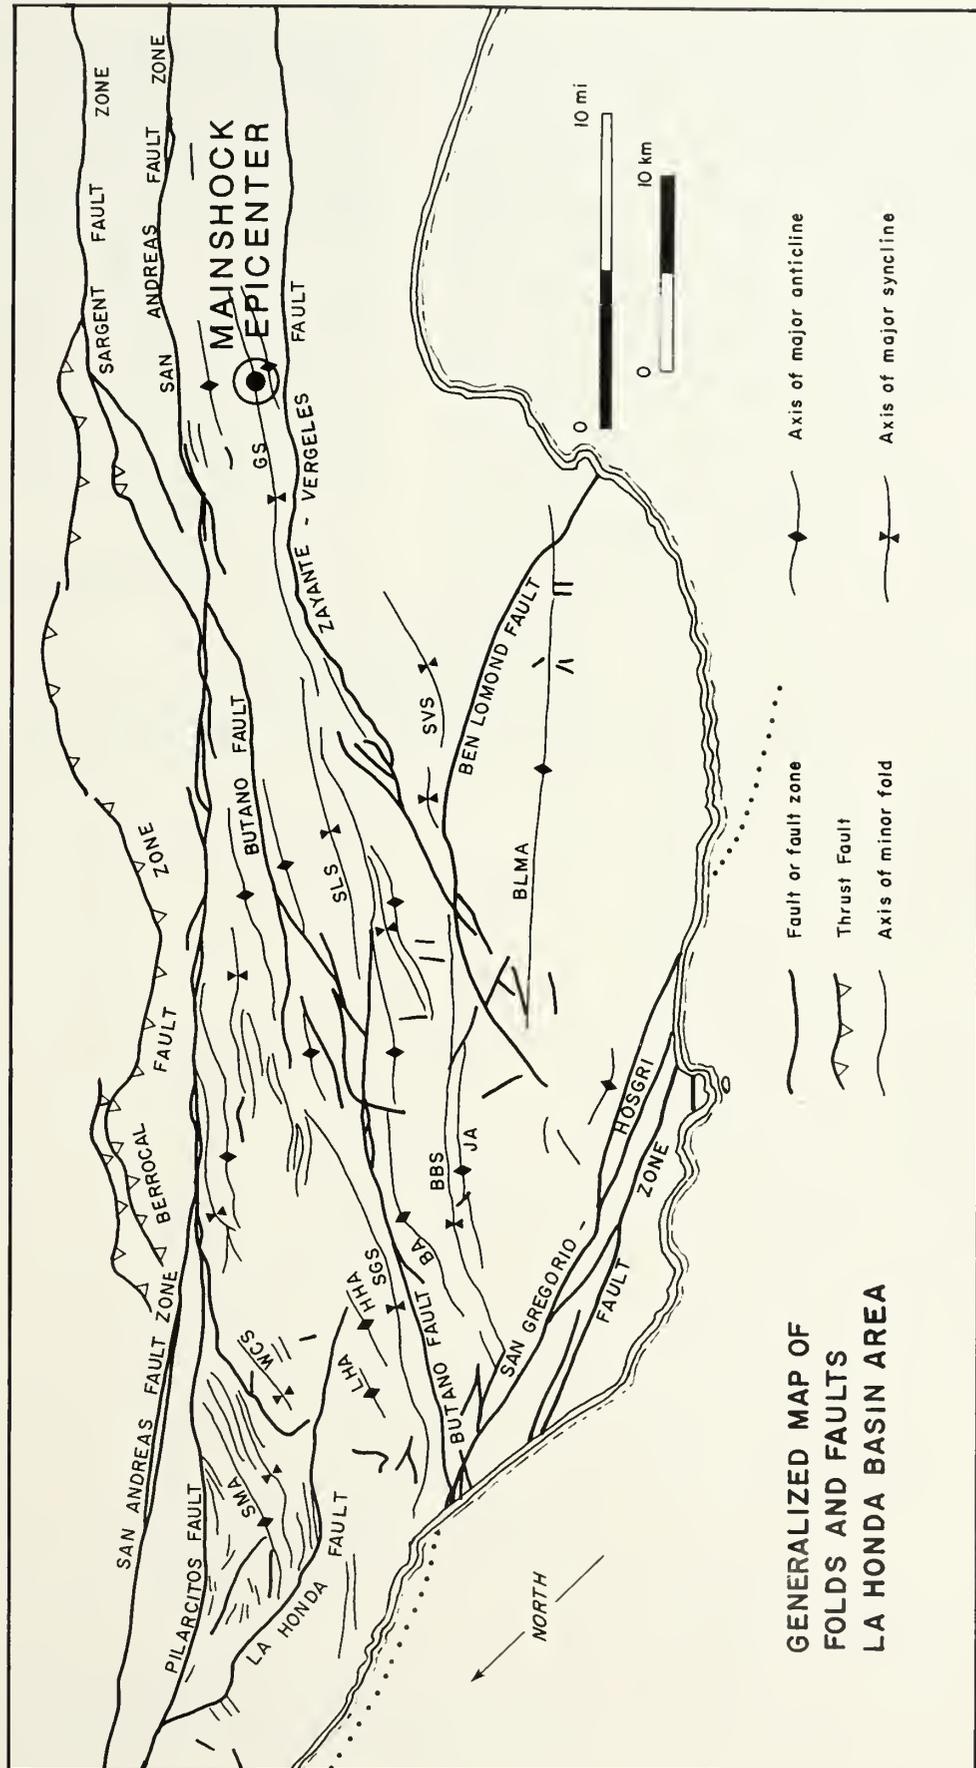
Figure 5. Generalized map of faults and folds southwest of the San Andreas fault modified from Stanley (1985). Berrocal and Sargent fault zones from McLaughlin (1974). Major folds are labeled as follows: BA-Butano anticline, BBS-Big Basin syncline, BLMA-Ben Lomond Basin syncline, BLMA-Ben Lomond Mountain anticline, GS-Glenwood syncline, HHA-Haskin Hill anticline, JA-Johansen anticline, LHA-La Honda anticline, SLS-San Lorenzo syncline, SMA-San Marcos anticline, SVA-San Vicente anticline, THA-Thoma anticline, TGA-Trenton anticline, WCS-Weeks Creek syncline.

Faults and folds in the Santa Cruz Mountains (Figure 5 and Brabb, 1989) are the result of wrench tectonics caused by interaction of the North American plate with the Pacific plate and the now subducted Farallon plate (Figure 6). Consequently most of the faults and folds trend northwest, parallel to the plate boundary.

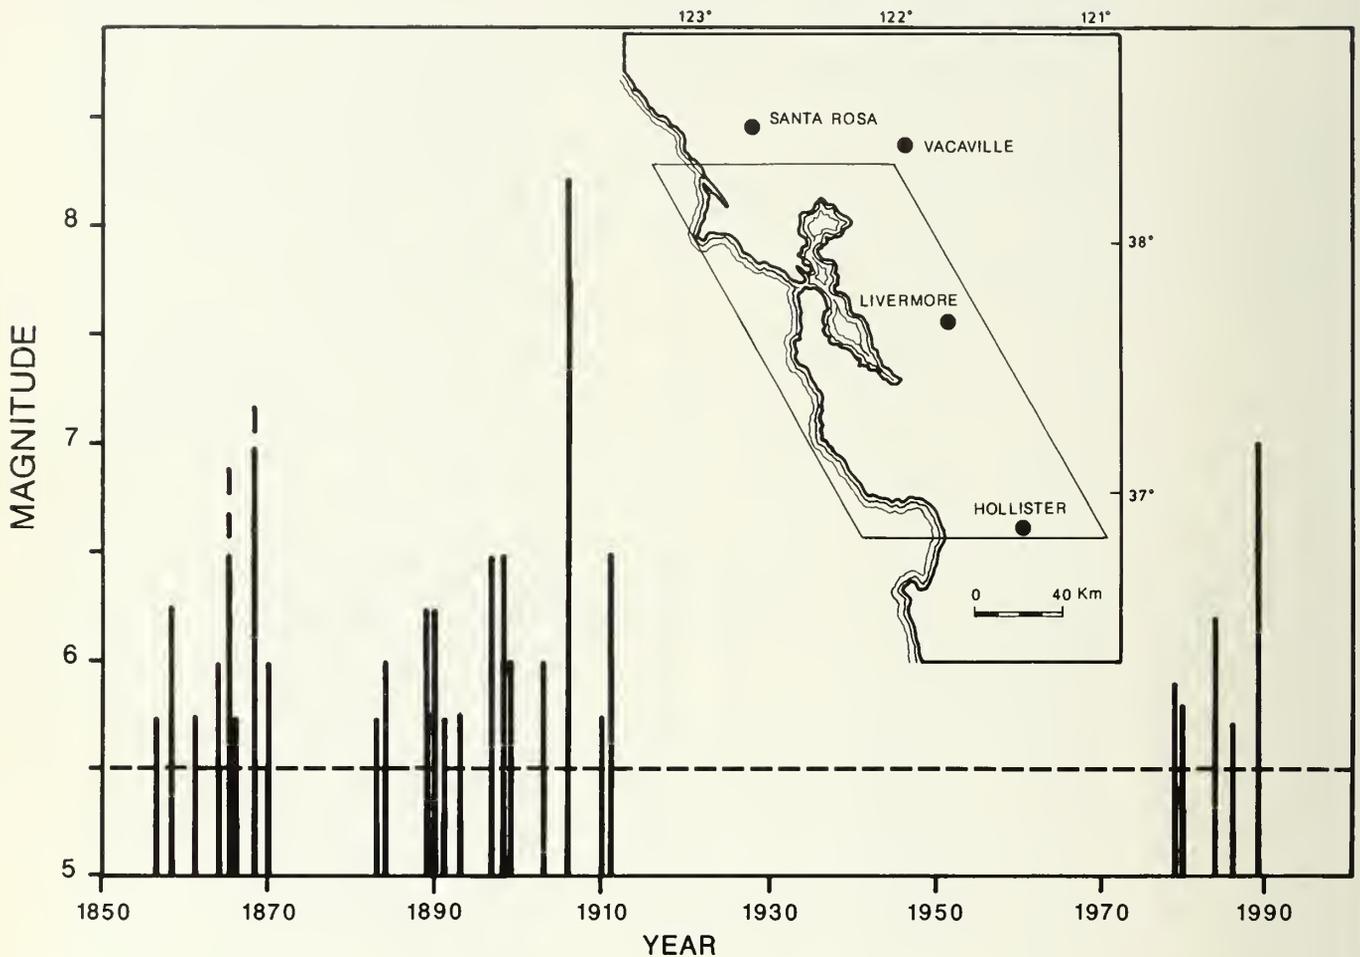
Figure 2. Earthquakes with $M > 5.5$ (dotted line) within 60 km of San Francisco Bay from 1849 to 1990. The index map shows the area for which data are displayed. Height of bar is proportional to earthquake magnitude.

Smaller earthquakes ($M \leq 5.5$) have also occurred in the Bay area, but they are not shown in Figure 2 because their record is not complete before 1900 and because they represent only a minor part of the seismic energy released. One of these smaller earthquakes in 1957 caused more than \$1 million damage in San Francisco (Oakeshott, 1959). Tocher (1959) and Jaumé and Sykes (1990) noted that the occurrence of $M > 5.0$ earthquakes in the Bay area increased after 1955.

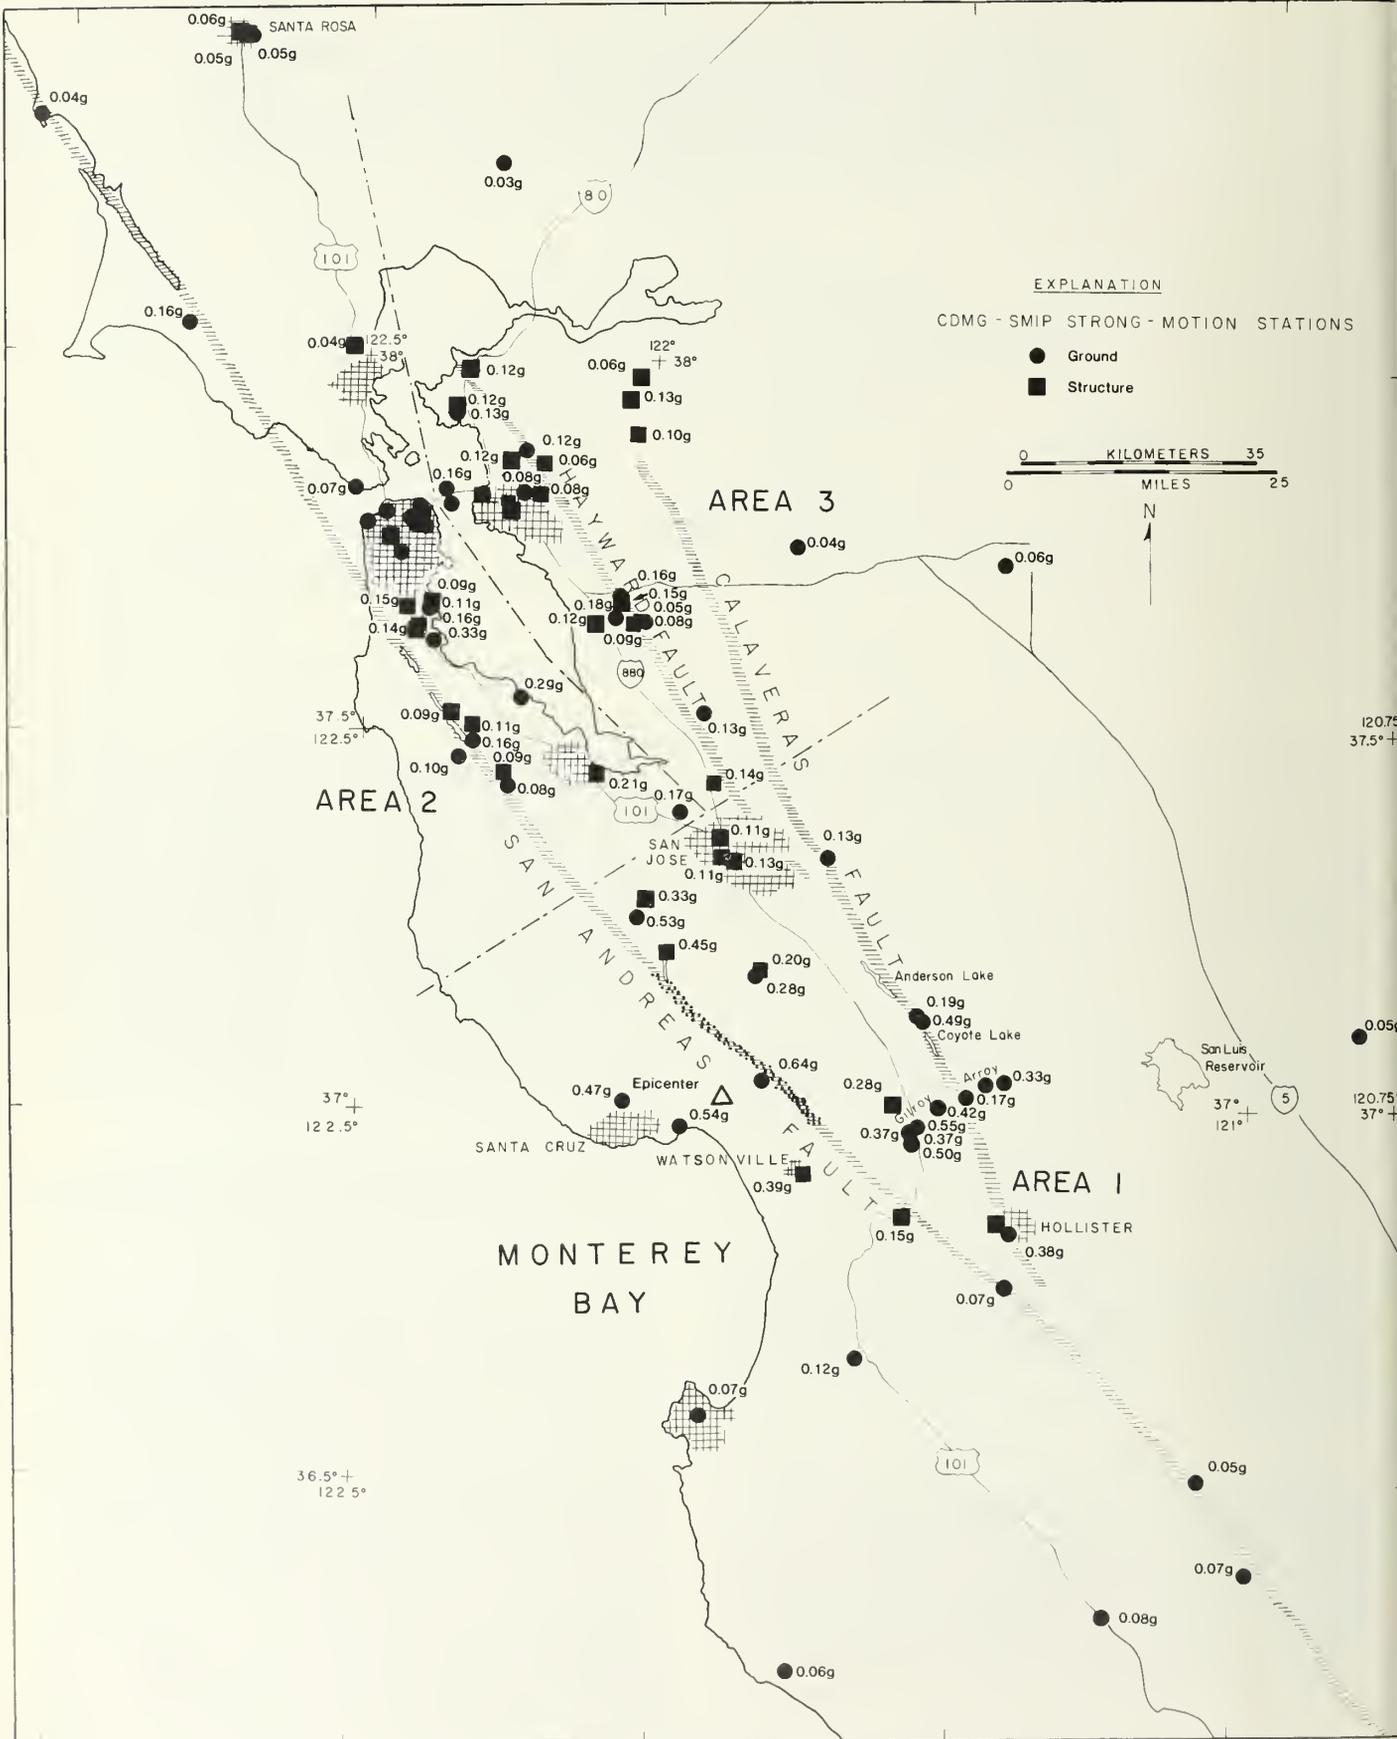
Figure 1A. Map of central coastal California showing the San Andreas fault, the epicenter and aftershock zone of the Loma Prieta earthquake, and the locations of SMIP stations that recorded the strong shaking. Peak horizontal accelerations recorded at each station appear next to the station. The San Francisco/Oakland area is repeated in Figure 1B at larger scale.

The Loma Prieta earthquake occurred on the San Andreas fault approximately 16 km east of Santa Cruz and 33 km southwest of San Jose. The map in Figure 1A shows the San Andreas fault, the earthquake epicenter and cities of central coastal California. The stippled line on the San Andreas fault between San Juan Bautista and Lexington Dam indicates the approximate extent of the aftershock zone and, by inference, the extent of fault rupture during the mainshock. The locations of Strong Motion Instrumentation Program (SMIP) stations that recorded the strong shaking during the earthquake are shown by solid symbols, and the peak horizontal acceleration recorded at each station is given near the symbol. Stations in the Oakland/San Francisco area are repeated in Figure 1B.

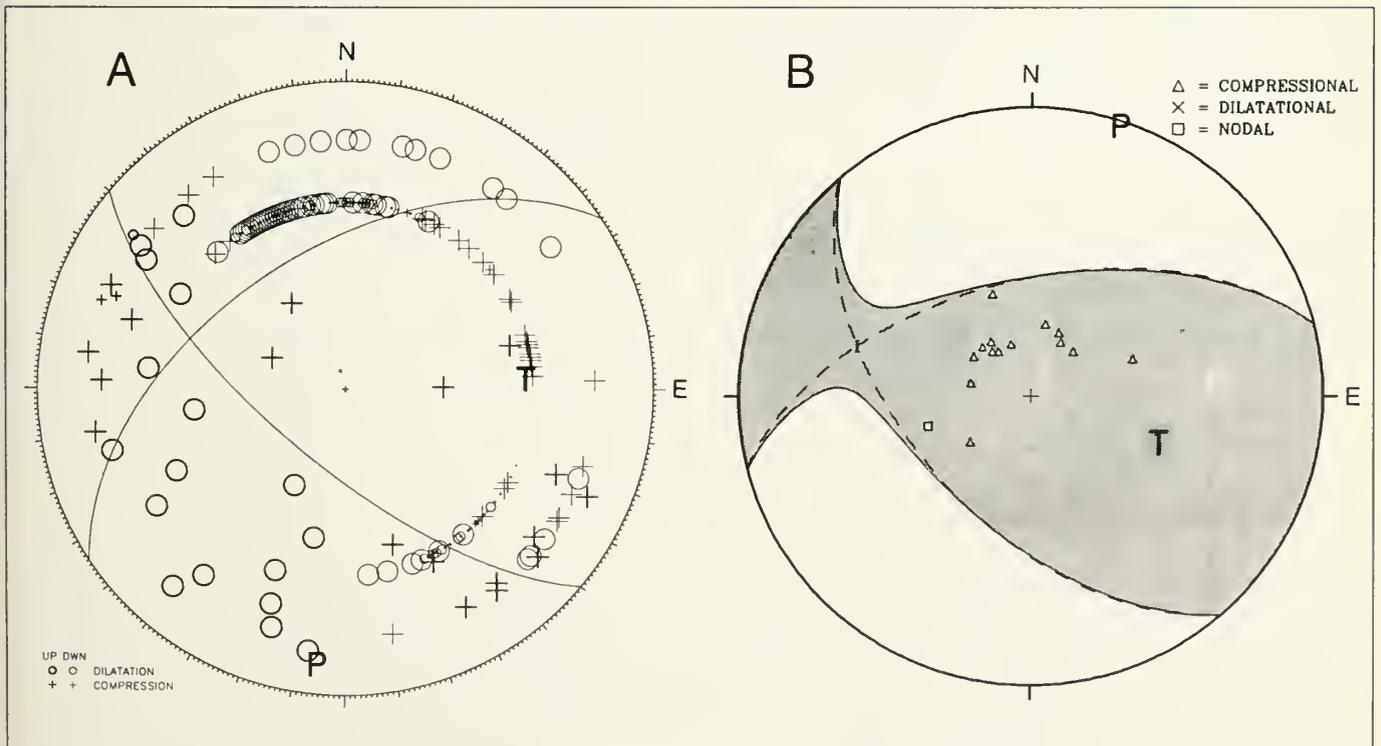
Figure 4. A. Lower hemisphere plot of fault-plane solution for the Loma Prieta main shock, based on data from 267 local and regional stations and the velocity model of Dietz and Ellsworth (1990). Circles and pluses indicate dilatational and compressional first motions, respectively. "T" is tension axis and "P" is pressure axis (source: Oppenheimer, 1990). B. Lower hemisphere nodal plane and nodal surface solutions for the main shock based on decomposition of the moment-tensor solution. Data from 15 worldwide stations were modelled to obtain the moment tensor. "T" is tension axis and "P" is pressure axis (source: S. Sipkin, NEIC, 1990).

In addition to obtaining the standard fault plane solution, other attempts were made in near real-time to determine the earthquake mechanism and moment tensor from analyses of longer period waves recorded at regional and teleseismic distances (see discussion by McNally and others, 1989). Most results are in good agreement with the mechanism shown in Figure 4 A. For example, the NEIC (1990) moment tensor solution is shown in Figure 4 B. The moment tensor gives a better characterization of the entire fault rupture, as opposed to the fault plane solution of Figure 4 A that characterizes only the rupture initiation.

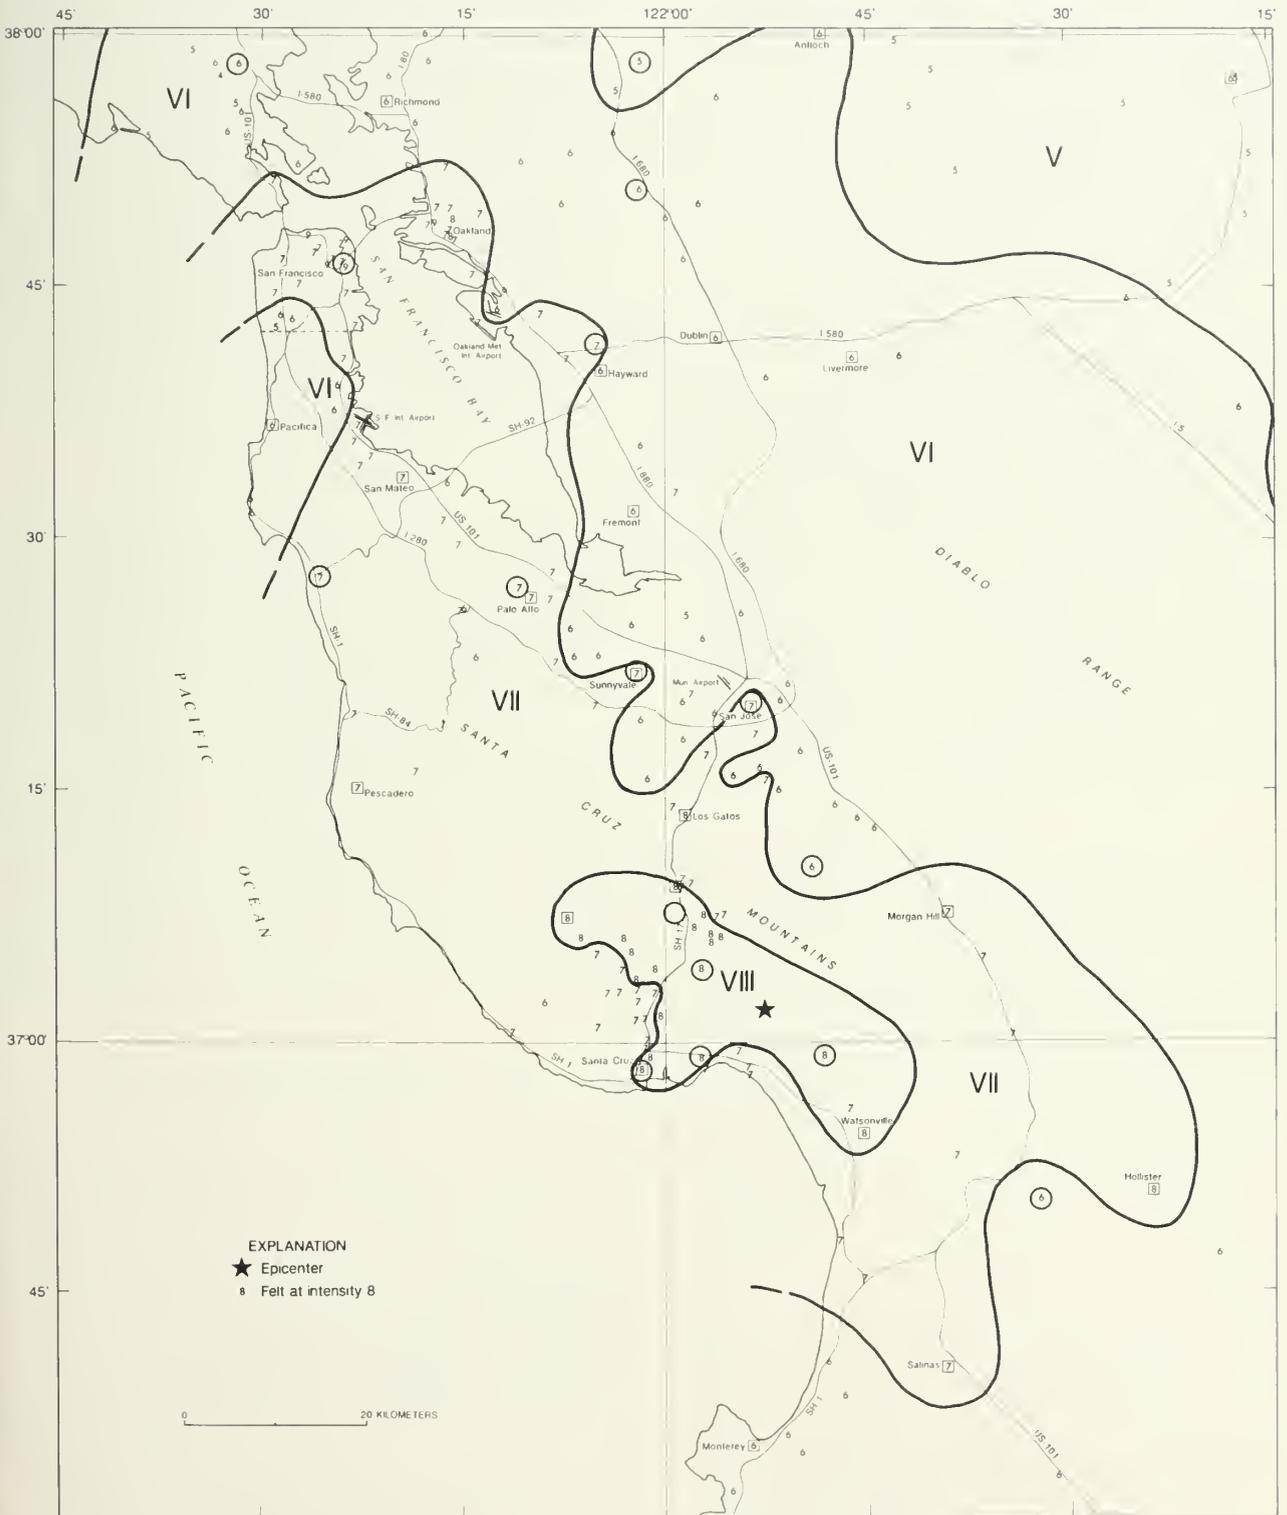
Figure 6. A. Isoseismal map for the San Francisco Bay region for the Loma Prieta earthquake of 17 October 1989. Locations that also reported the 1865 earthquake are circled, and are listed in Table 3 (source: Stover and others, 1990).

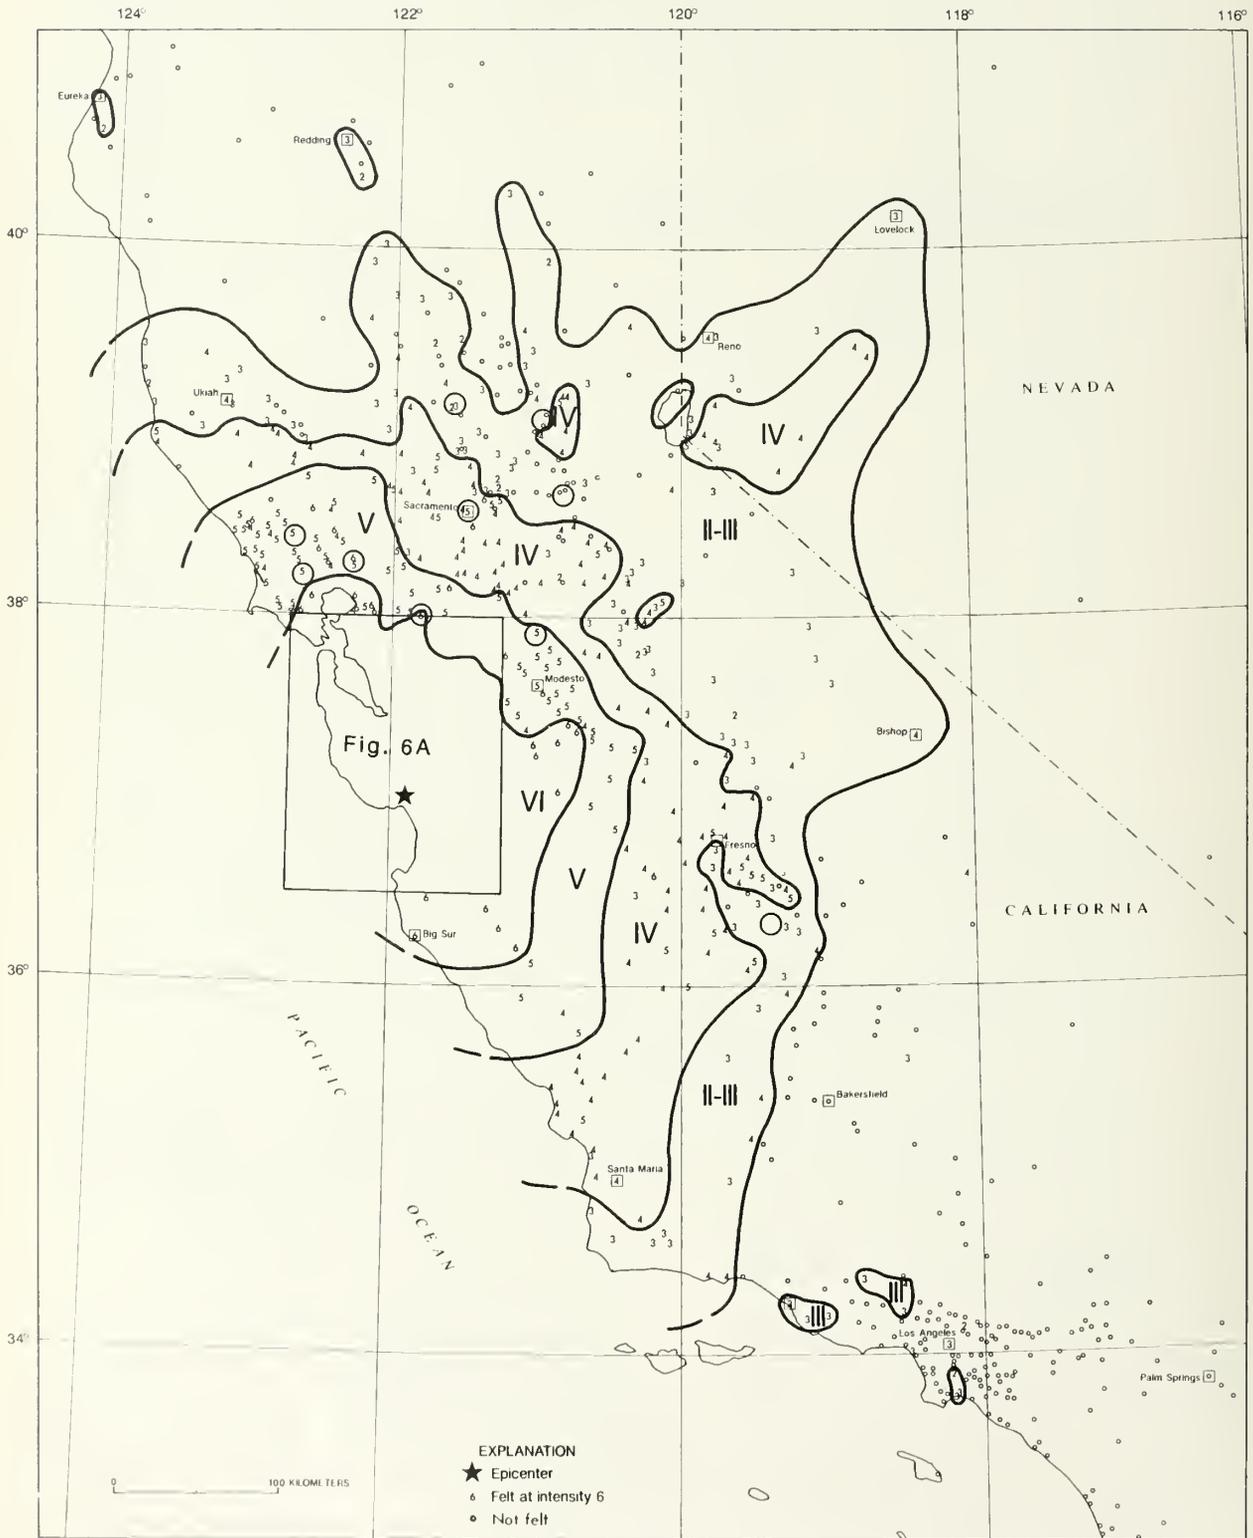
Figure 6. B. Isosismal map for the surrounding region for the Loma Prieta earthquake. Locations that also reported the 1865 earthquake are circled, and are listed in Table 3 (source: Stover and others, 1990).

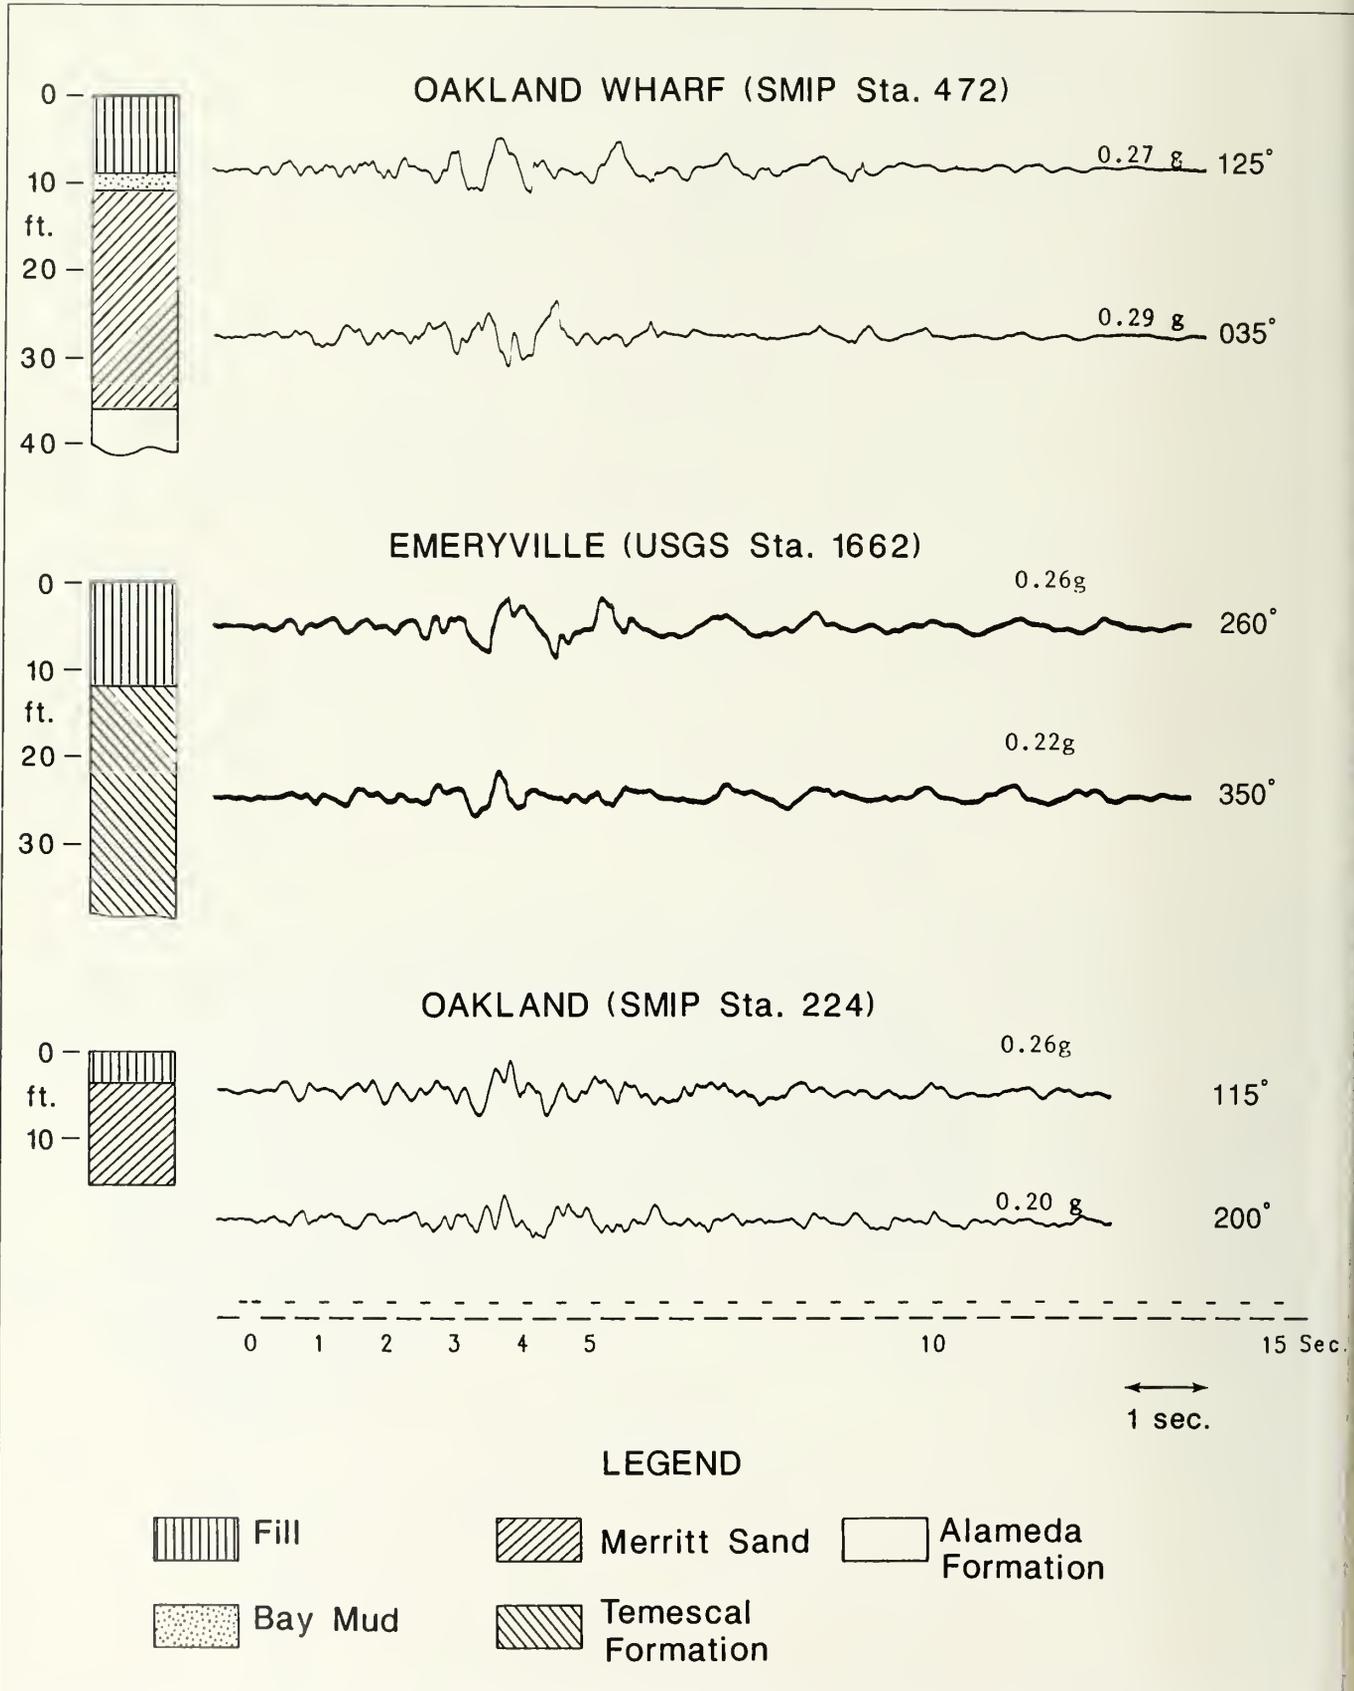
Figure 7. Horizontal components of the accelerograms from three stations in the Oakland area, each 2 km from the Cypress Structure. The shallow soil profile near each station is also shown.

The records from the stations at the wharf, at Emeryville and near Lake Merritt (Figure 7) are all quite similar in peak values and predominant frequency despite the differences in the near-surface geologic conditions and depths of fill and bay mud. This suggests that the specific near-surface geology at the Cypress Structure did not cause significantly different motion than that shown by the records in Figure 7.
