**THE LOMA PRIETA
(SANTA CRUZ MOUNTAINS)
CALIFORNIA,
EARTHQUAKE OF 17 OCTOBER 1989**

Division of Mines and Geology

**THE LOMA PRIETA
(SANTA CRUZ MOUNTAINS), CALIFORNIA,
EARTHQUAKE
OF
17 OCTOBER 1989**

Special Publication 104

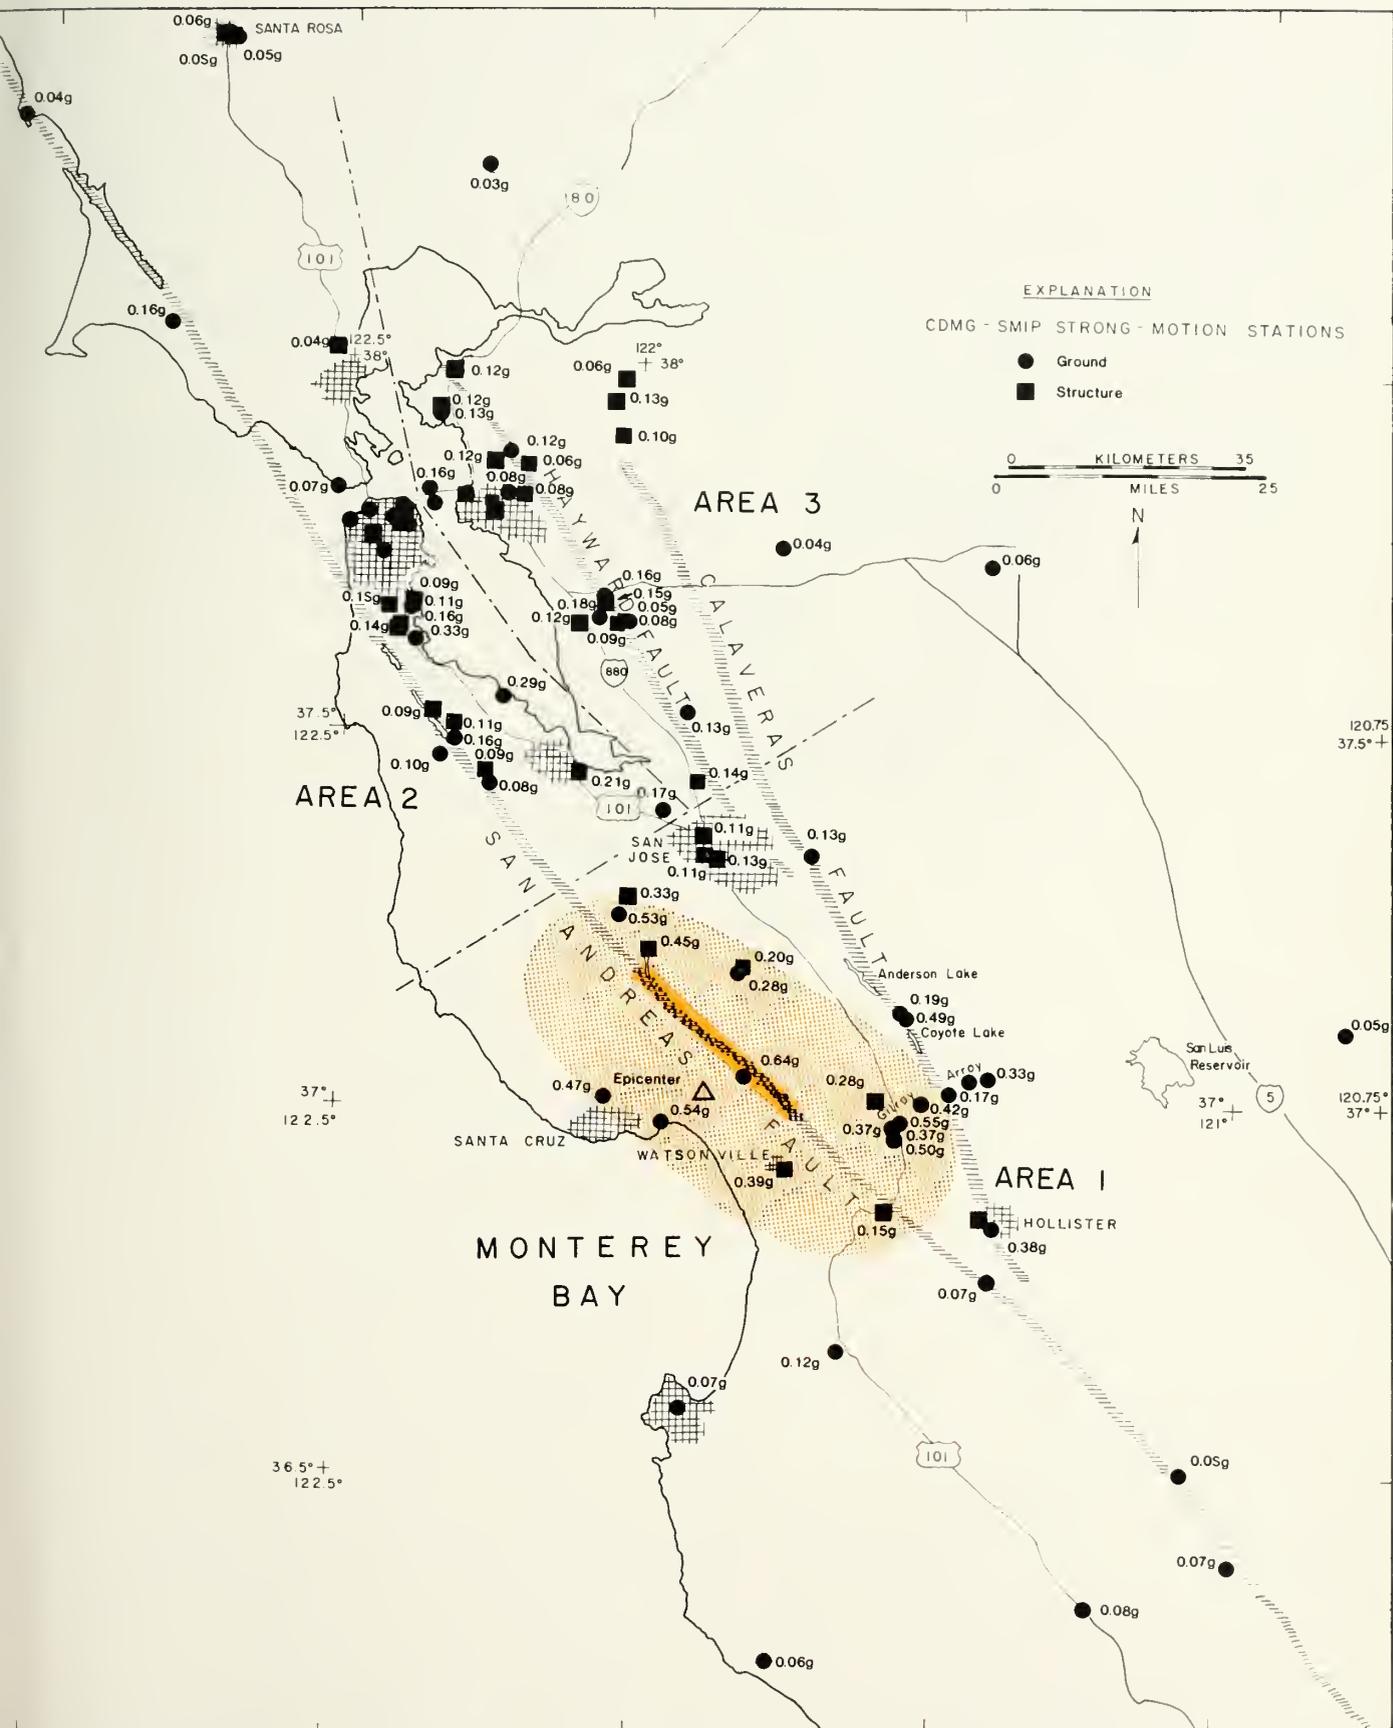
Figure 11. Strongly shaken zone (stippled area) for the 17 October 1989, Loma Prieta earthquake (peak acceleration generally 0.4 g or greater).

For the Loma Prieta earthquake, a zone within about 20 km of the fault experienced the strongest shaking. This region, where the peak acceleration was generally 40% g or greater, is indicated in Figure 11. The region includes the heavily damaged coastal area from Santa Cruz to Watsonville, where the strong shaking lasted for 10 seconds or more. (Note that the Oakland/San Francisco area is approximately 90 km from the fault rupture.)

To gain some understanding of what shaking levels should be anticipated if the same event were to happen farther north on the San Andreas next to San Francisco, for example from Daly City northward, the zone of strongest shaking from Figure 11 is overlain on the San Andreas fault in Figure 12. The figure shows that all of the northern San Francisco peninsula would be included in the zone of strong shaking. Consideration of accelerations at distances beyond 20 km in Figure 11 suggests that, for the Daly City event being considered, rock accelerations in Oakland would be near 20-30% g, in contrast to near 10% g in the Loma Prieta event. If the same amplification occurs that occurred in the Loma Prieta event, the motion in much of the flat-lying portion of Oakland is expected to be 40-60% g.

To gain some understanding of what shaking levels should be anticipated if an event like the Loma Prieta earthquake were to occur on the Hayward fault, the zone of strongest shaking from Figure 11 is overlain on the northern section of the Hayward fault in Figure 13. The strongly-shaken area would cover almost all of the East Bay if this occurred. The long duration shaking that occurred in the Capitola - Watsonville area (see Figure 3A, for example) could be expected through much of the East Bay. The San Francisco peninsula would also be strongly shaken, with values of 20% g occurring at rock sites, and significantly higher levels in soil areas. In this case, accelerations in the flat-lying portions of Oakland would exceed the 0.64 g at Corralitos, but nonlinear and nearfield effects preclude even a rough numerical estimate.

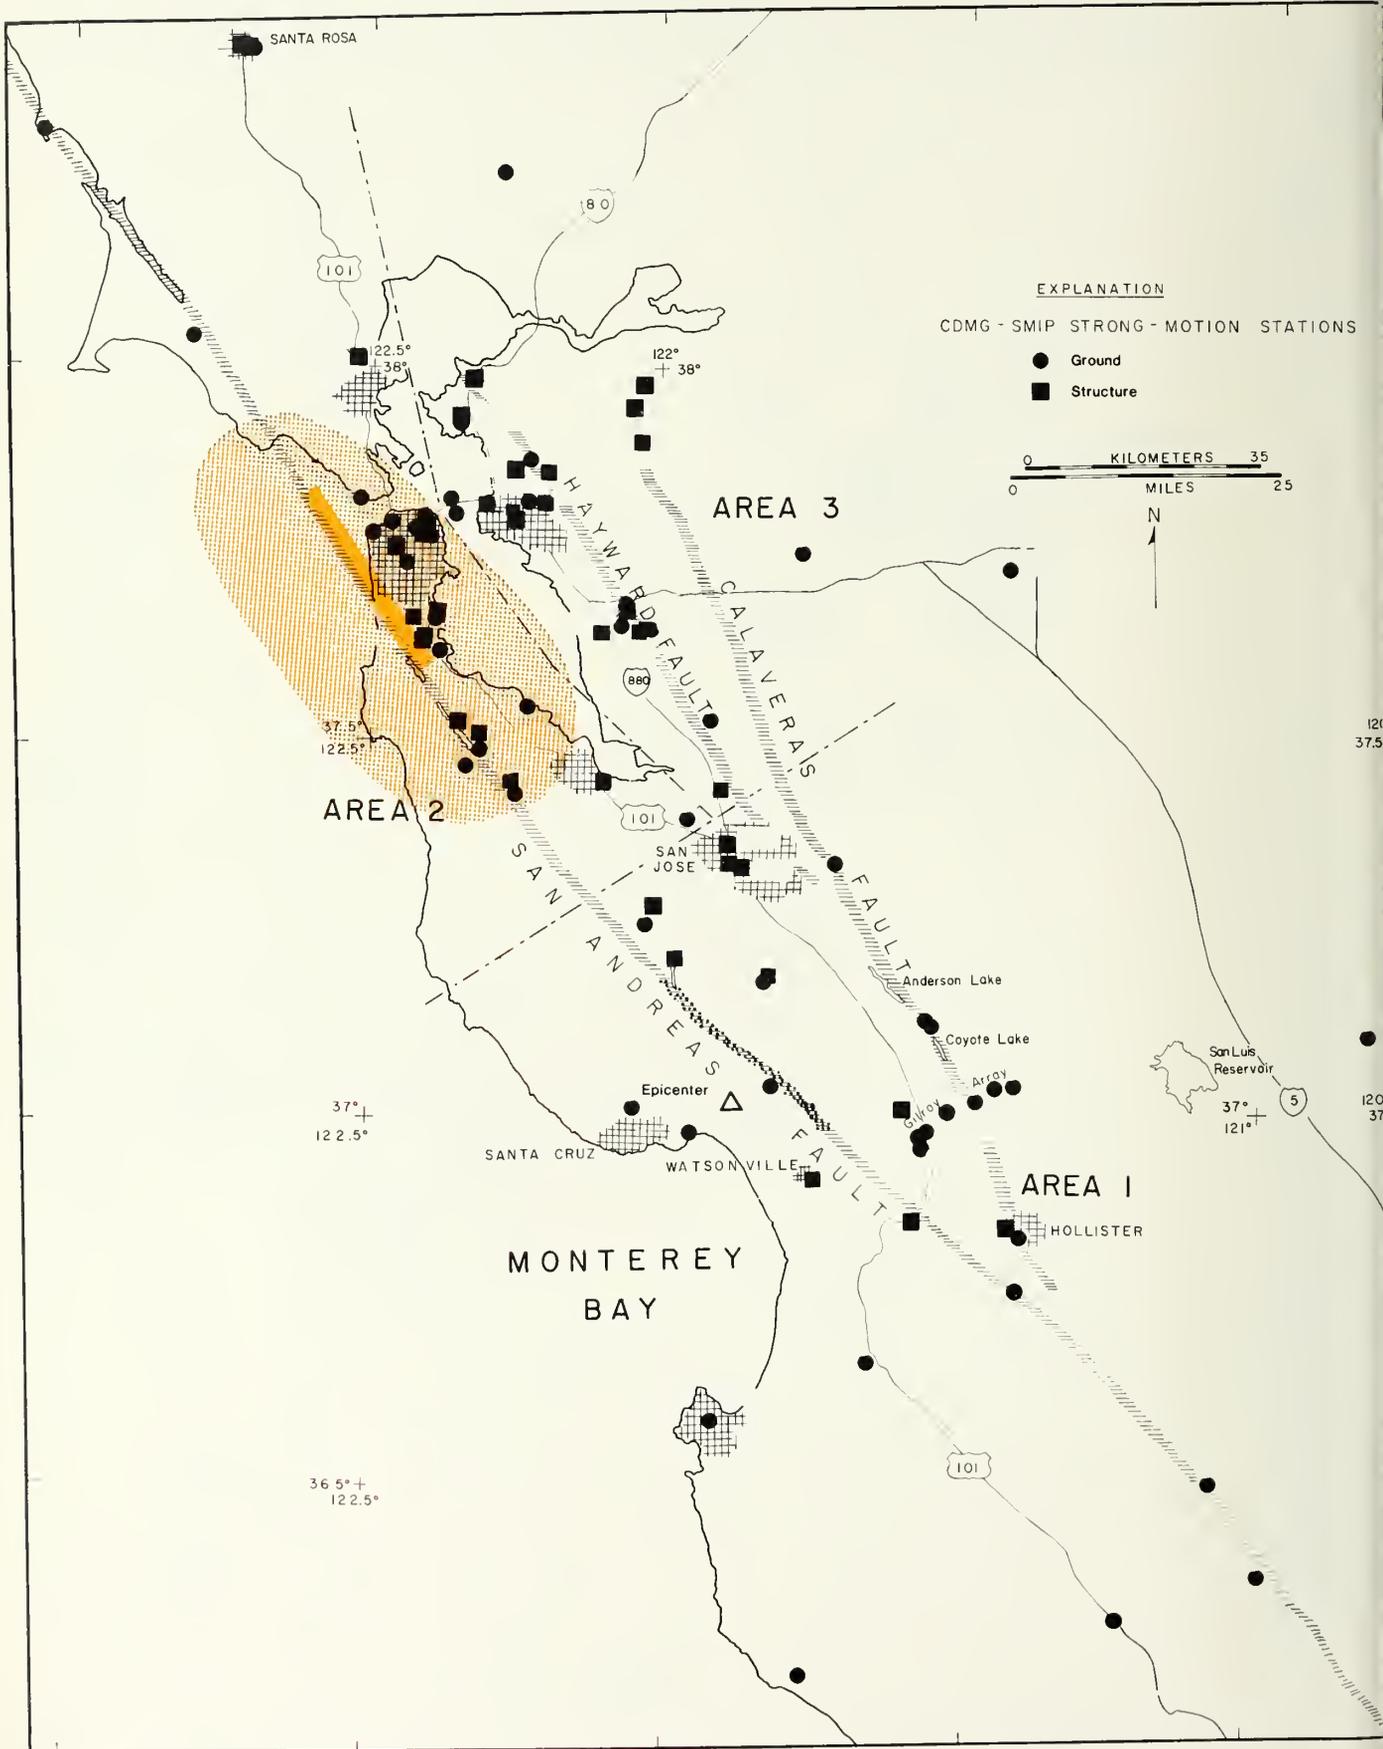
Figure 12. Strongly shaken zone anticipated from a magnitude 7 earthquake like the Loma Prieta event on the San Andreas Fault near San Francisco.

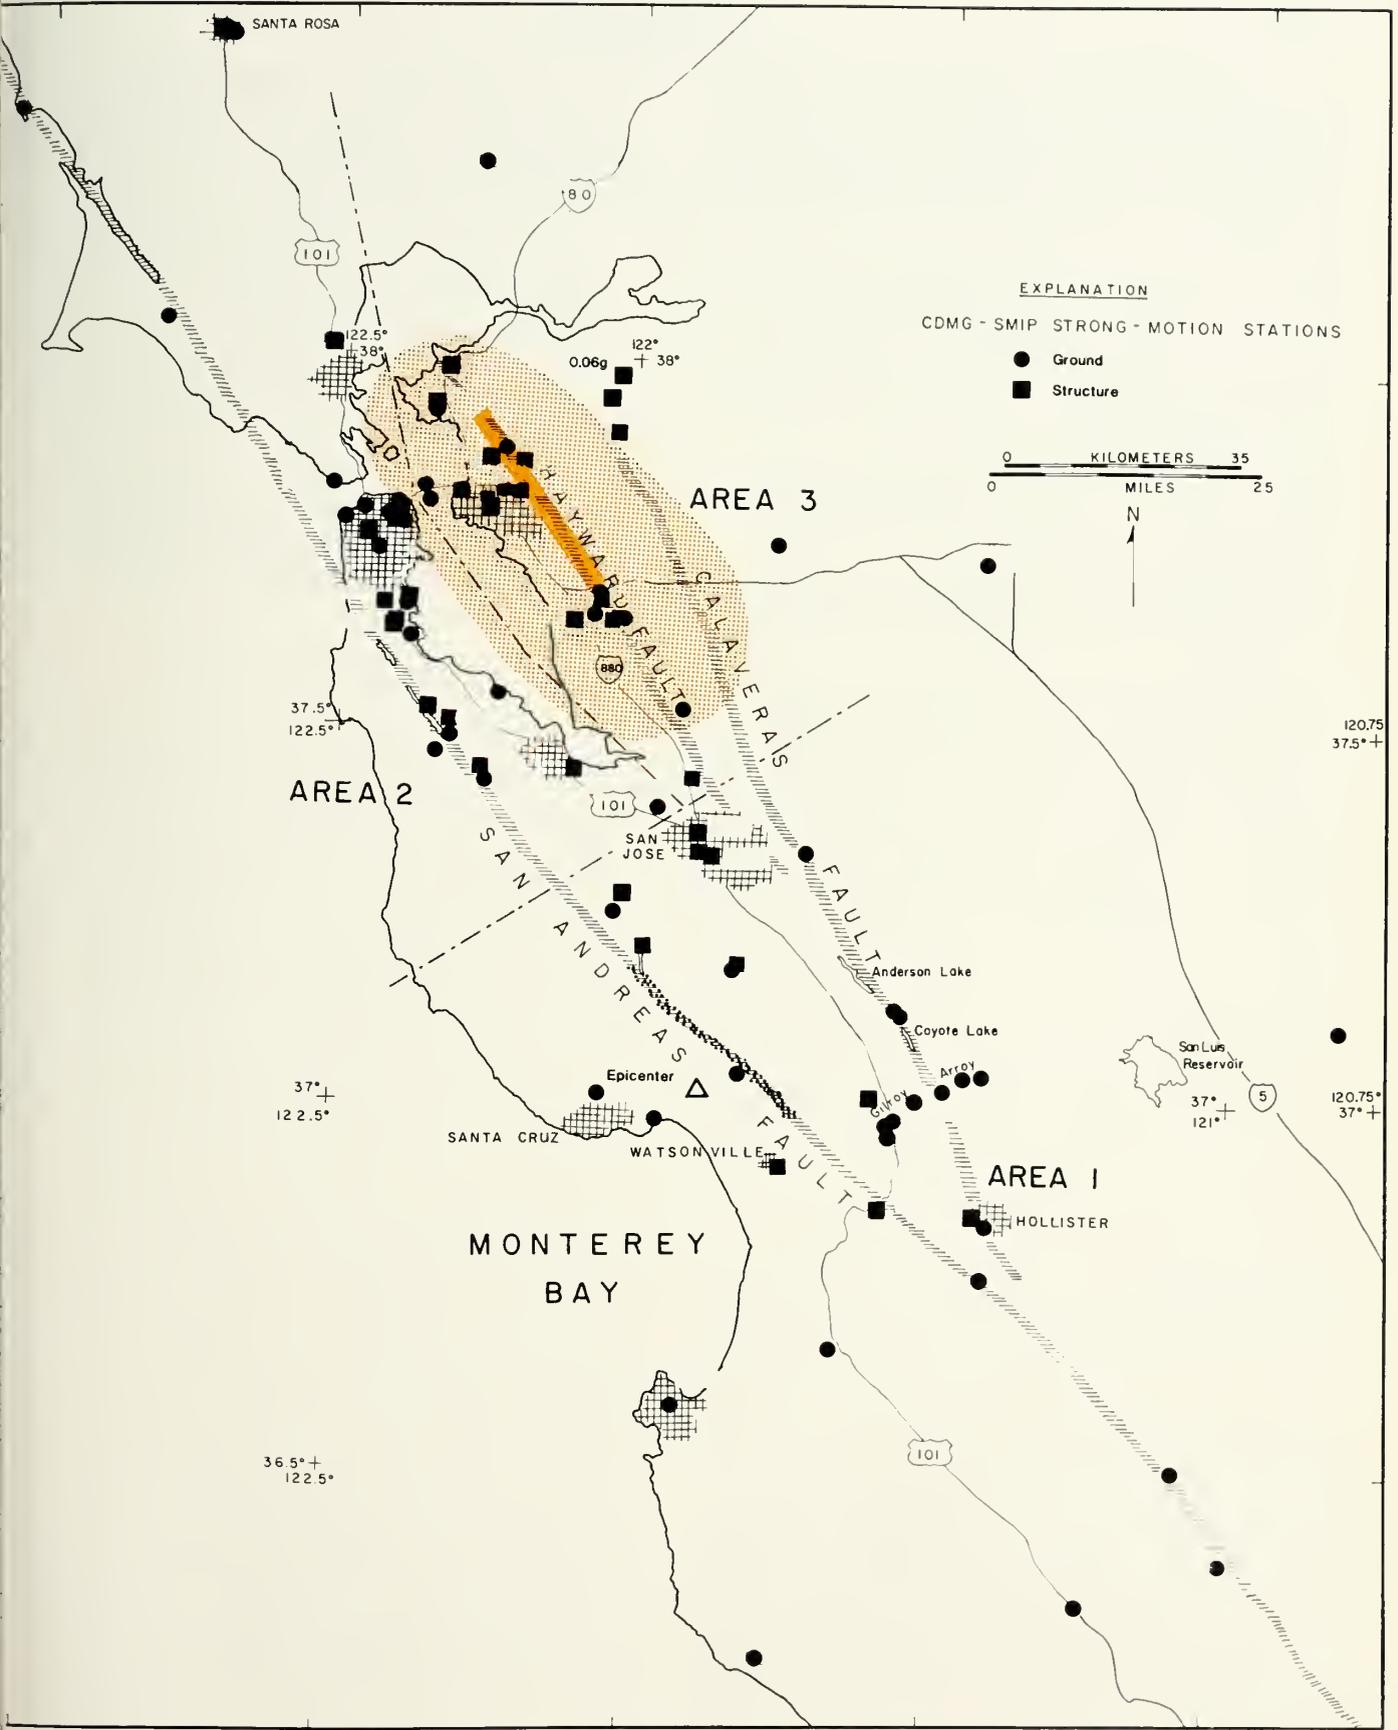
Figure 13. Strongly shaken zone anticipated from a magnitude 7 earthquake like the Loma Prieta event on the Hayward Fault near Oakland.

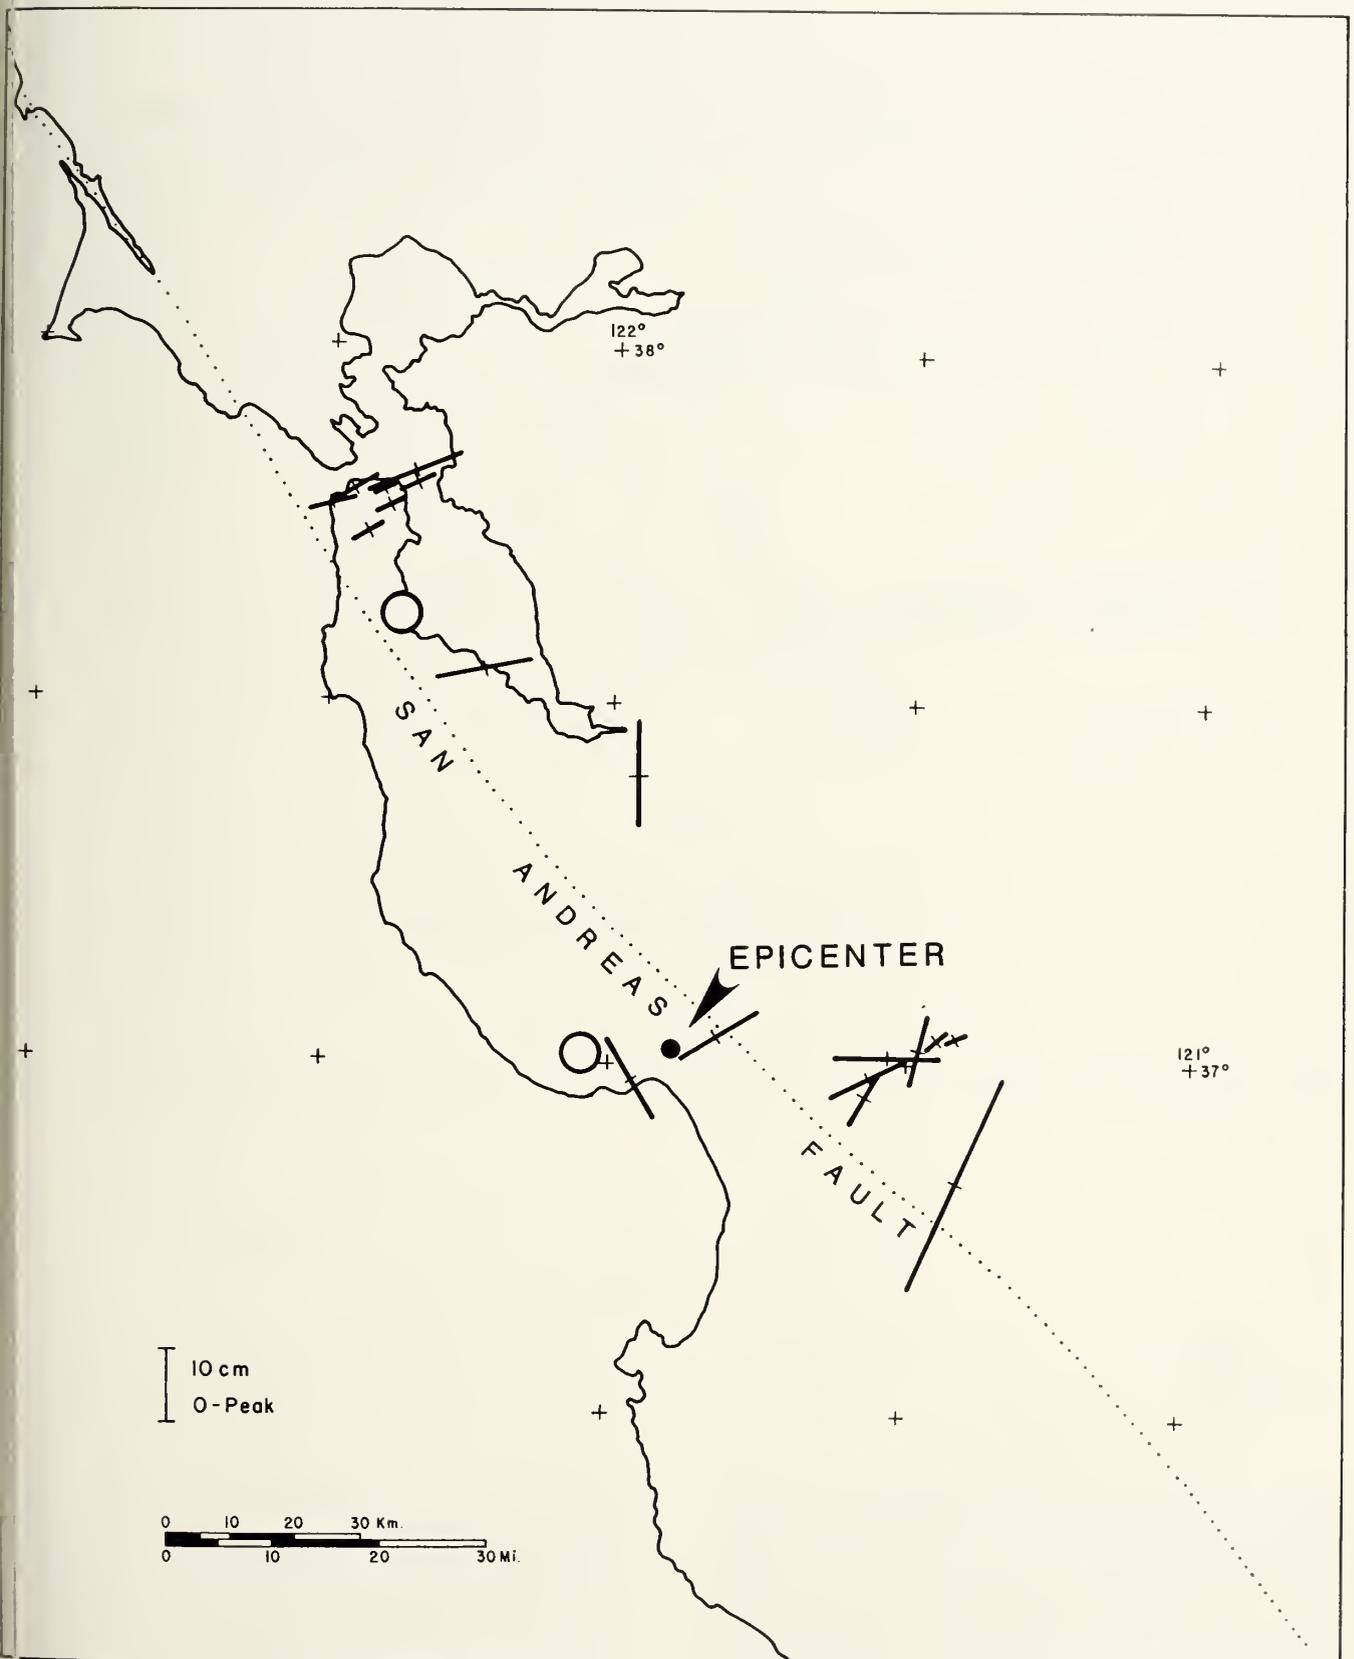
Figure 5. Measured polarizations of horizontal displacements for processed SMIP accelerograms. Direction of line indicates azimuth of polarization; a circle indicates weak or no obvious polarization direction. Length of line is proportional to peak displacement. Line is centered at station.

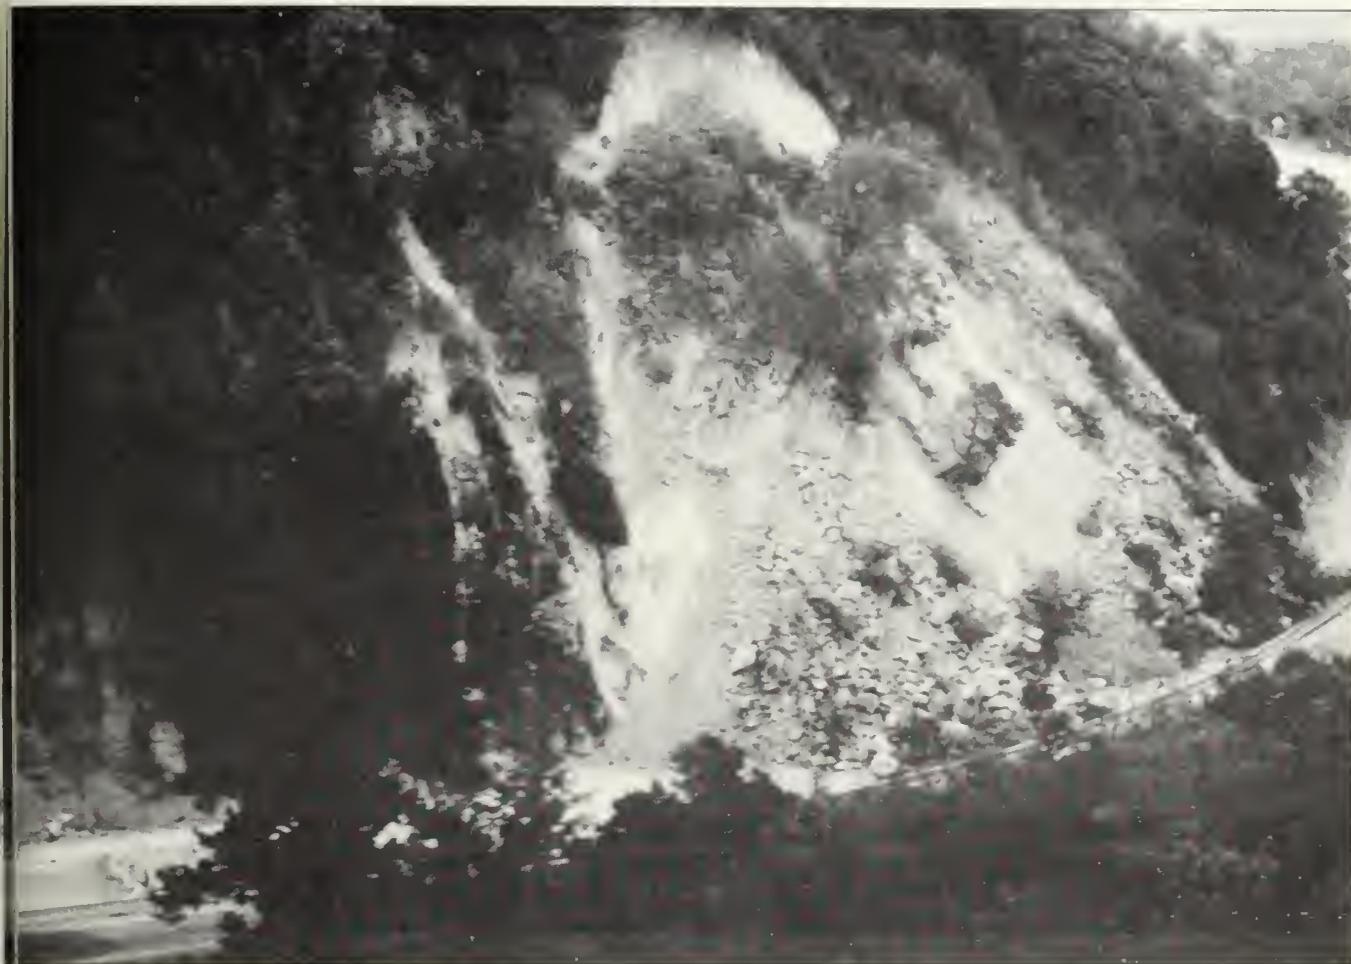
Photo 1. A major debris slide at "Laurel Hill" on State Highway 17 blocked the northbound lanes for 33 days. Aerial view is toward the southeast. Bedding planes in the hard, jointed sandstone of the Purisima Formation dip about 60° south (to the right). Orthogonal joint planes dip northward (to the left), creating a wedge-shape in the over-steepened cutslope. (Airphoto by T. E. Spittler)

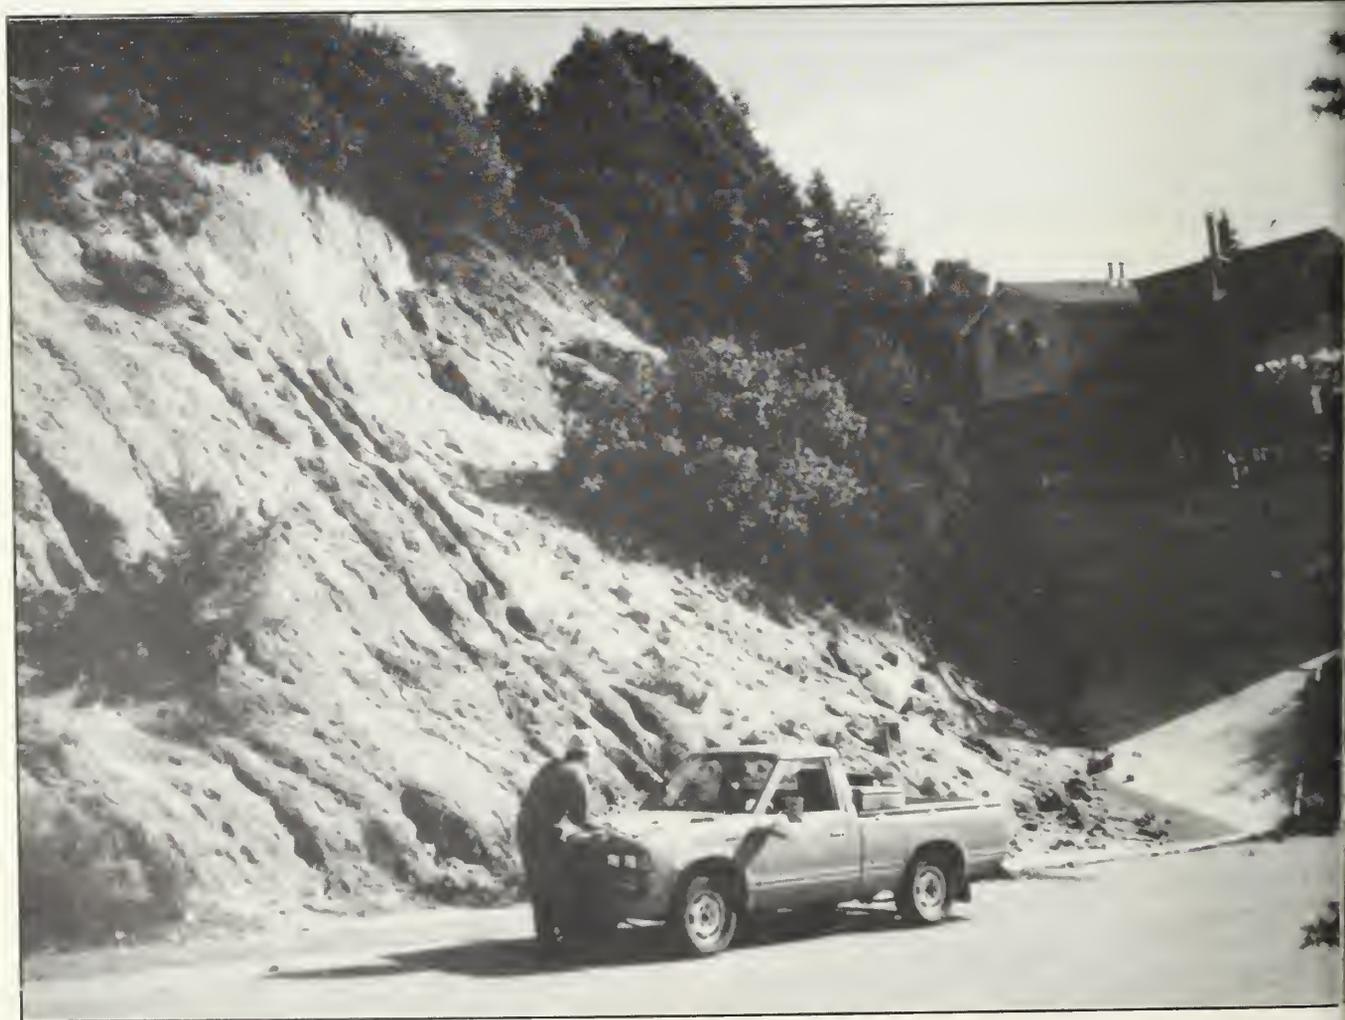
Photo 2. Small debris slide adjacent to a house in the Santa Cruz Mountains. (Photo by T. E. Spittler)

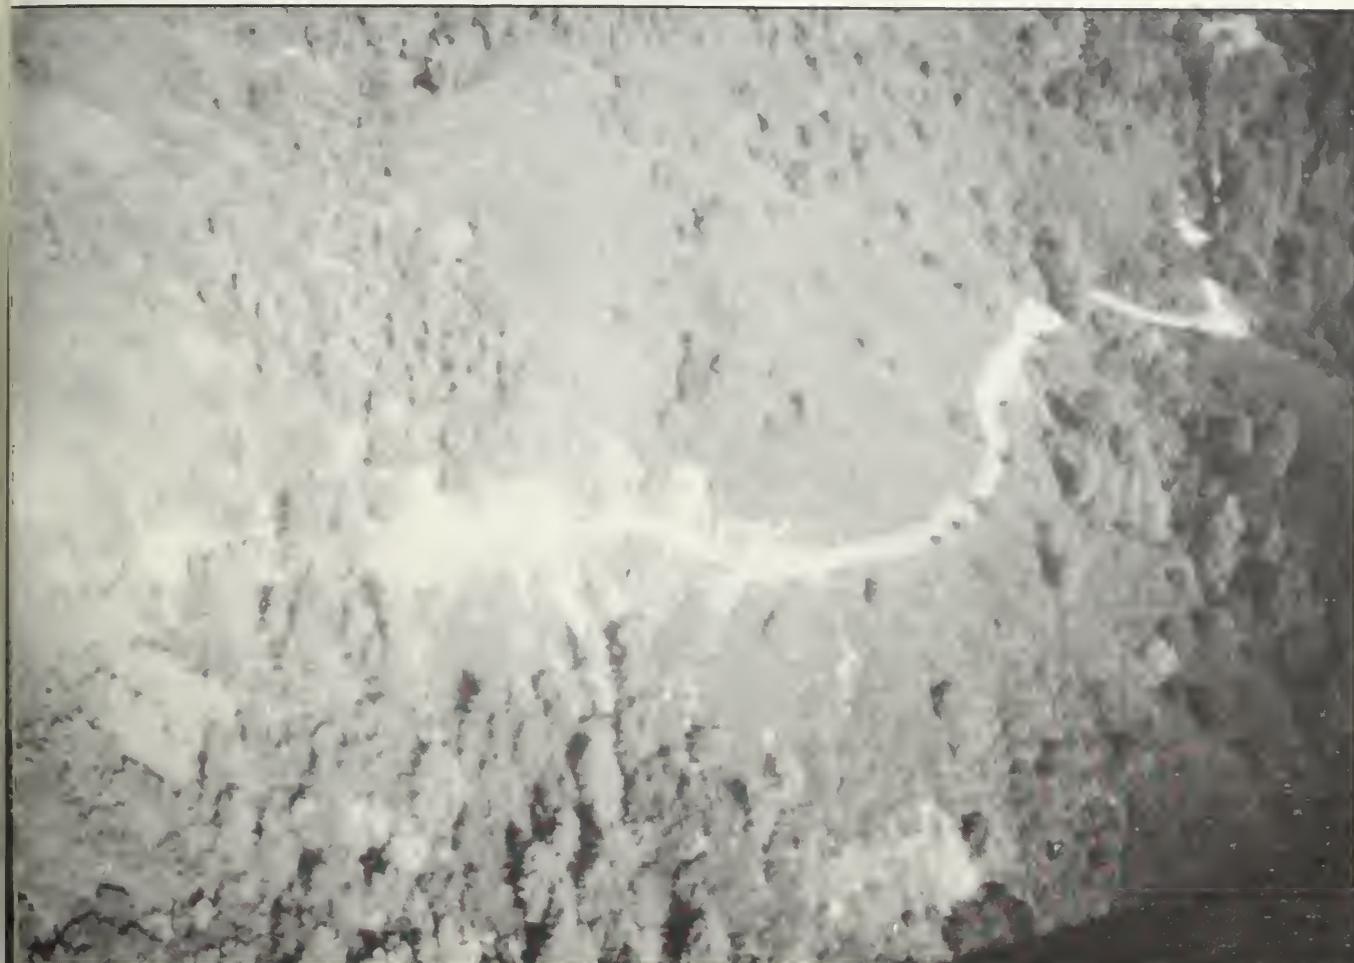
Photo 3. Radial fractures around spur ridges. The patched asphalt shows the fracture pattern across Highland Way in the Santa Cruz Mountains. Fracture sets continue up slope from the road where they arch over the crest of the spur ridges and join. The fractures also continue down slope. (Photo by T. E. Spittler)

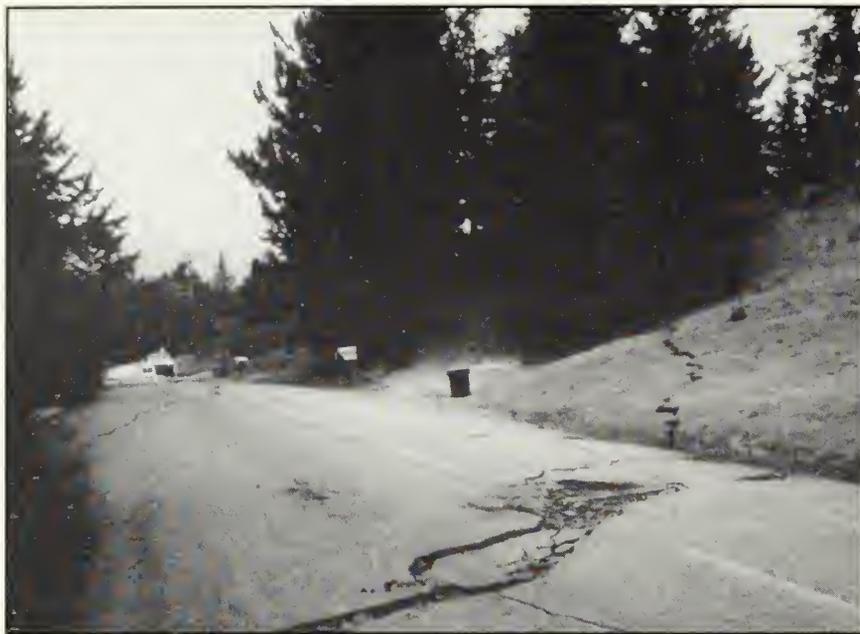
Photo 4. Incipient landslide scarp within the Villa del Monte subdivision along the summit of the Santa Cruz Mountains. (Photo by J. P. Schlosser)

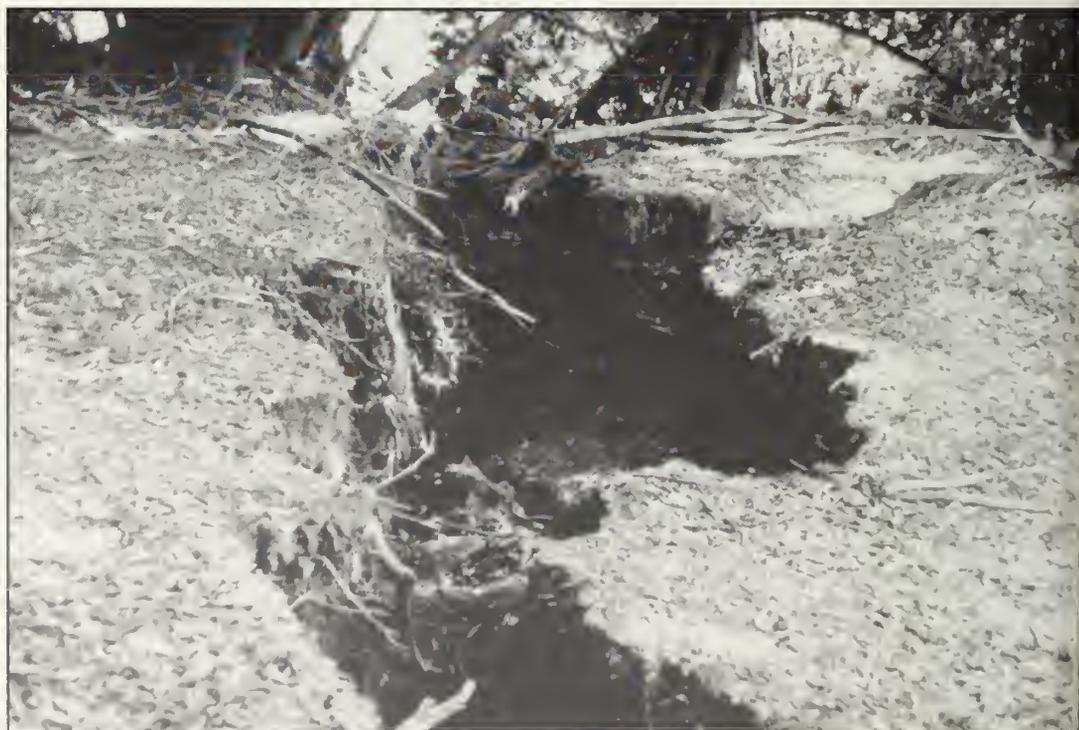
Photo 5. Headwall scarp of large landslide near Schultheis Road. (Photo by J. P. Schlosser)

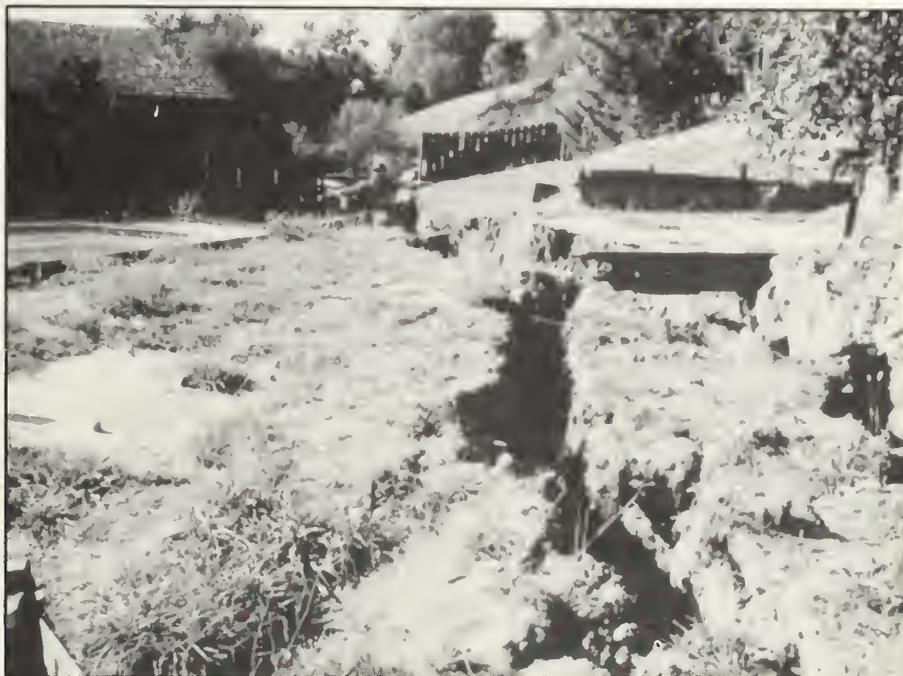
Photo 6. Landslide scarp adjacent to a house in the Villa Del Monte area, about 3 km east of Highway 17. (Photo by J. P. Schlosser)

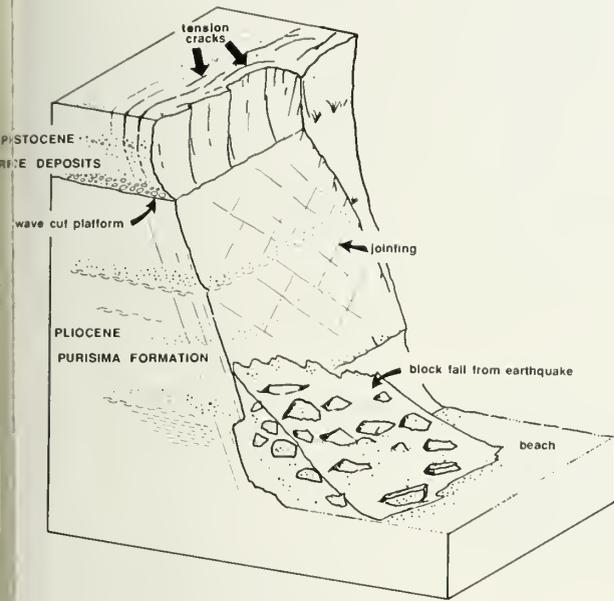
Figure 3. Block diagram showing seaciff structure and typical failure style in seaciffs underlain by well-jointed Pliocene Purisima Formation siltstone. Note the tension cracks in the Pleistocene terrace deposits and undercut seaciff from Plant and Griggs, 1990).

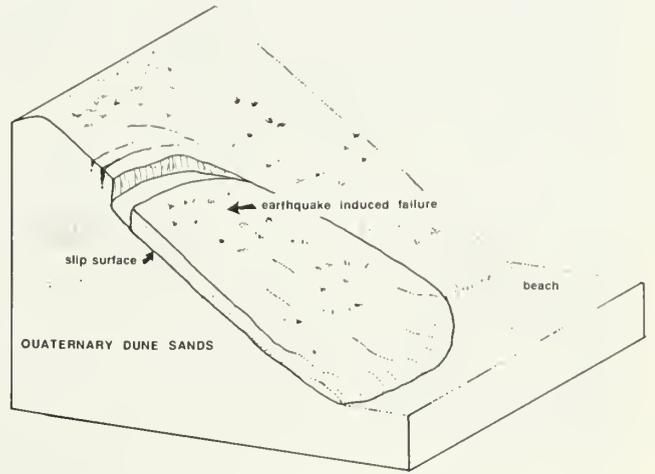
Figure 5. Block diagram of dry sand flow in weakly consolidated dunes. Note the tension cracks in the cohesive surface layer (from Plant and Griggs, 1990).

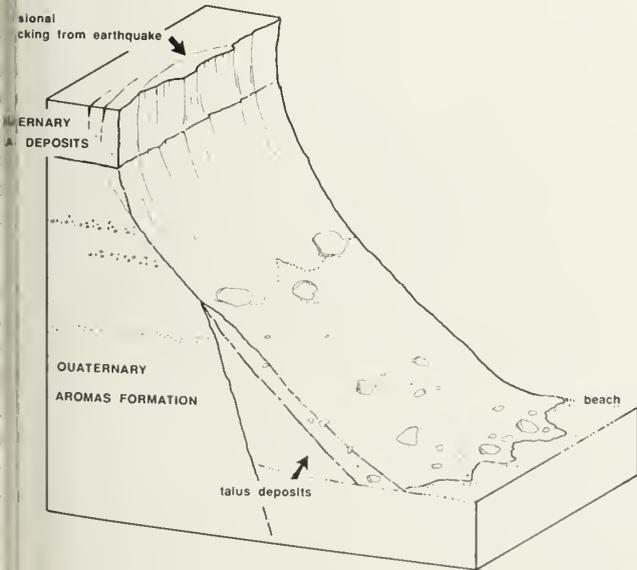
Figure 4. Block diagram showing structure and typical failure style in seaciffs underlain by Pleistocene Aromas Sands. Note that the failure occurred in the upper portion of the cliff and sands cascaded down to the steep talus slope from Plant and Griggs, 1990).

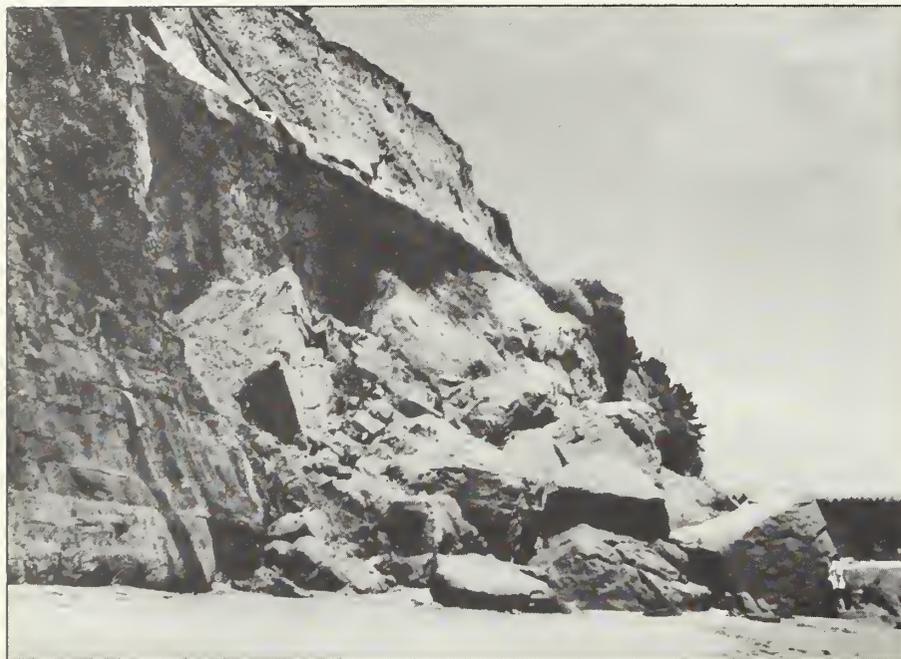
Photo 1. Joint-controlled wedge failure in the Pliocene Purisima Formation. Marine erosion processes undercut these cliffs, which failed along intersecting joint planes. (Photo by Gary B. Griggs)

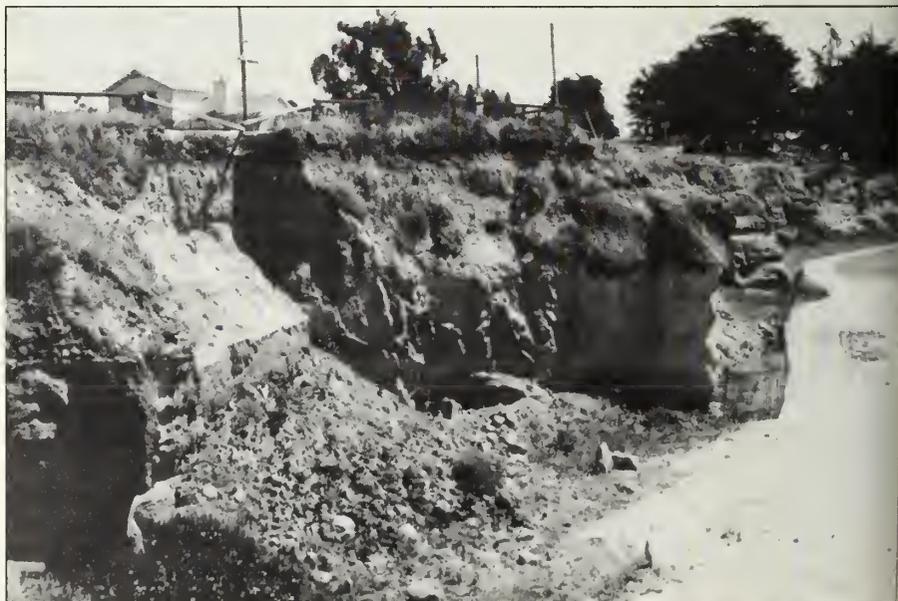
Photo 2. Coastal landslides at Point San Lorenzo, Seabright State Beach. Block fall at center left and rotational slump at center. Note park bench at top of terrace surface is within the landslide block. New protective fencing with warning signs has been placed farther inland; older fencing dangles precariously. (Photo by Robert H. Sydnor)

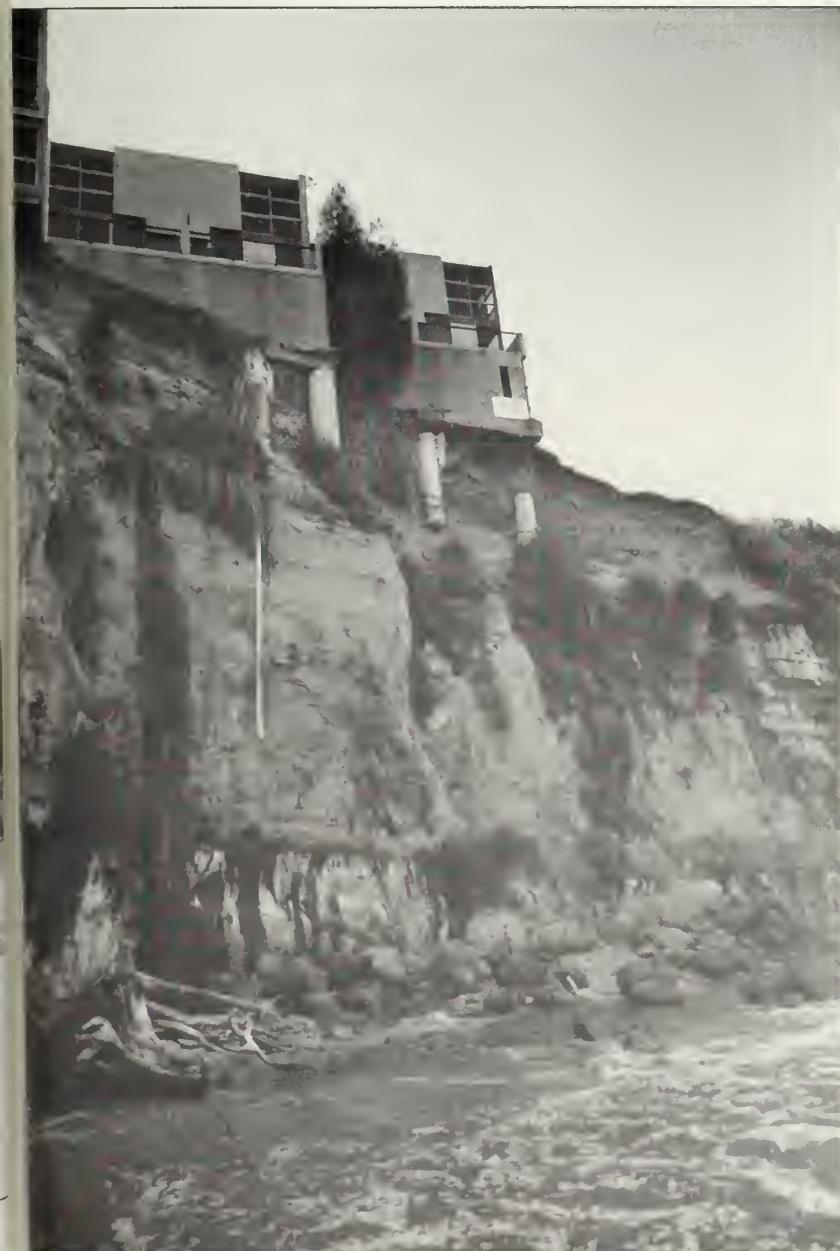
Photo 3. Coastal cliff failure below the Crest Apartments, Depot Hill, Capitola. Bedrock is the intensely jointed Purisima siltstone. (Photo by Gary B. Griggs, November 1989)

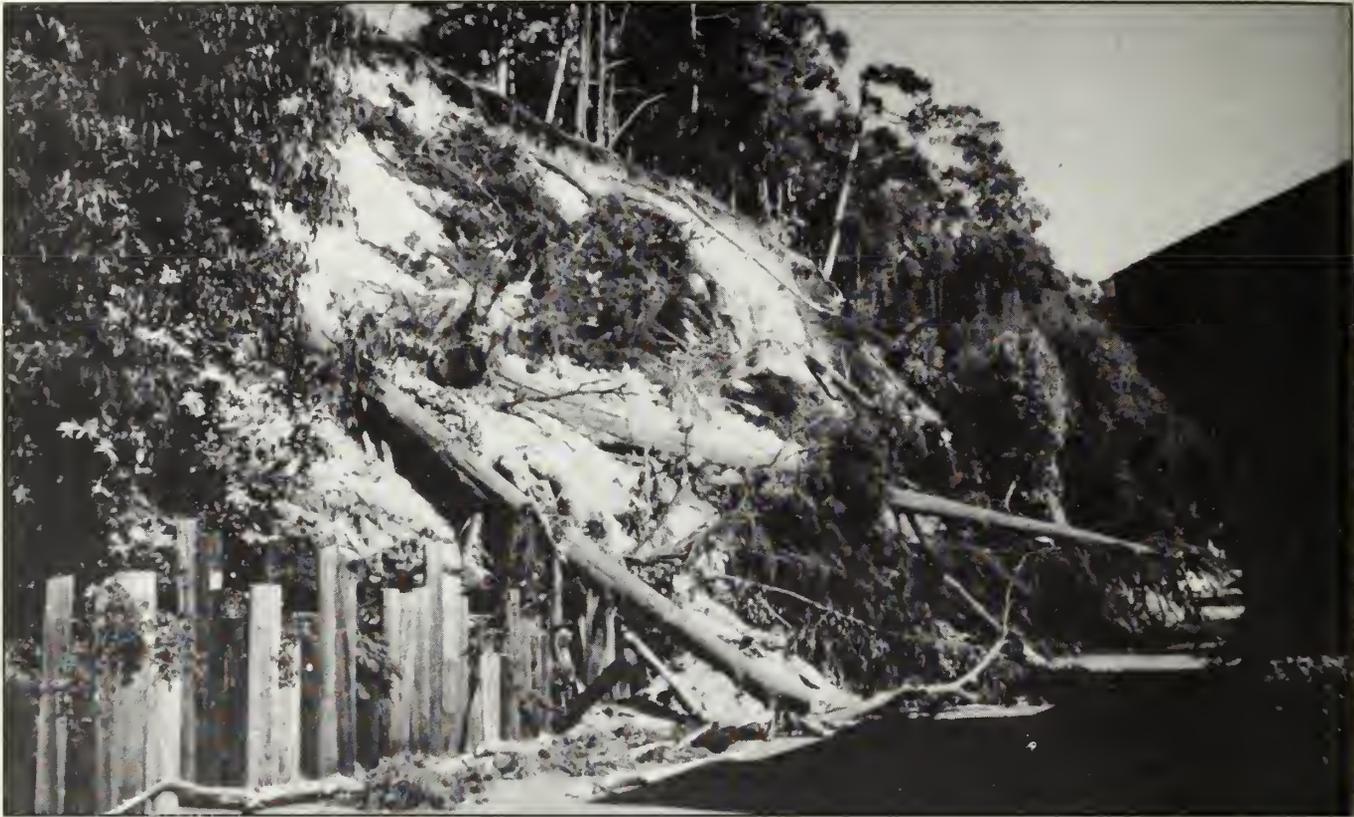
Photo 4. Coastal bluff landslide at Pot Belly Beach, 0.2 km east of New Brighton State Beach. Vertical telephone poles were an ineffective retaining wall. (Photo by Robert H. Sydnor)

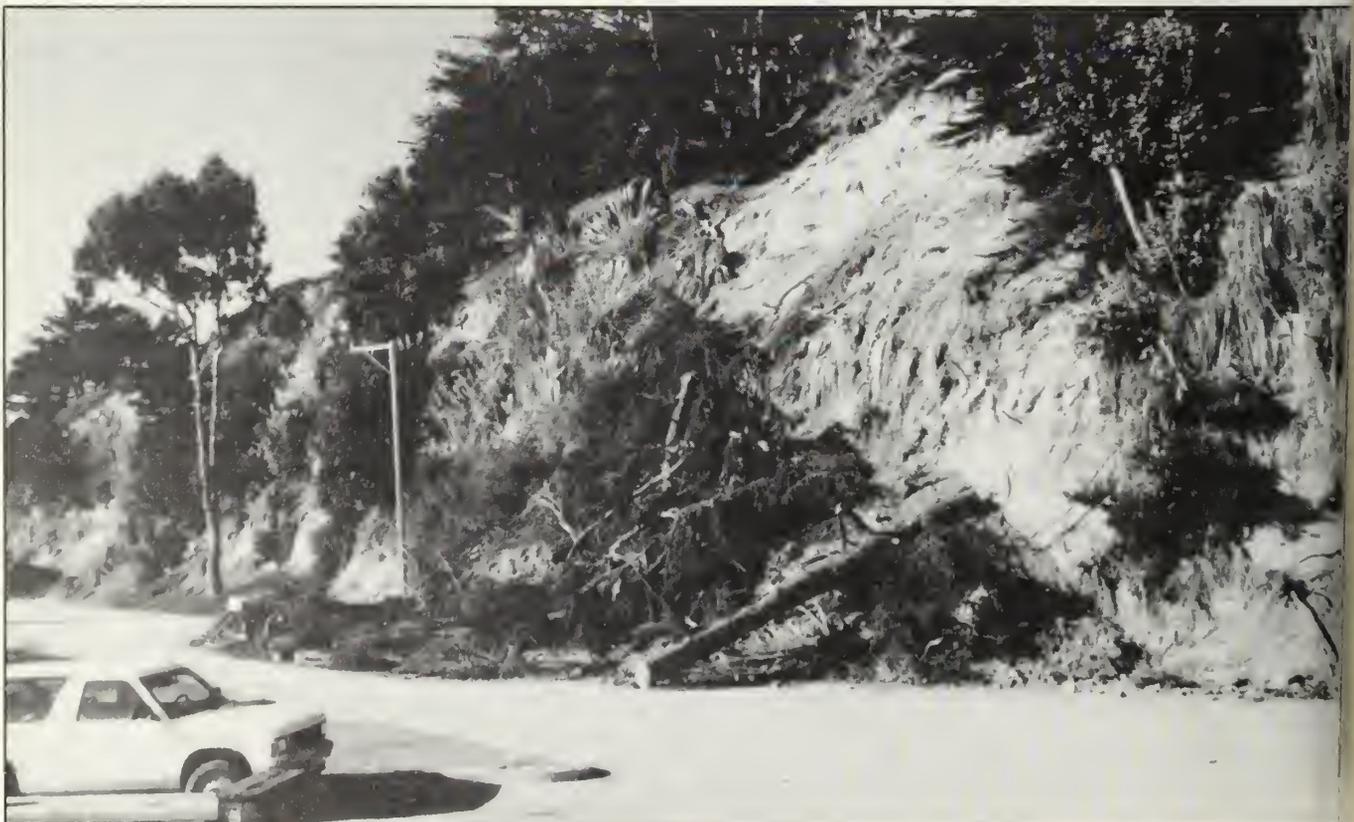
Photo 5. Numerous landslides temporarily closed Seacliff State Beach and adjacent Las Olas Drive. Bedrock is Purisima sandstone. Sawyers have felled top-heavy eucalyptus and cypress trees to make access for crane-supported dragline and track-mounted backhoe. Utility lines were relocated underground during cliff repair. (Photo by Robert H. Sydnor, October 20, 1989)
