**THE LOMA PRIETA
(SANTA CRUZ MOUNTAINS)
CALIFORNIA,
EARTHQUAKE OF 17 OCTOBER 1989**

Division of Mines and Geology

**THE LOMA PRIETA
(SANTA CRUZ MOUNTAINS), CALIFORNIA,
EARTHQUAKE
OF
17 OCTOBER 1989**

Special Publication 104

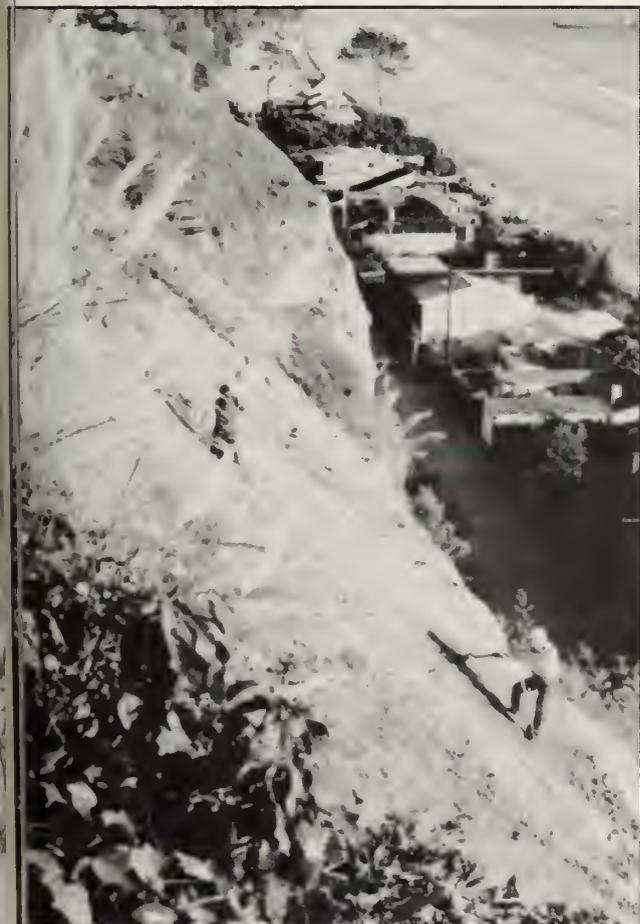
Photo 6. Engineering geologist and worker belayed on cliff above Las Olas Drive. Bedrock is Purisima sandstone. (Photo by Gerald E. Weber)

Remedial grading and removal of landslide blocks on these steep cliffs proved difficult because of restricted access from either above or below. Access problems were exacerbated by several private gazebos and decks which encroached onto state park land at the brink of the cliff. Most of the remedial grading was performed by a crane-supported dragline. The field work was inspected by an engineering geologist belayed by mountaineering ropes on the cliff face (Photos 6 and 7).

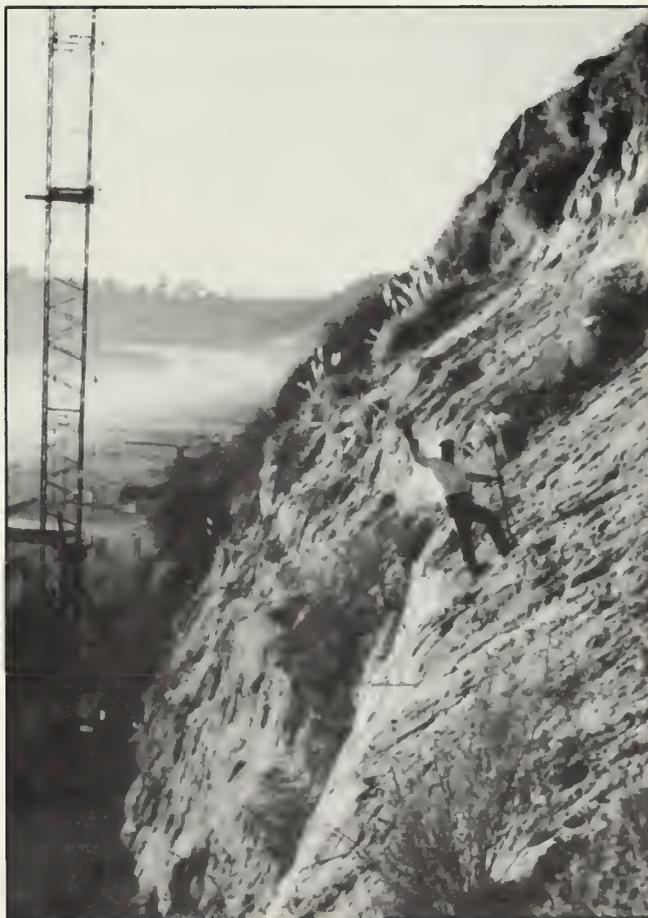
Photo 7. Crane-supported dragline and belayed worker remove loose landslide blocks above Las Olas Drive near Seacliff State Beach. No equipment access was available from above. (Photo by Gerald E. Weber)

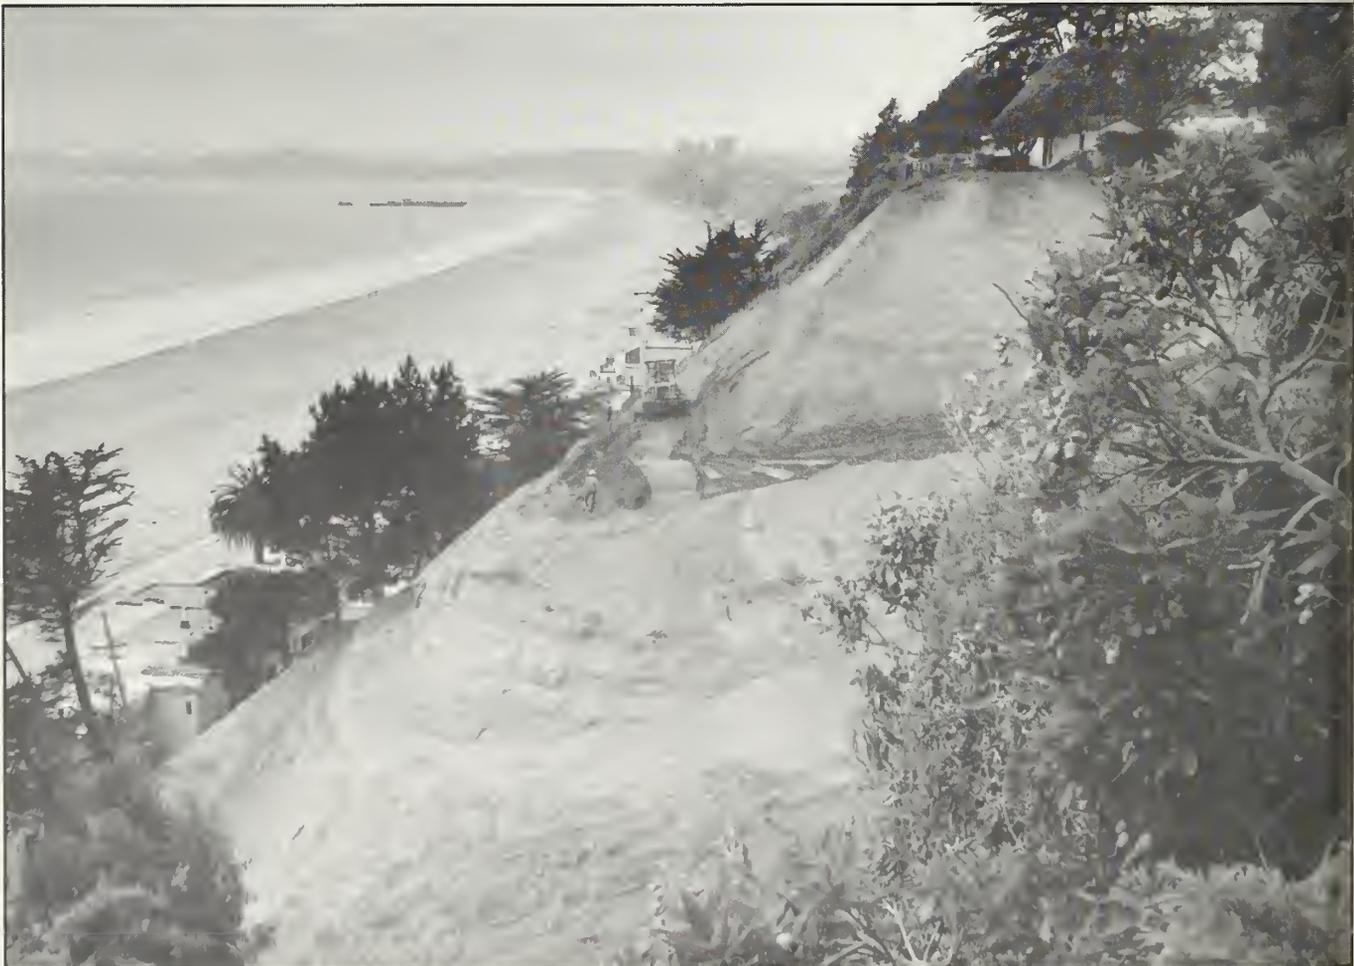
Photo 8. Remedial grading at the Sea View Drive landslide in Rio Del Mar. Loose friable sands are being removed and the slope angle reduced. The former residence was located directly upslope from where the bulldozer is working; only the separate guest house remains. (Photo by Robert H. Sydnor, May 2, 1990)

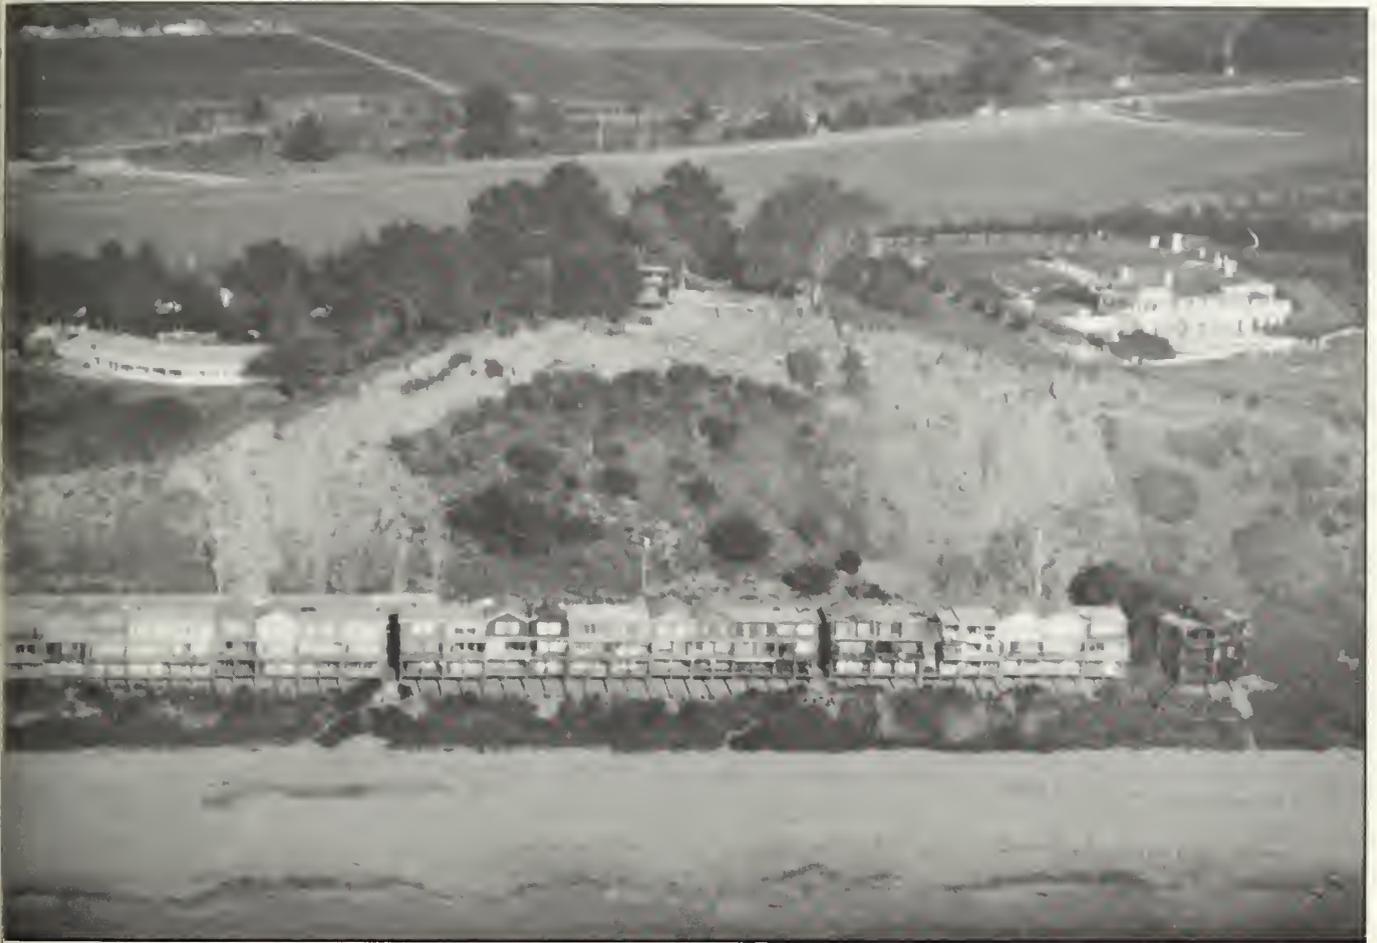
Photo 9. Very large dry sand flow above Place de Mer development in Rio Del Mar. Houses at the top and base of this failure were at risk (Airphoto by Gary B. Griggs, November 1, 1989).

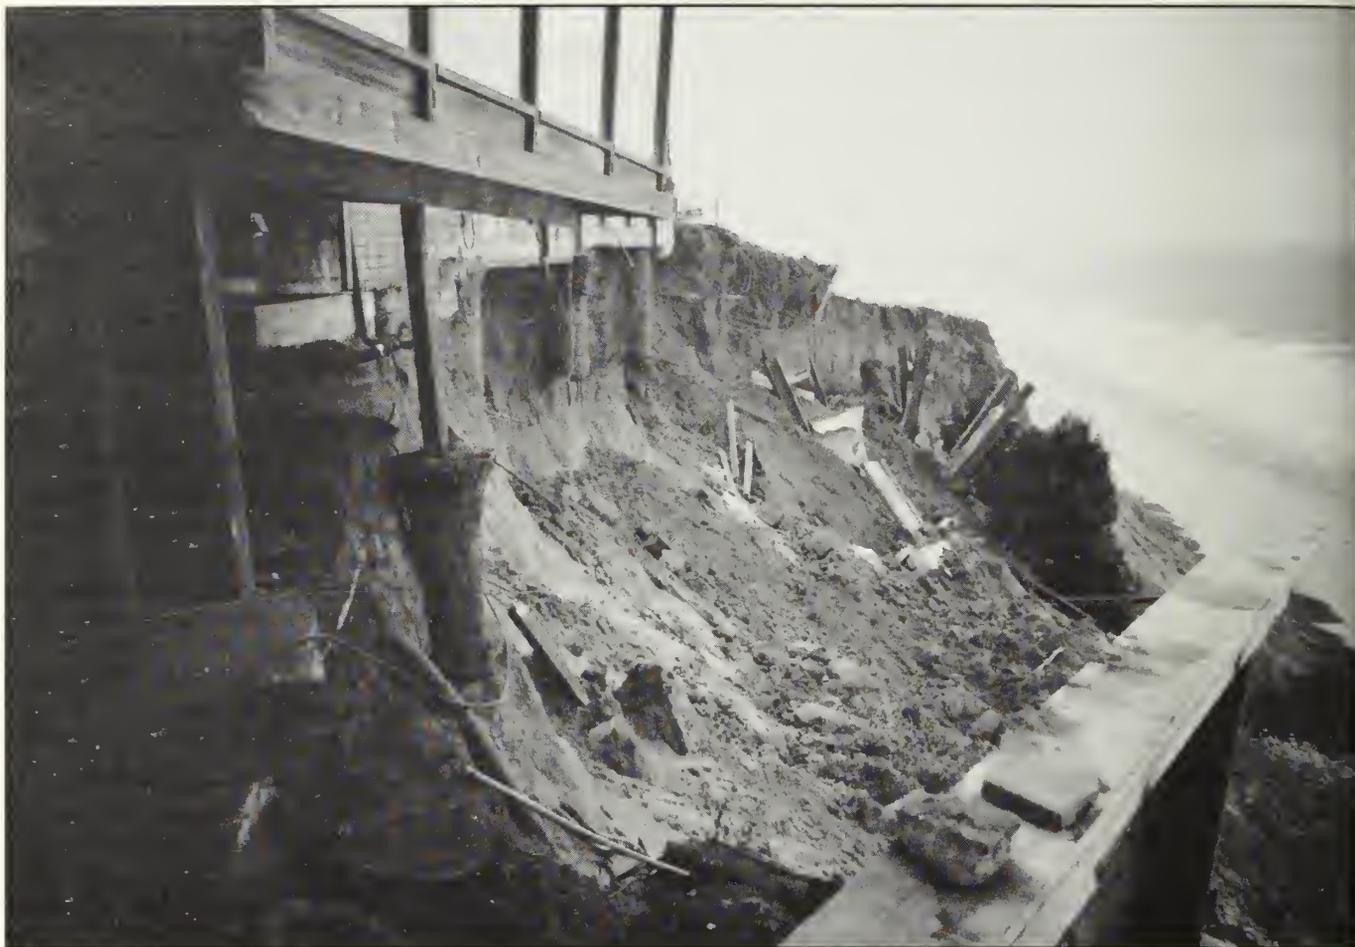
Photo 10. Coastal landslide in unconsolidated sands of the Aromas formation, above Place de Mer development (Photo by Robert H. Sydnor, October 20, 1989).

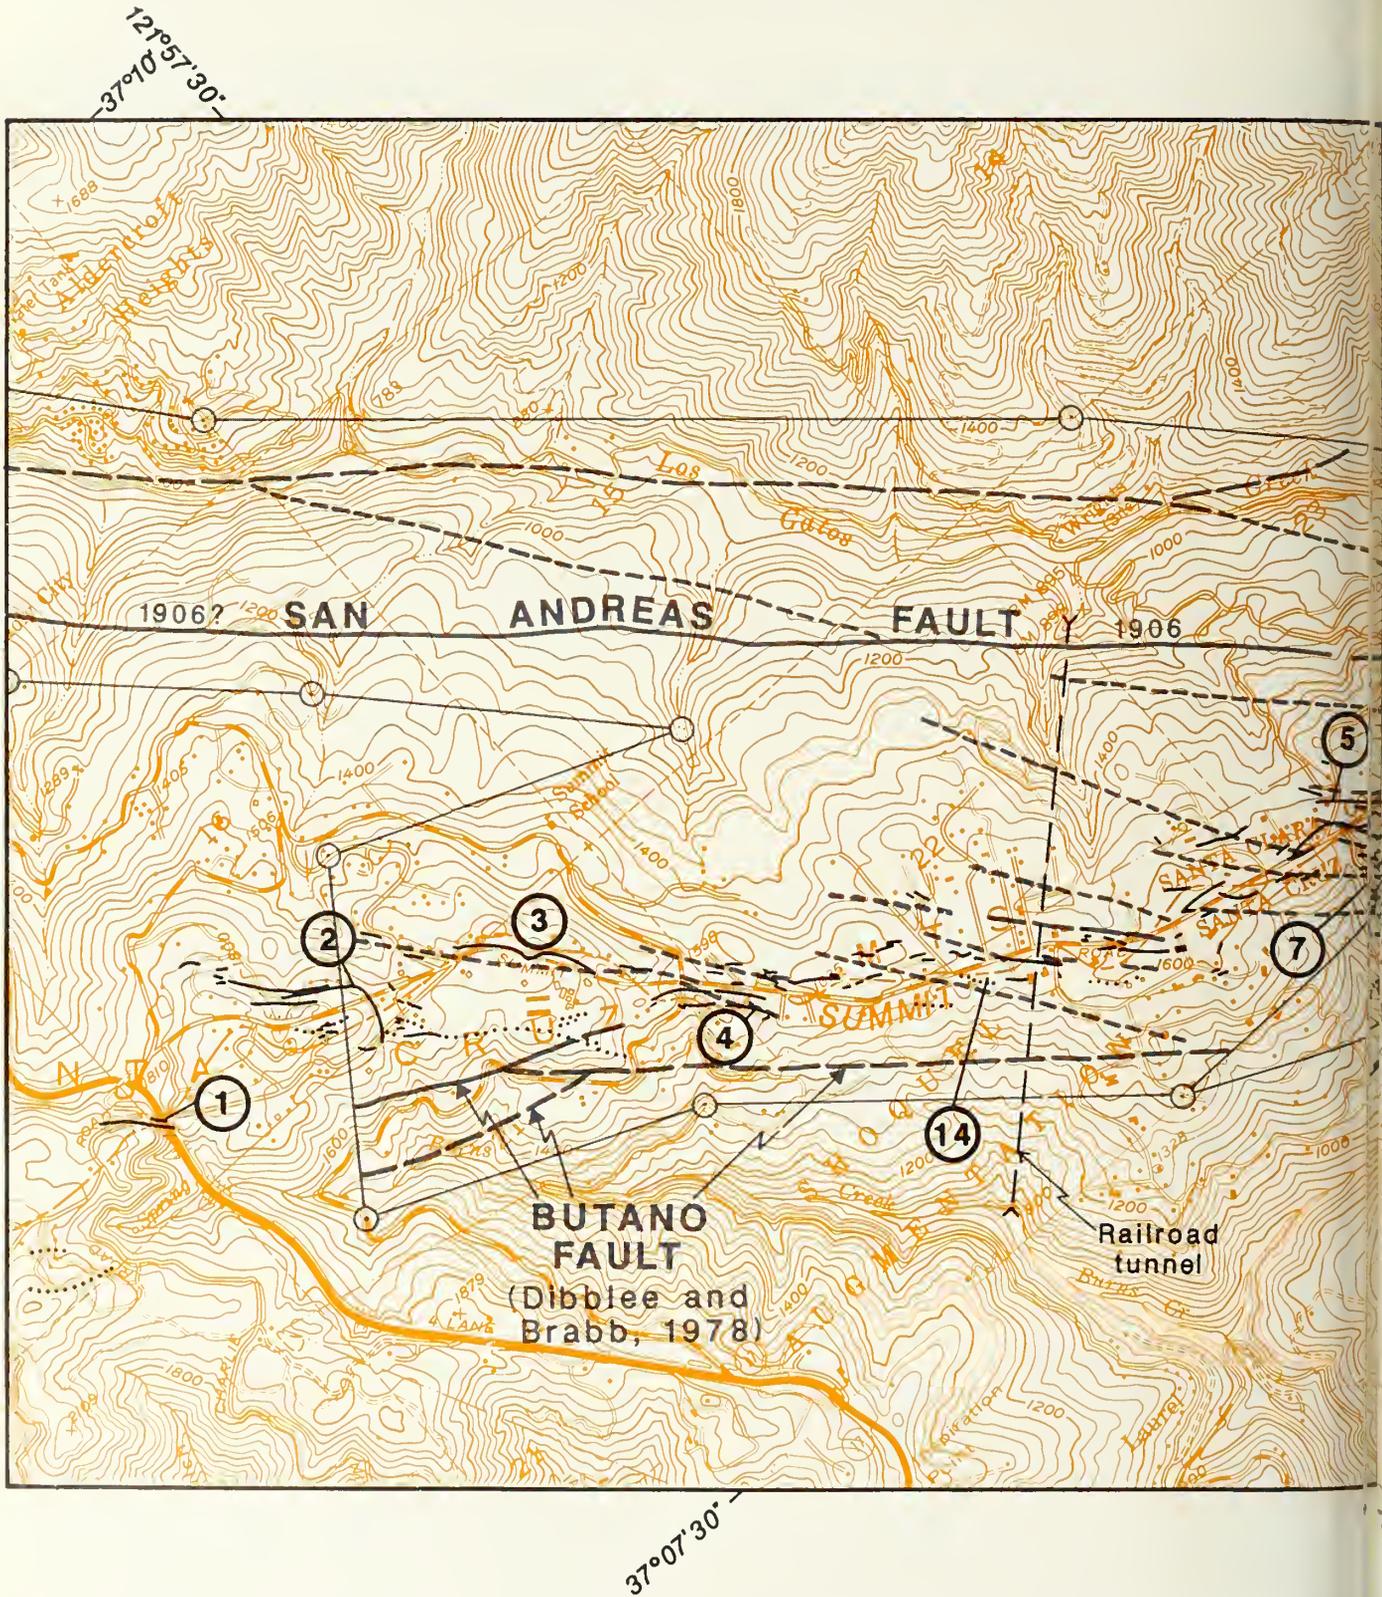
Figure 2. Preliminary map showing the distribution of fissures developed during the 17 October 1989 earthquake. Fissures shown by heavy solid lines are generalized in Wells and others (1989). Selected linear fissures from Spittler and Harp (1990) are shown by dotted line. Base map shows fault traces and Special Studies Zones established under the Alquist-Priolo Act (California Division of Mines and Geology, 1976). Numbers identify localities discussed in Table 1 (overleaf) and in the text.

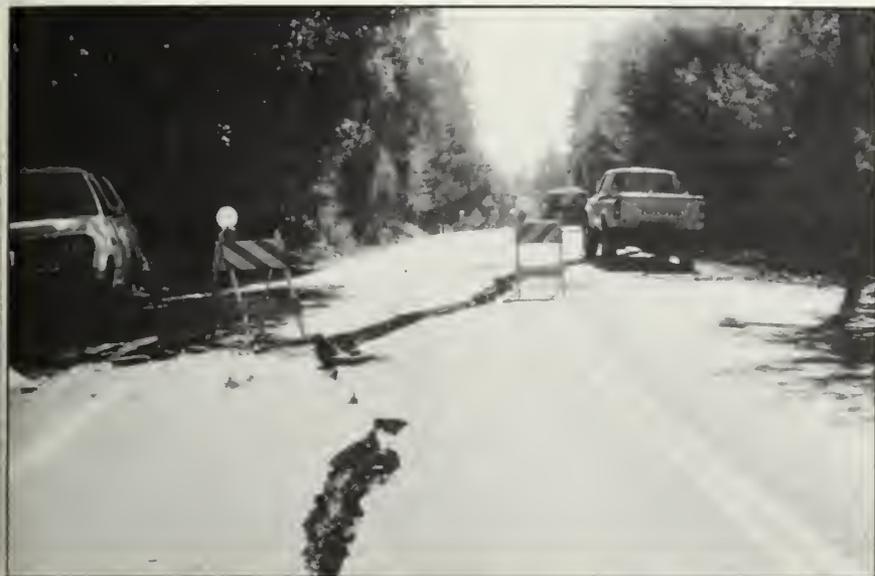
Photo 1. Portion of sinuous fissure zone in Summit Road at locality 3 (Figure 2) showing significant extensional and vertical offset. (Photo by E.W. Hart, 10/18/89)

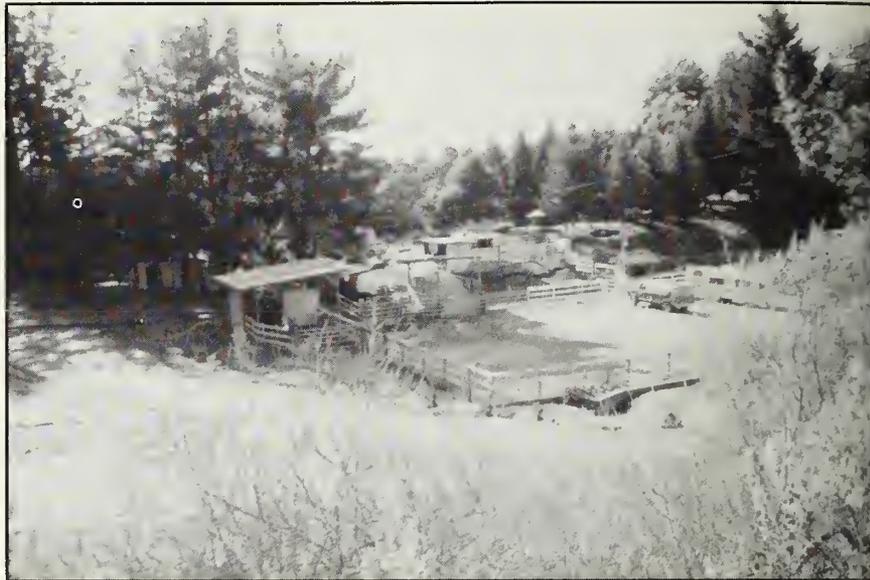
Photo 3. Fissure formed along the base of a pre-existing scarp at locality 4 (Figure 2). House at southeastern end of this fissure (left of photo) was damaged by extension. Linear scarp defines margin of depression and provides good evidence of previous fissuring. (Photo by E.W. Hart, 10/25/89)

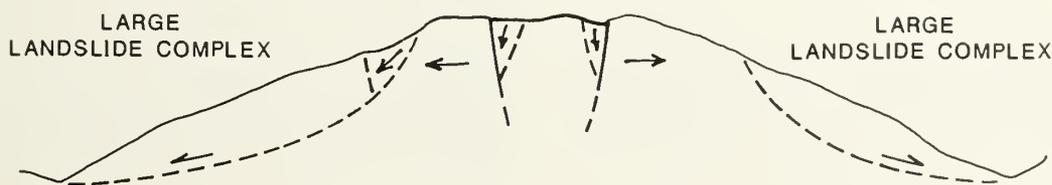
Figure 3. Schematic cross section through ridge of Summit Road showing seismically-induced lateral-spreading of ridge. Outward movement of ridge induces differential settlement forming back-facing scarps and linear depressions on top of ridge. Large landslide complexes, which generally flank ridges, also are activated and move downslope coseismically. Displacements on ridgetop tend to follow pre-existing faults, bedding planes, or other rock structures, which are not detailed in this model.

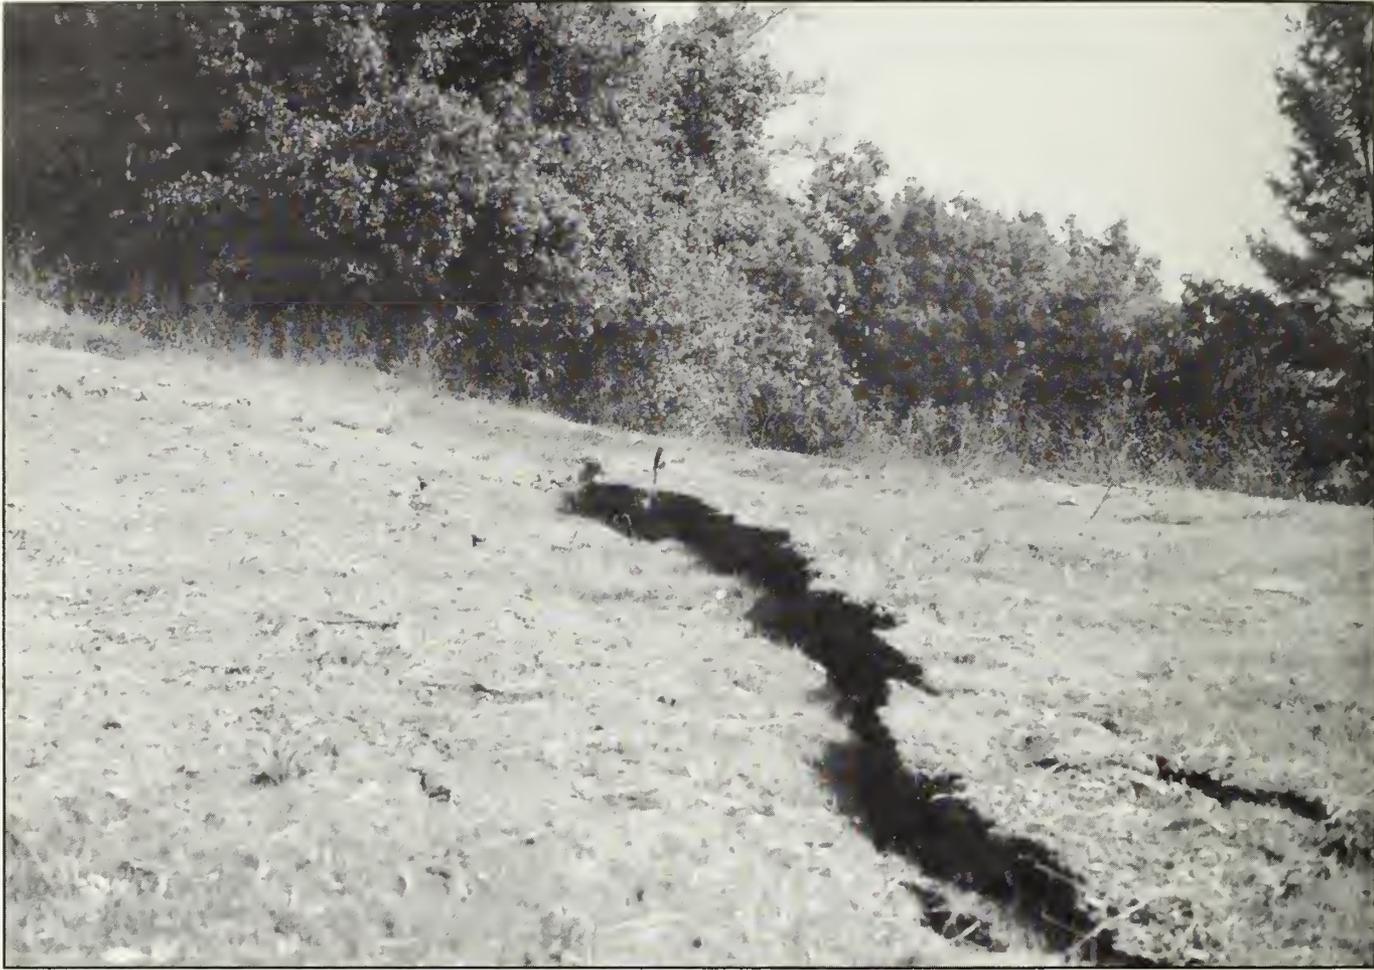
Photo 4. Looking southeast at uphill-facing scarp and associated fissures along sidehill bench at locality 9 (Figure 2); note knife for scale. Features are similar to fault-like fissures on ridgecrest above but appear to interconnect with landslide features to northwest and southeast. Presence of bench indicates previous rupture events. (Photo by W. A. Bryant, 1/11/90)

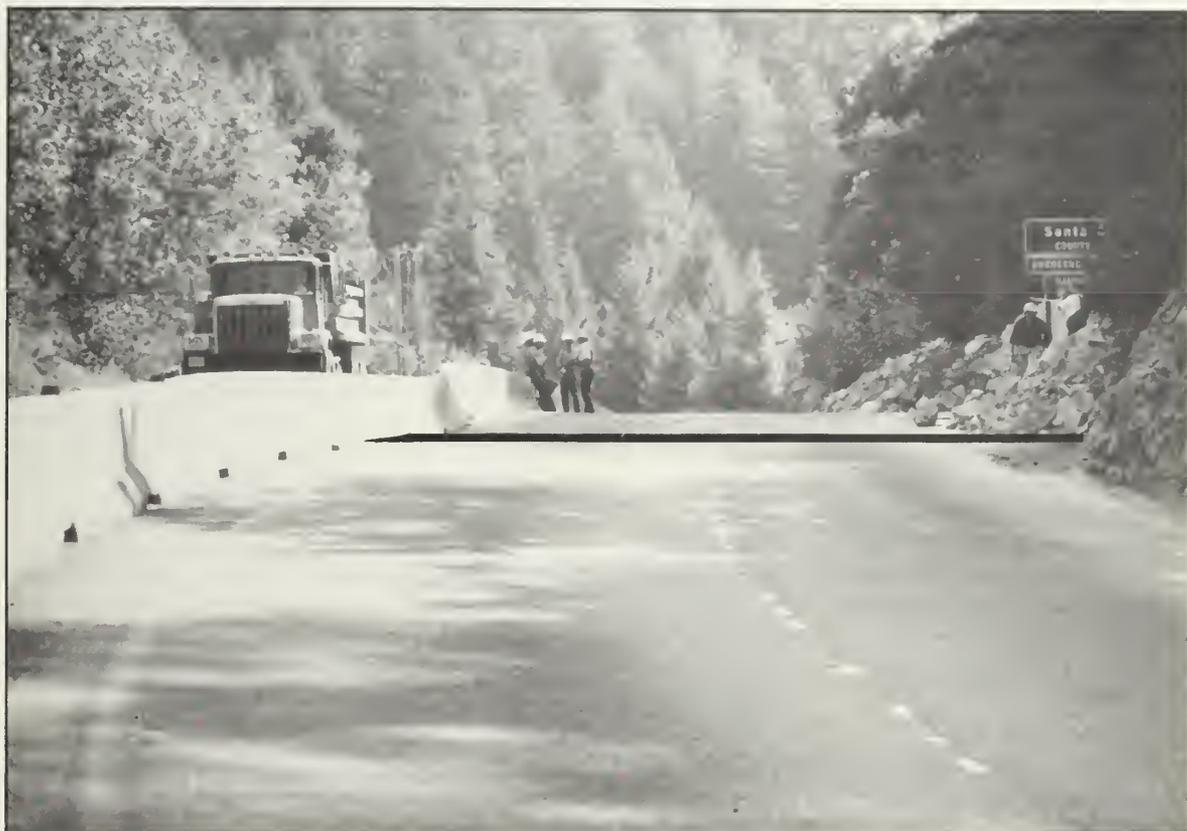
Photo 1. Bedding plane, normal faulting expressed as a 40 cm heave in Highway 17. View looking south toward Santa Cruz County.

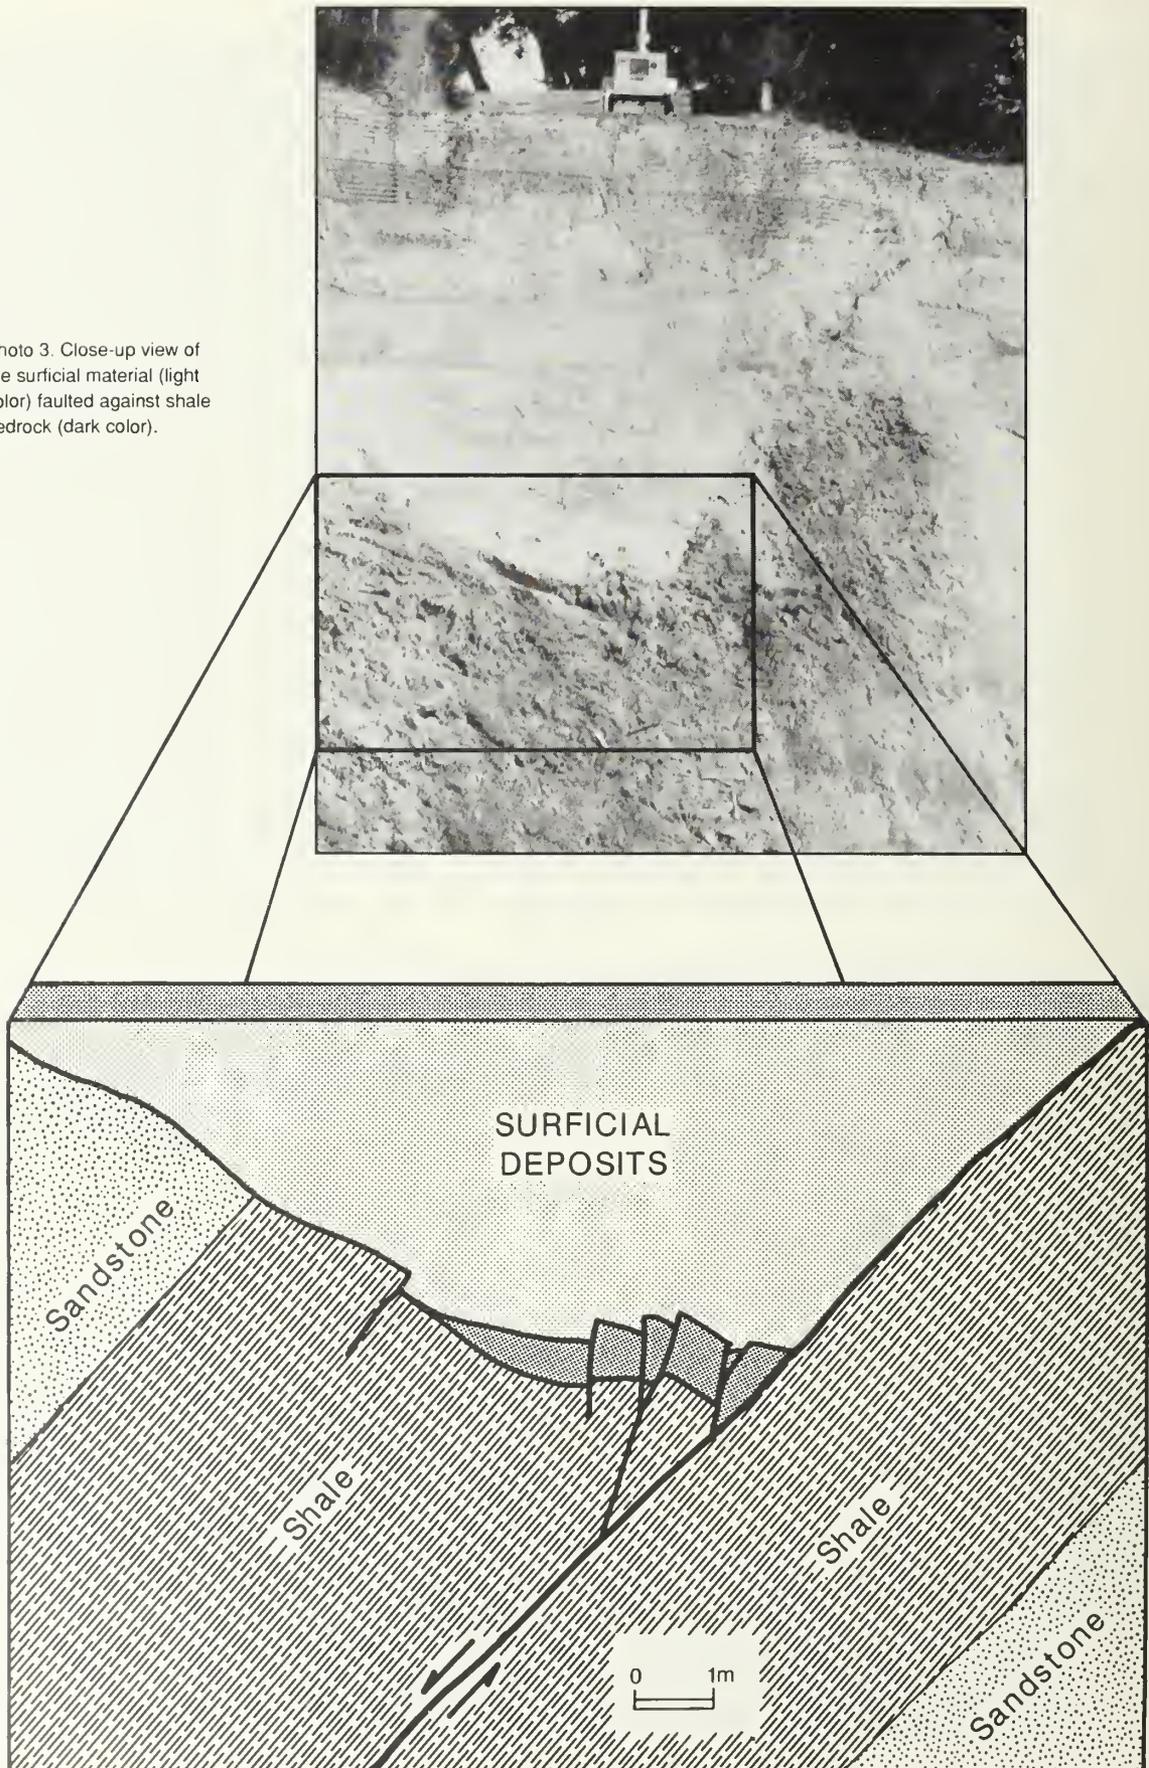
Figure 2. Preliminary geologic log of the fault relationships in the bottom 2 m of surficial deposits.

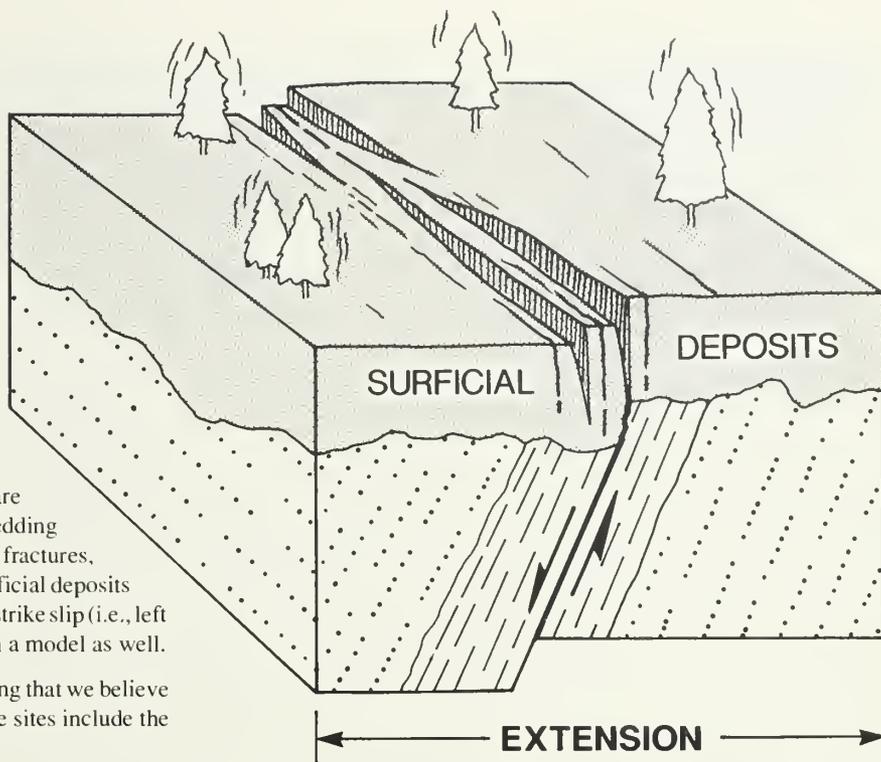
Figure 3. Development of extensional ground fissures in surficial deposits due to coseismic normal slip along a bedding plane within shale bedrock.

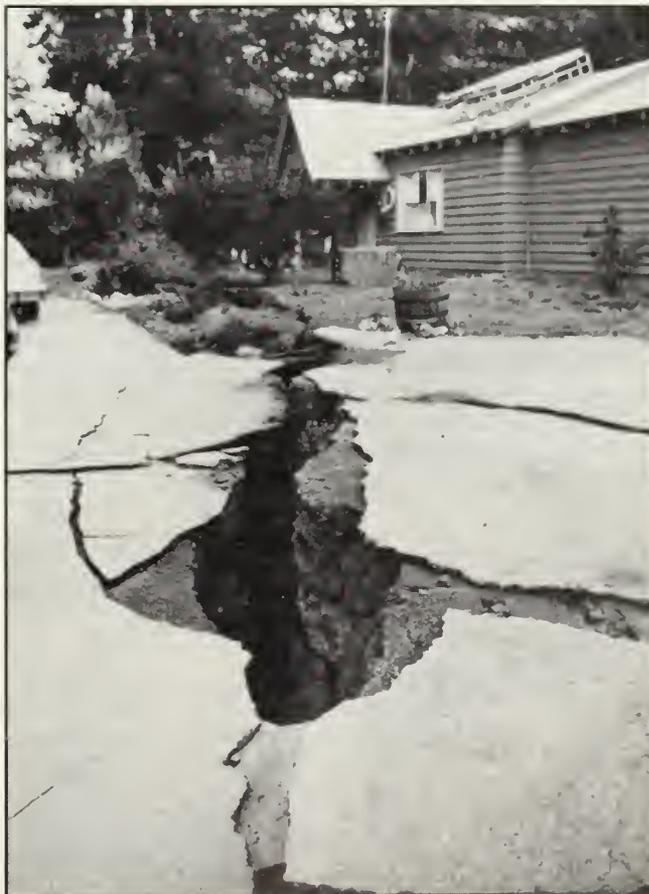
Photo 4. Northwest view of the dramatic extensional ground fissure that passed within several meters of the front door of the Tranbarger home.

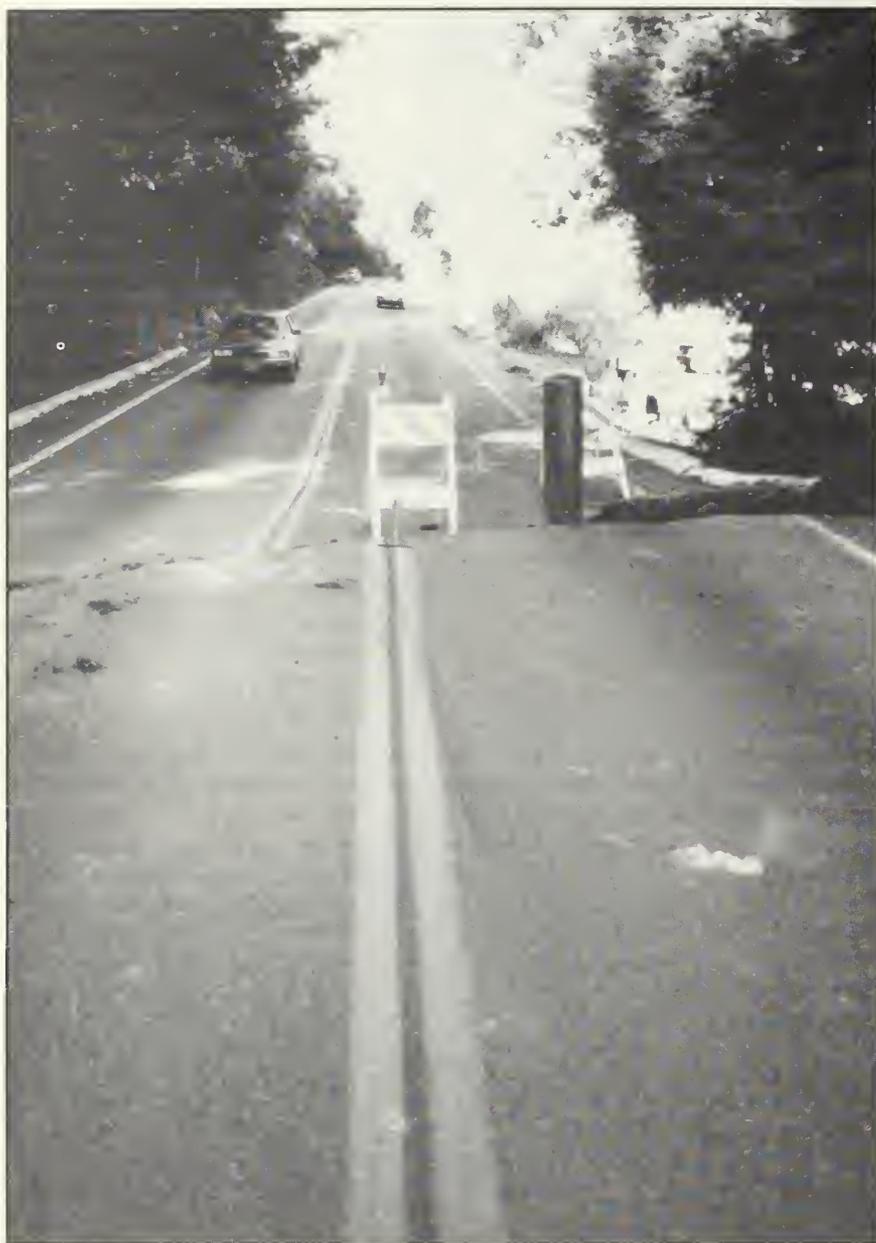
Photo 5. Northwest view across the left lateral displacement of Summit Road near the Tranbarger property. In this area, the extensional ground fissure near the Tranbarger home (driveway at upper right corner) changes to a north-trending zone of shear.

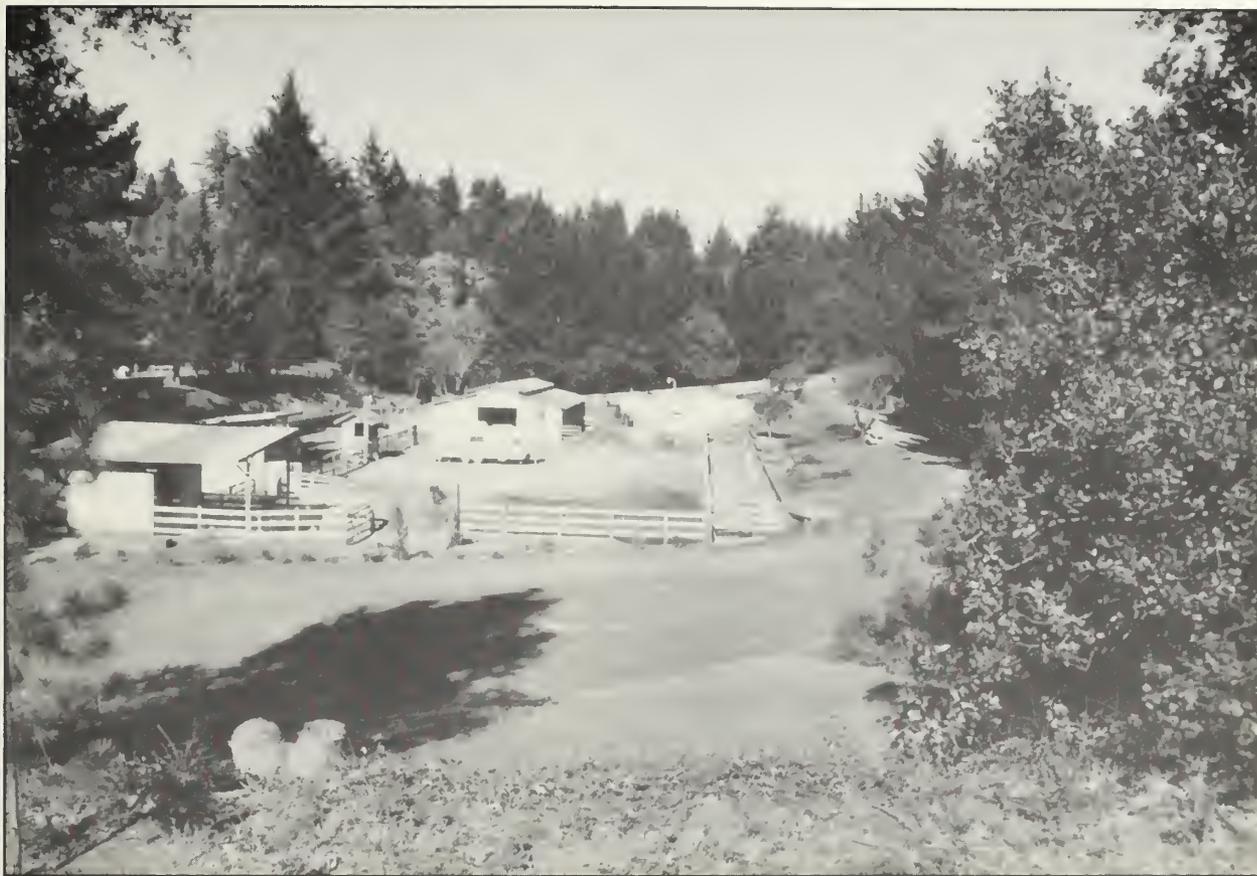
Photo 6. Northwest-trending ridgetop depression near the crest of Summit Ridge. Linear zones of ground fissures developed along both the north and south edges of the depression.

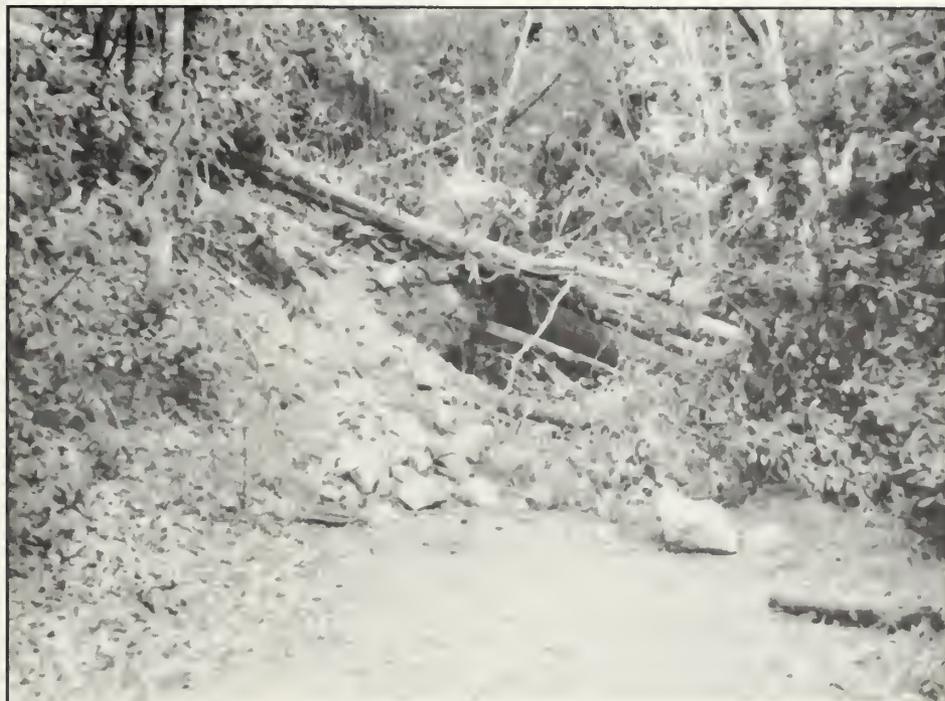
Photo 2. Translational/rotational landslide blocking road at eastern edge of forest. (Photo by David Soho)

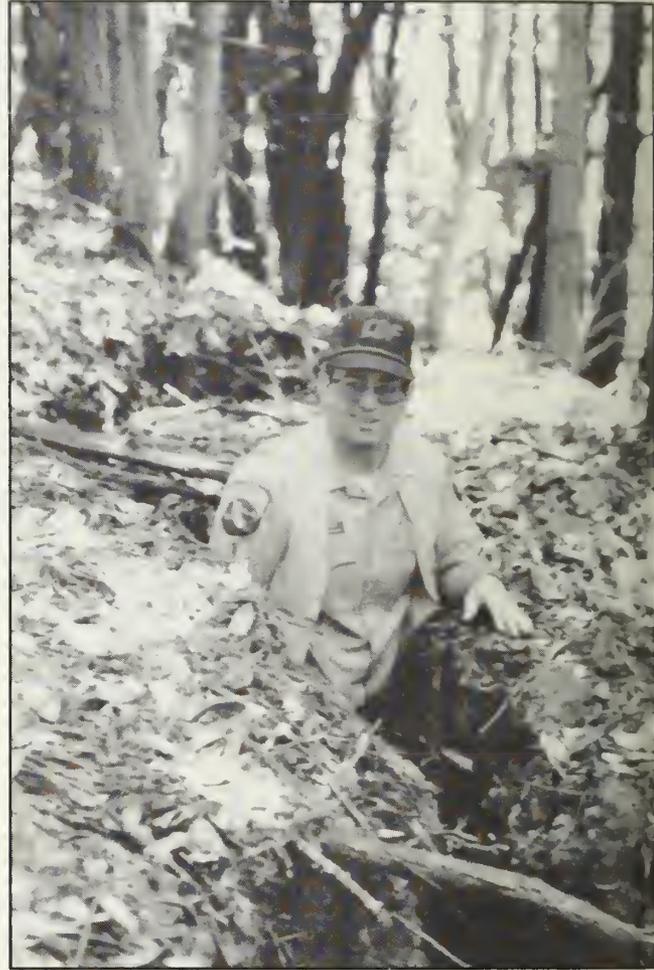
Photo 4. Fresh cracks resulting from earthquake shaking upslope from Amaya Creek along the southeast side of the stream channel. (Photo by Trinda L. Bedrossian)

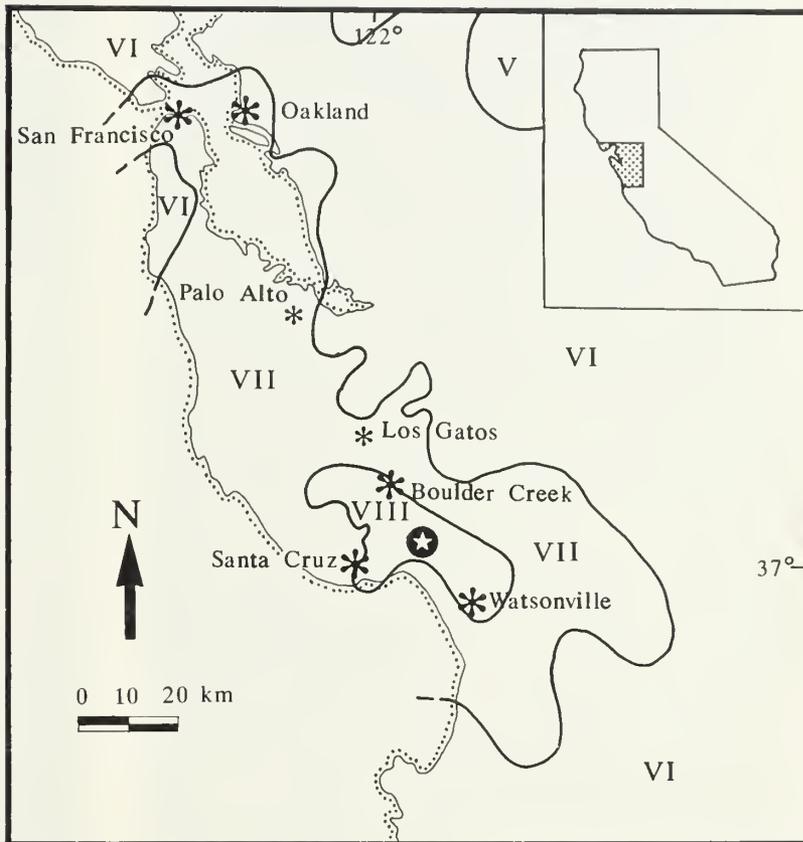
Figure 1. Map showing distribution of Modified Mercalli ground shaking intensities from the Loma Prieta earthquake (modified from Stover and others, 1990). Ground shaking of MM intensity VIII was estimated for the epicentral region. Localized ground shaking of MM intensity IX occurred in parts of San Francisco and Oakland underlain by artificial fill and bay mud. White star within black circle represents location of earthquake epicenter. Large asterisks represent general locations of photographs presented in this article. Smaller asterisks are other locations mentioned in the text.

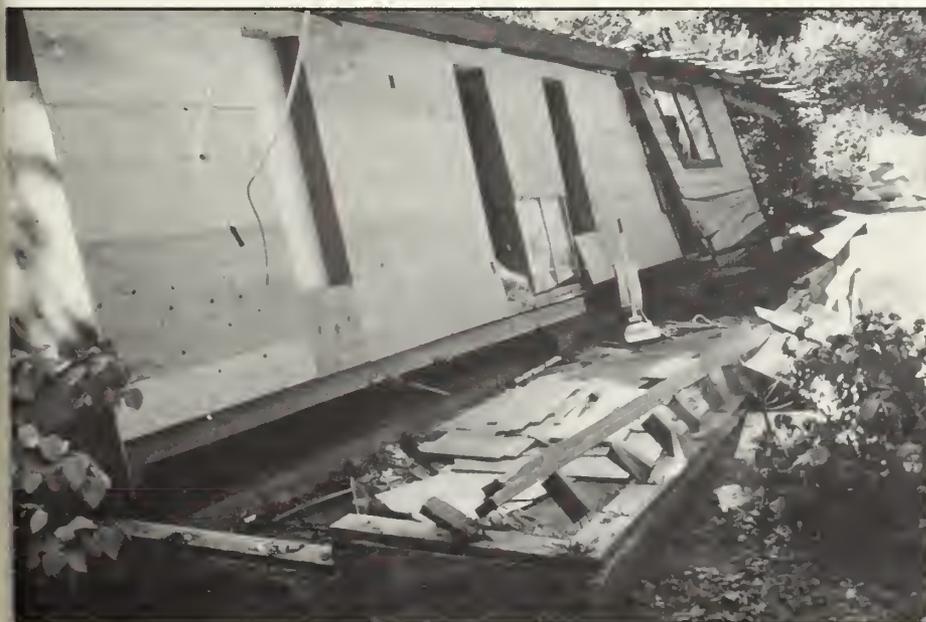
Photo 1. House thrown from its foundation near Summit Road in the Santa Cruz Mountains.

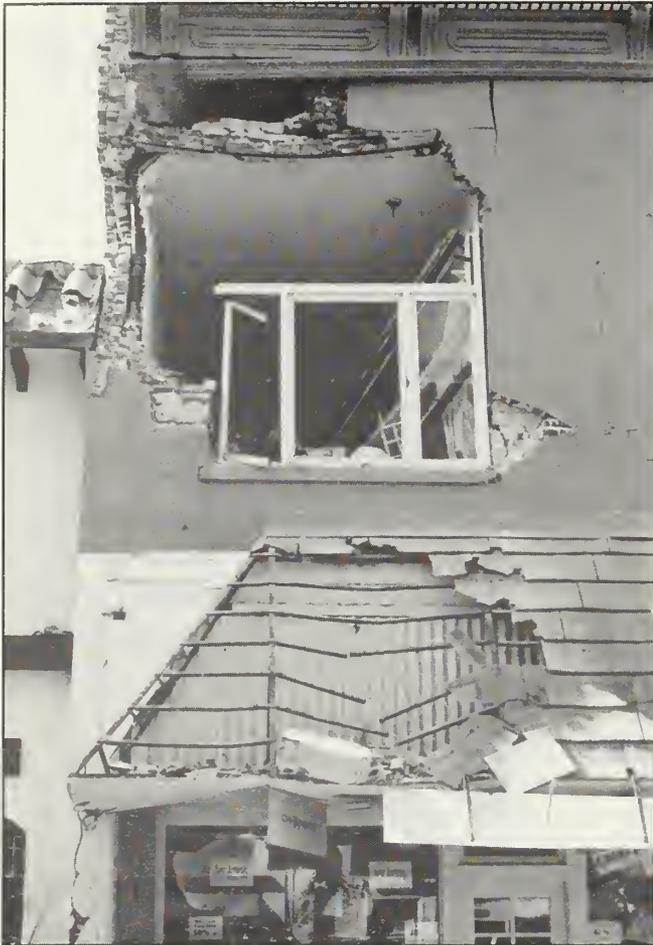
Photo 2. Partially collapsed masonry building in the Pacific Garden Mall, Santa Cruz.

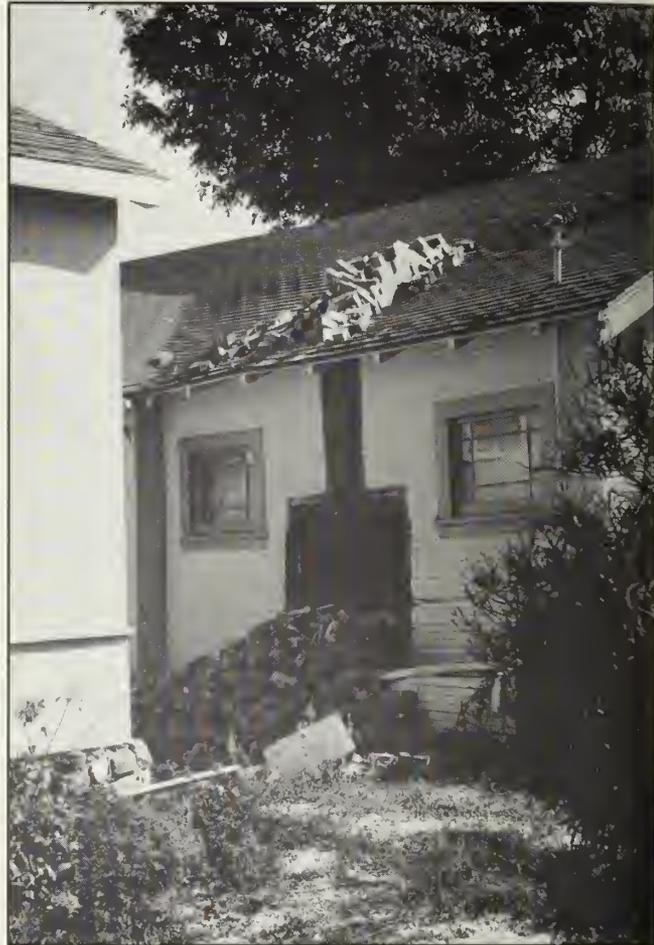
Photo 3. Collapsed chimney in the heavily damaged residential area of Santa Cruz (from Montgomery, 1990).

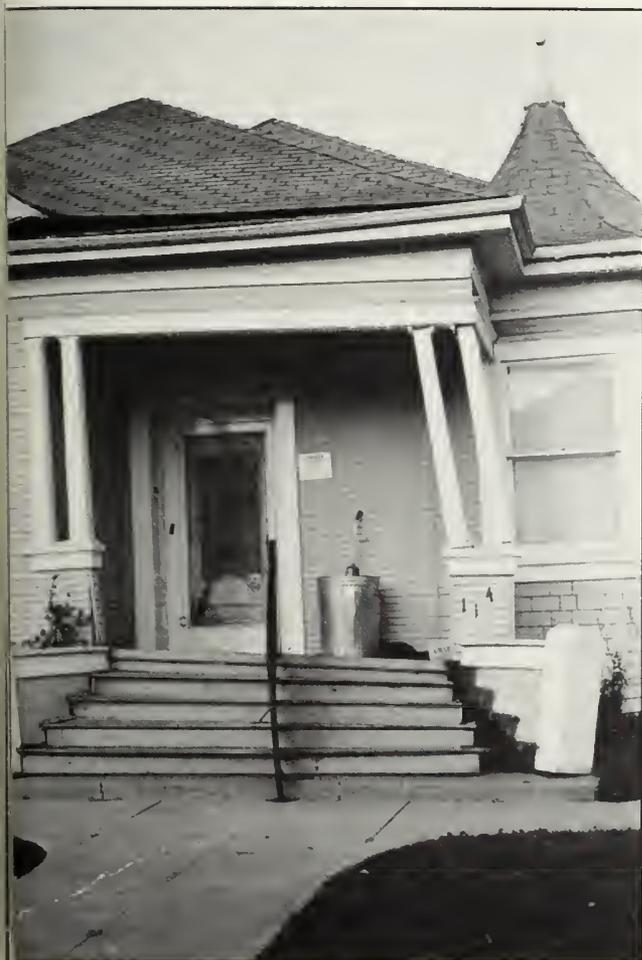
Photo 4. Structural damage to a Victorian-style house in Watsonville.

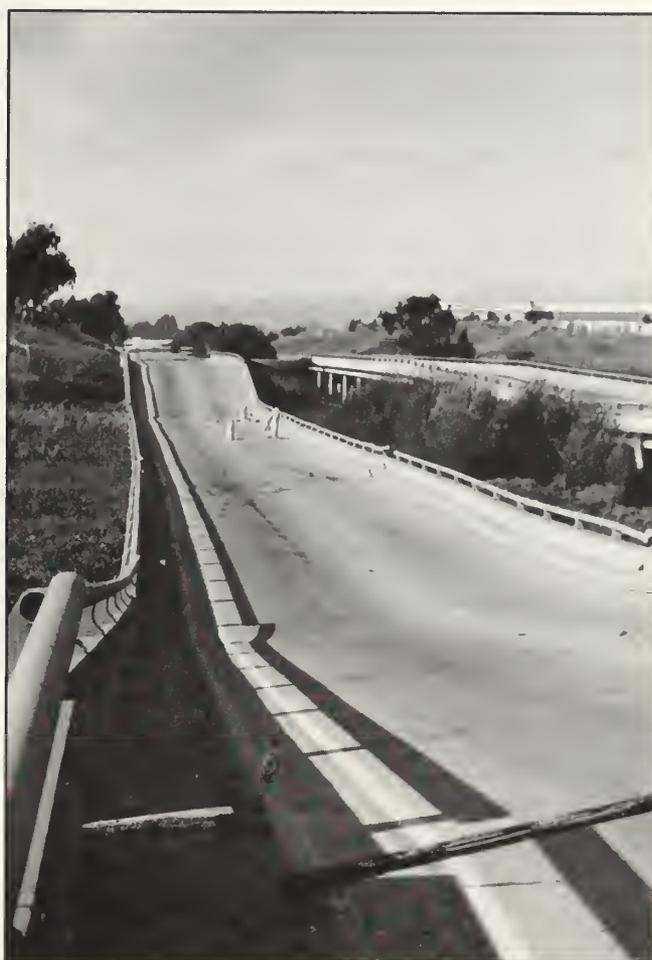
Photo 5. Collapsed section of Highway 1 at Struve Slough near Watsonville. The young alluvium underlying the failed portion of the structure had been identified as having a high potential for liquefaction (Dupré, 1975).
