**THE LOMA PRIETA
(SANTA CRUZ MOUNTAINS)
CALIFORNIA,
EARTHQUAKE OF 17 OCTOBER 1989**

Division of Mines and Geology

**THE LOMA PRIETA
(SANTA CRUZ MOUNTAINS), CALIFORNIA,
EARTHQUAKE
OF
17 OCTOBER 1989**

Special Publication 104

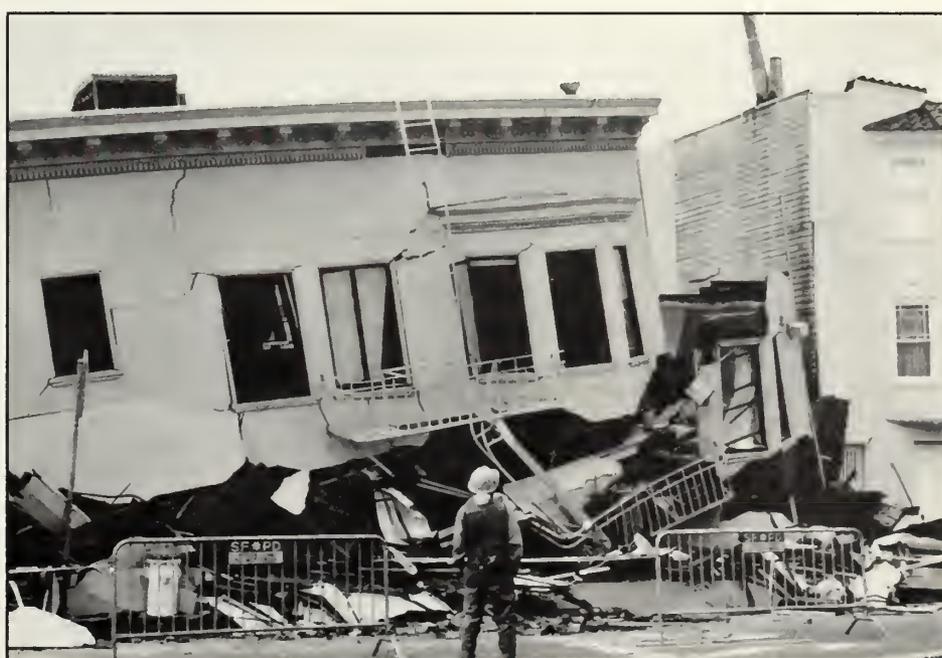
Photo 6. Collapsed apartment building in the Marina District of San Francisco.

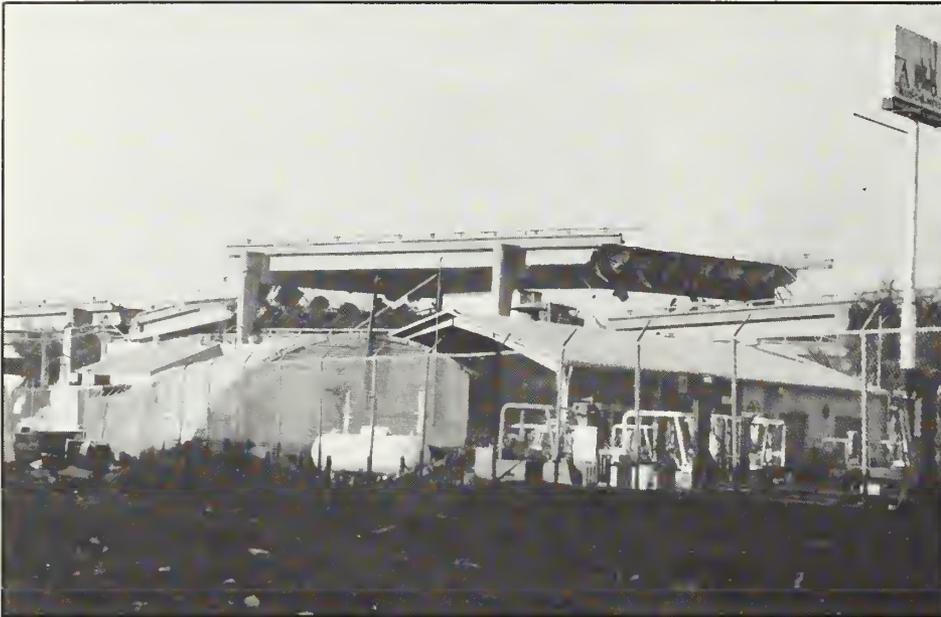
Photo 7. Partially collapsed portion of Interstate 880 near 13th and 14th streets in west Oakland.

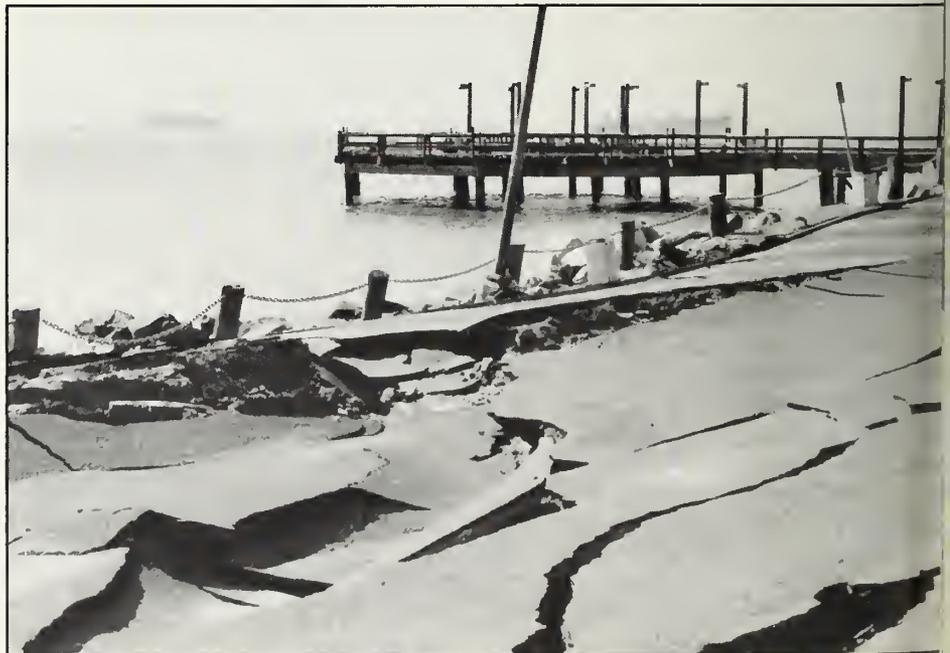
Photo 8. Pavement disrupted by lateral spreading of sand fill in the Port of Oakland.

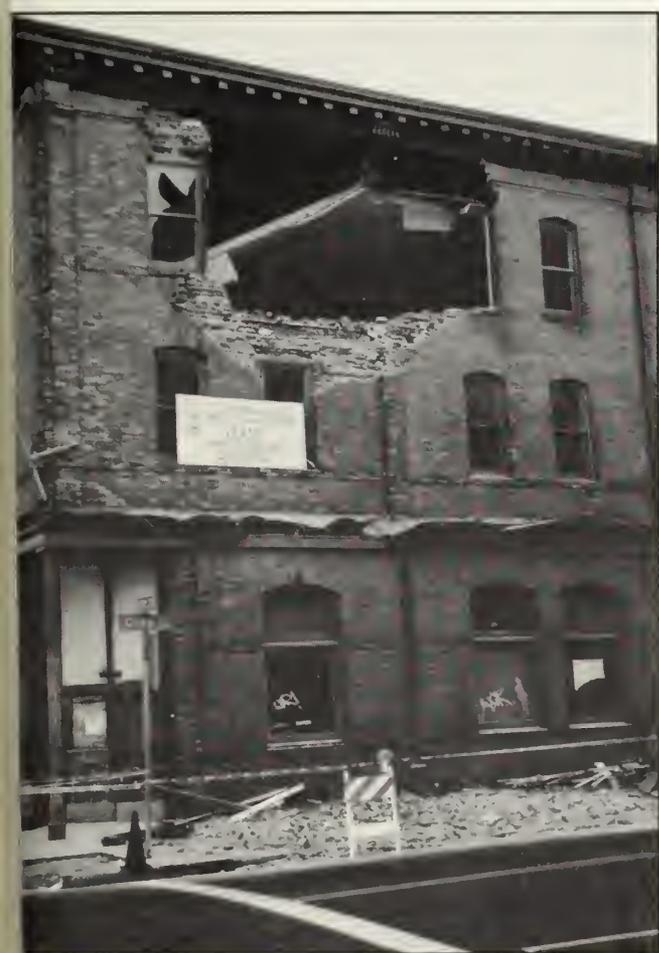
Photo 9. Partially collapsed unreinforced masonry building in downtown Oakland.

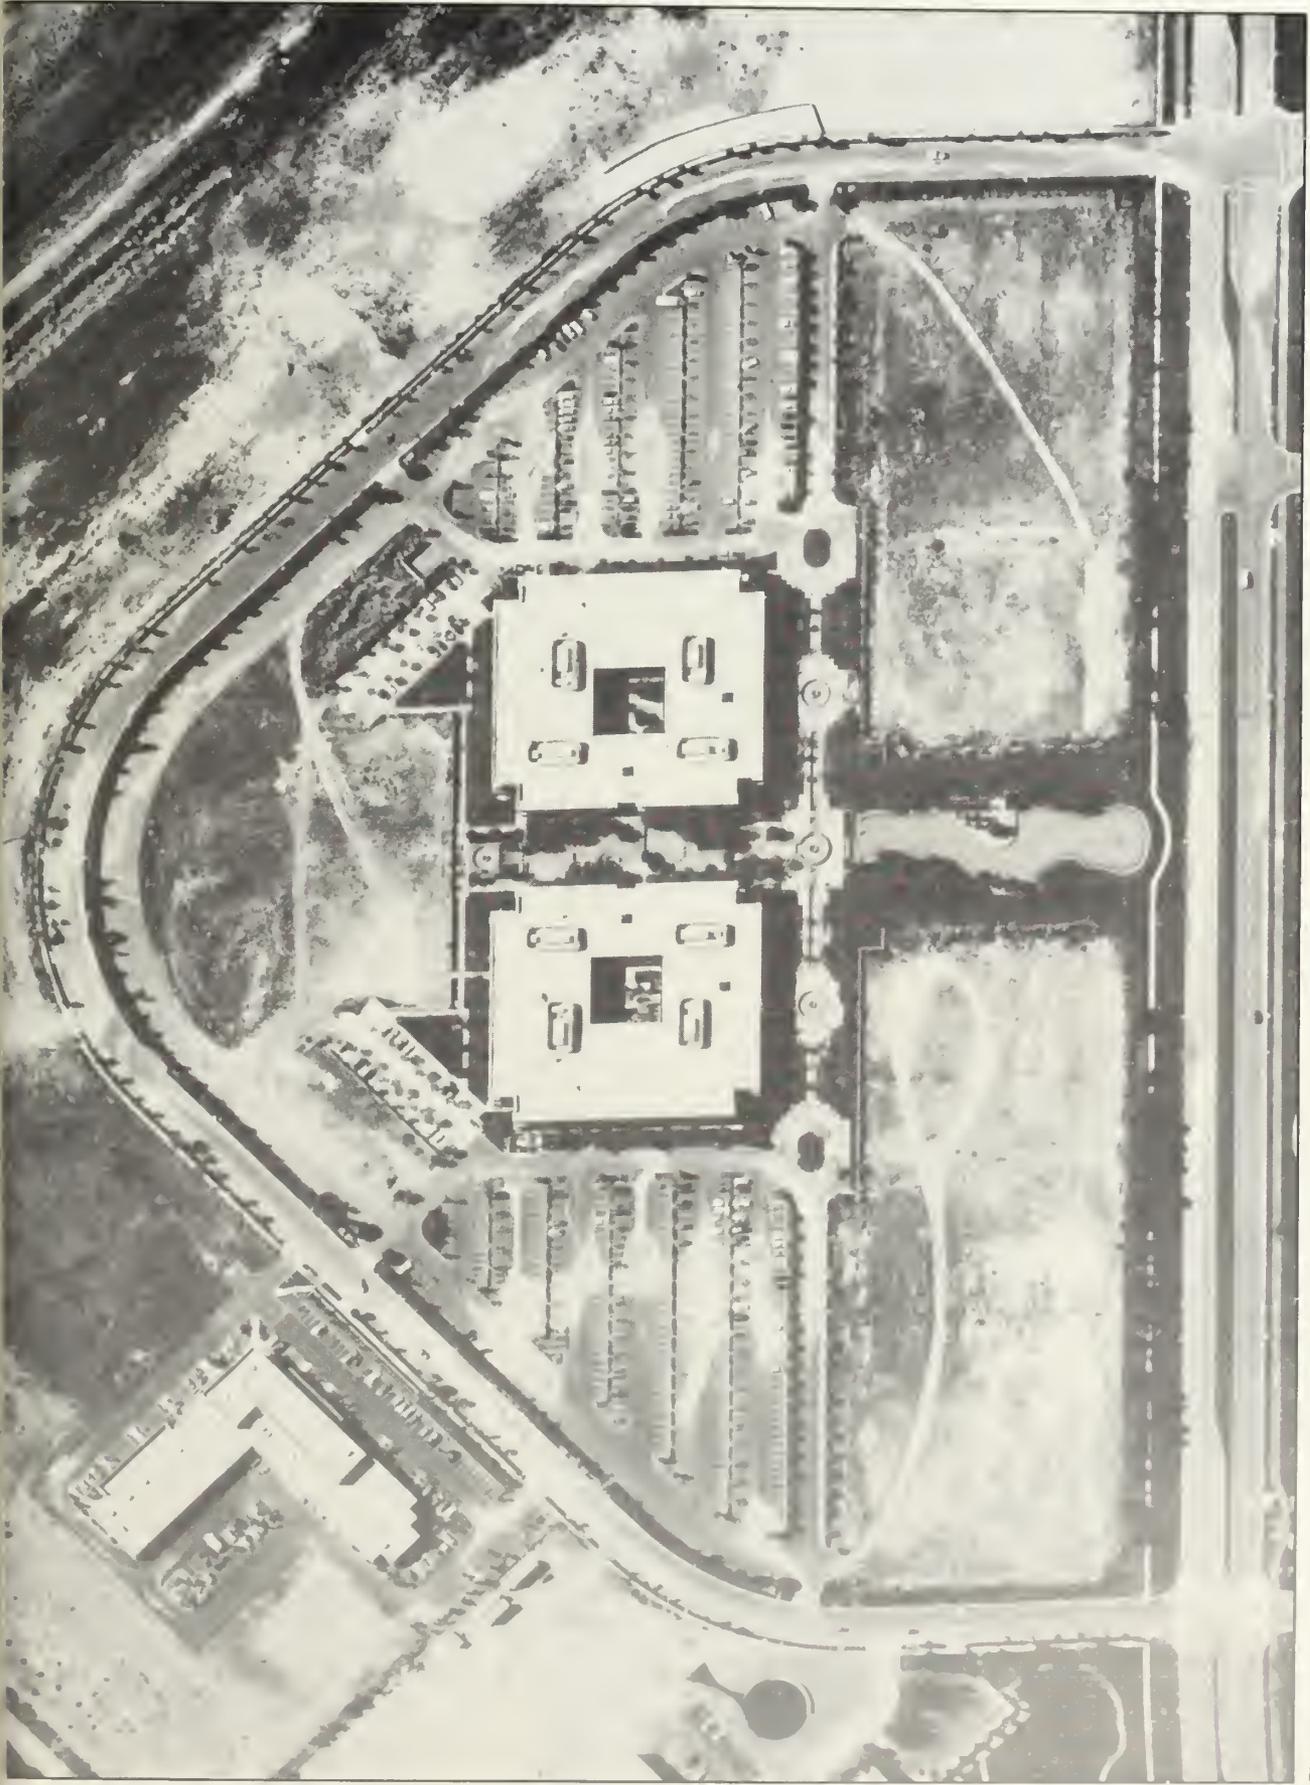
Photo 1 Twenty times enlargement of a portion of an IRIS-II panoramic camera aerial photograph showing liquefaction in a parking lot of an industrial park complex in Alameda. Notice white patches of sand against black asphalt in parking lots on both sides of complex.

Ground failures - As mentioned, liquefaction effects accompanied by the ejection of water and sand (flow failure) were generally identifiable on IRIS-II imagery (Photos 1 and 2). Because of good contrast, dry sand was more easily seen on dark ground or pavement, while wet sand was more easily seen on light colored ground. One case of suspected liquefaction at a high school football field in Santa Cruz proved not to be liquefaction, but runoff from water sprinklers. What appeared to be liquefaction along the boardwalk in Santa Cruz and at some locations near a shopping mall in Alameda, turned out, upon field inspection, to be ruptured water mains that had brought sand and water to the ground surface. We speculate that failure of the water mains probably resulted from liquefaction at depth.

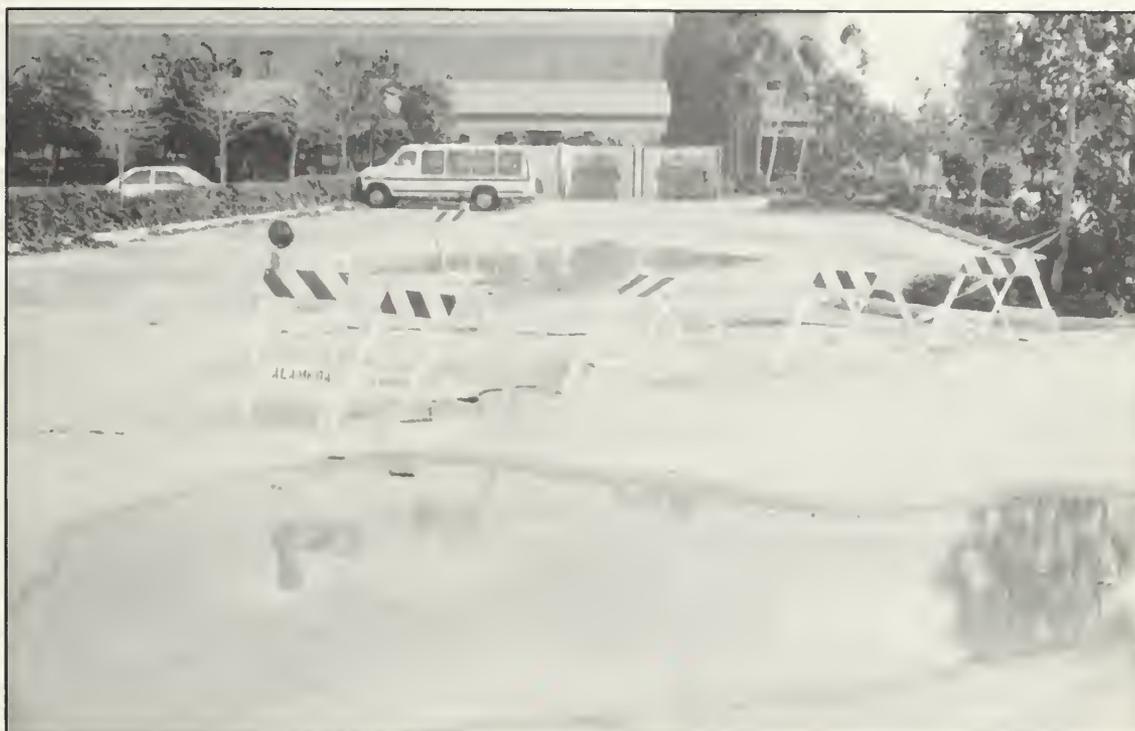
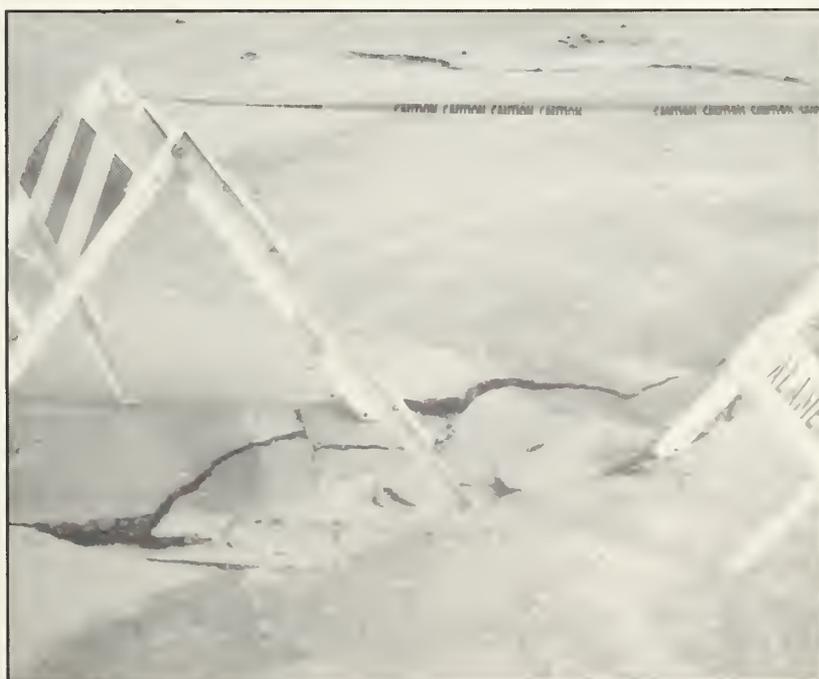
Photo 2. (A) Ground level photograph of liquefaction in parking lot of industrial complex (Photo by Charles R. Real) shown in Photo 1. (B) Close-up view of damaged area (Photo by Fumio Kaneko).
