Appendix L: Underground Storage Tank Remediation Report

Project No.
8346.000.003

Subject: Ball Ranch
300 Camille Avenue
Alamo, California

UNDERGROUND STORAGE TANK REMEDIATION

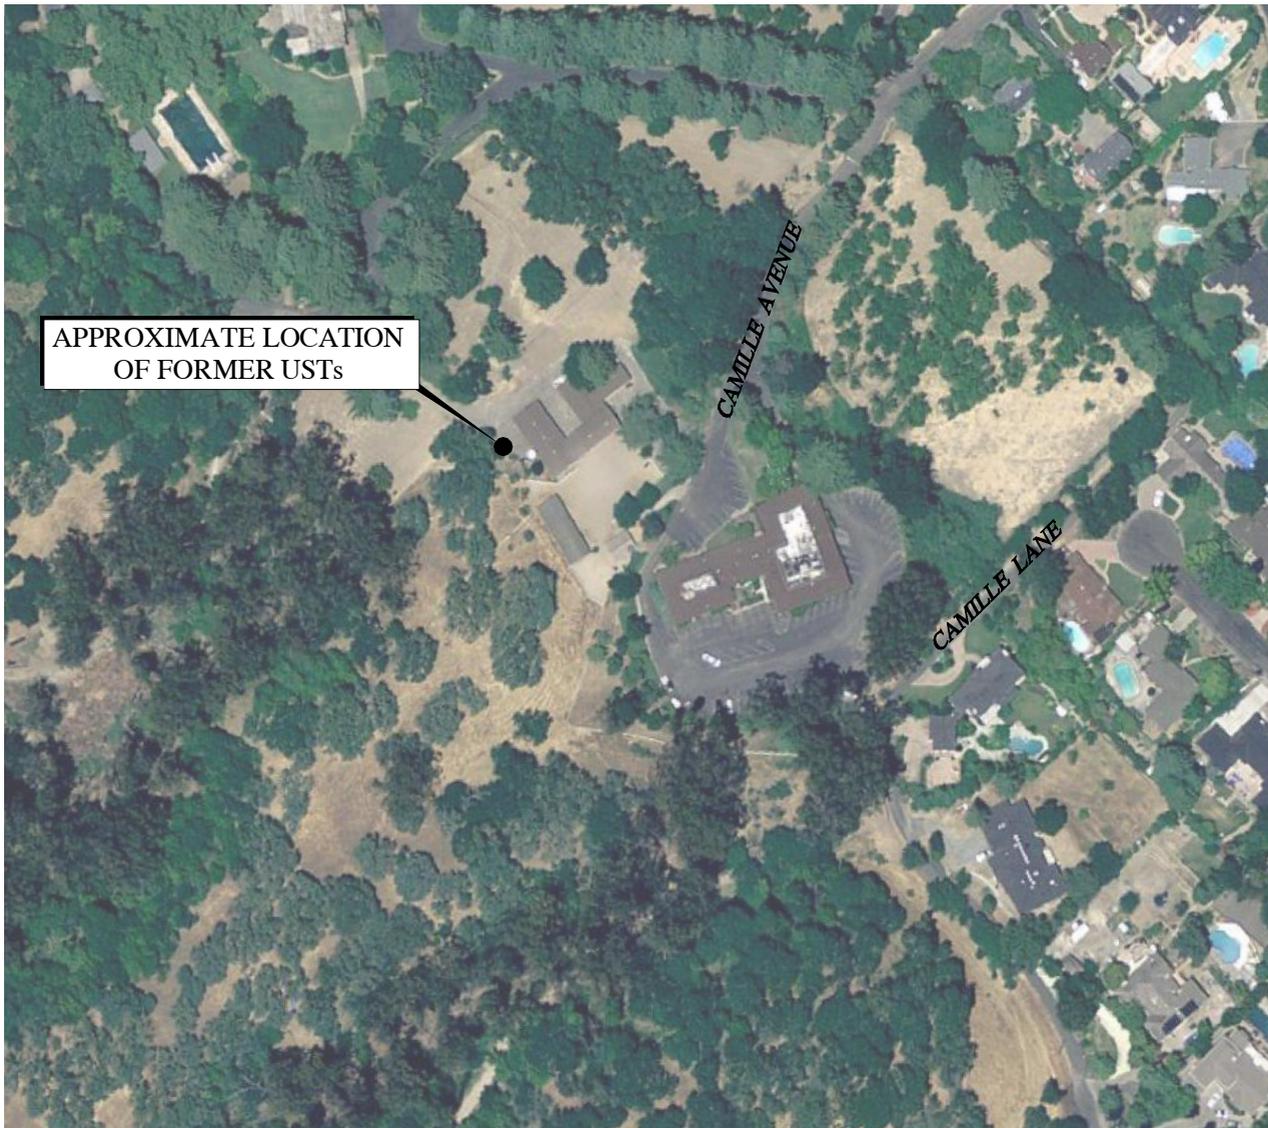
FIGURE NO
2

The subject Property consists of an existing rural residential/ranch located near the western terminus of Camille Avenue, in Alamo, California (Figure 1). Two underground fuel storage tanks were previously located within the site, southwest of a three-car garage (Figure 2). The two tanks were reported to each have a capacity of approximately 500 gallons and were used for the storage of gasoline.

APPROXIMATE LOCATION
OF FORMER USTs

FORMER UST LOCATION
BALL RANCH
ALAMO, CALIFORNIA

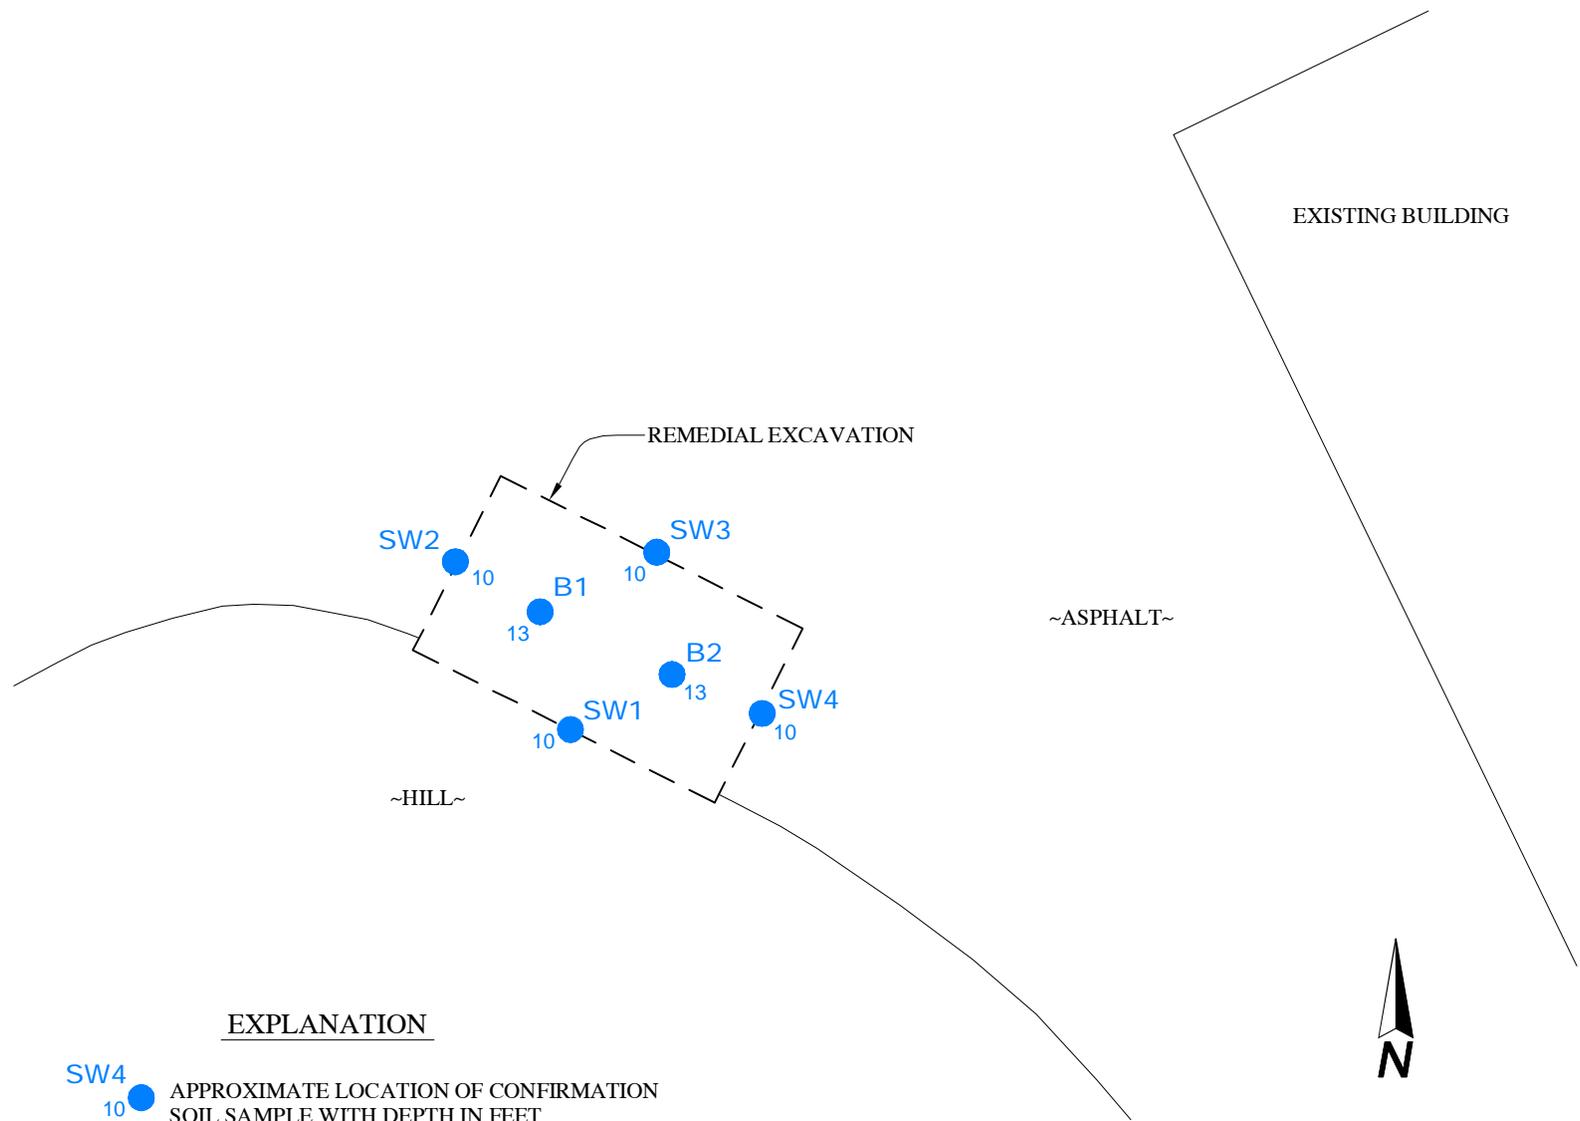
EXCAVATION SITE PLAN		PROJECT NO.: 8346.000.000 DATE: OCTOBER 2009 DRAWN BY: PC CHECKED BY: SPM	FIGURE NO. 3
	BALL RANCH			
	ALAMO, CALIFORNIA

We collected a total of two confirmation base samples and four confirmation sidewall samples from the completed excavation. The samples were collected from the backhoe bucket in new stainless steel sleeves and sealed with Teflon and plastic caps. We collected one discrete sample of the native overburden and a four point composite sample from the impacted soil stockpile.

SW4
10 ● APPROXIMATE LOCATION OF CONFIRMATION
SOIL SAMPLE WITH DEPTH IN FEET

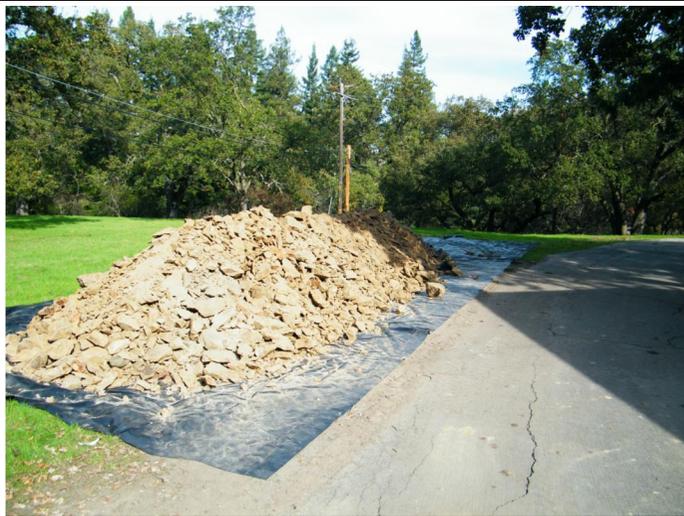
Approximately 25 cubic yards of impacted soil was excavated from below the base of the former UST basin, stockpiled on plastic sheeting, and subsequently transported to the Keller Canyon landfill in Pittsburg, California. Copies of the non-hazardous waste manifests and landfill receipts are provided as an attachment.

The native overburden and impacted soil stockpiles exhibited trace detections of TPHd at concentrations of 3.5 and 3.8 mg/kg.

STOCKPILE OF IMPACTED SOIL

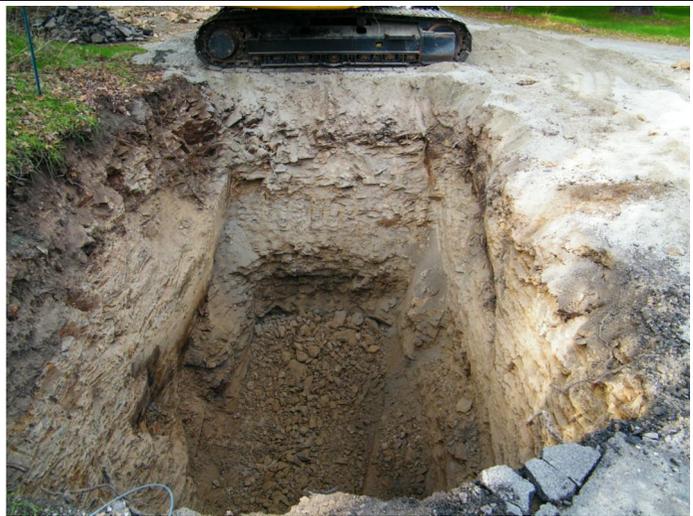
We observed a layer of medium-grained sand near the base of the UST basin from approximately 8 to 9 feet bgs. The sand, which was presumably placed beneath the USTs during the installation, exhibited a slight hydrocarbon odor. The native soil encountered beneath the sand also exhibited a hydrocarbon odor and consisted of a dense, light brown siltstone. The native soil from the base of the former UST basin exhibited PID readings ranging from 50 to 80 parts per million (ppm). Based on real time PID readings, the base of the former UST basin was extended from 9 to 13 feet bgs. Upon completion, the excavation measured approximately 10 feet by 18 feet with a depth of approximately 13 feet. No groundwater was encountered during the excavation.

The excavation confirmation samples exhibited no detections of TPHg, TPHd, BTEX, and MTBE above laboratory reporting limits.

VIEW OF BASE OF COMPLETED EXCAVATION

Since the sidewalls and base of the excavation appeared to be free of significant impacts, the excavation was backfilled the same day with the original aggregate base and native overburden material. The backfill activities are summarized in a separate report.

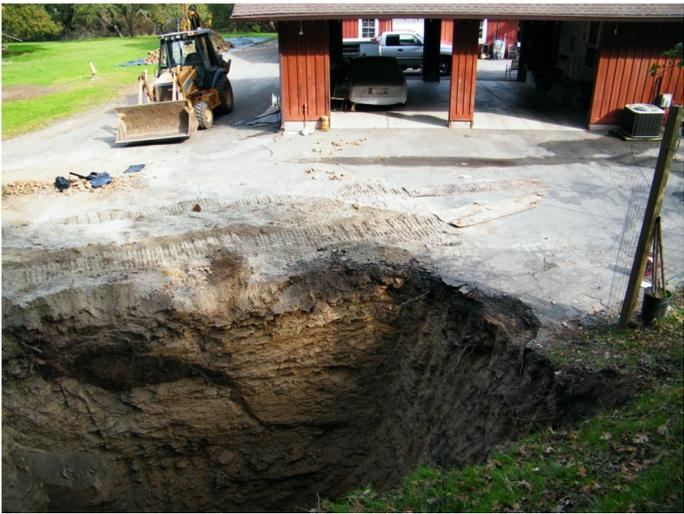
VIEWING EAST ACROSS THE EXCAVATION

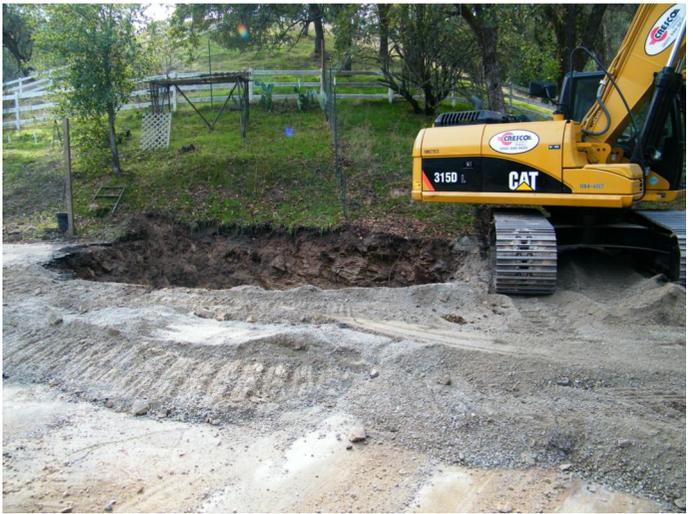
VIEWING SOUTH TOWARDS THE EXCAVATION

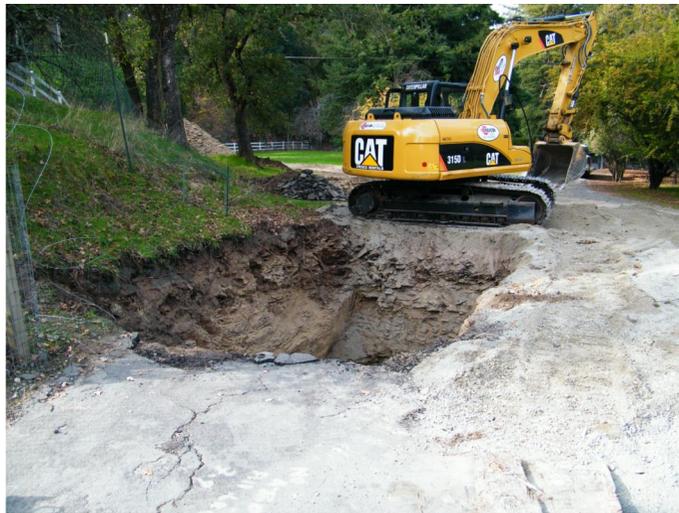
VIEWING WEST ACROSS THE EXCAVATION
